# Vintage Radio

## The Astor KM 4-Valve Reflexed Receiver

Developed during the very early days of radio, reflex circuits were used in receivers right up until the 1950s. One such set was the Astor KM.

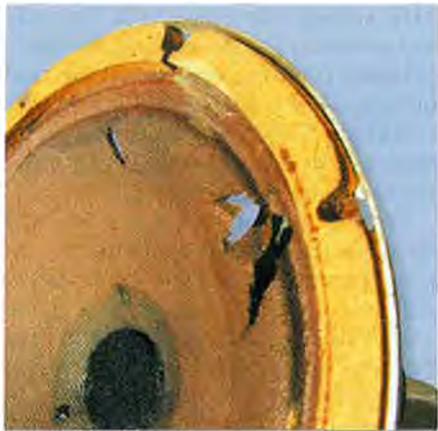
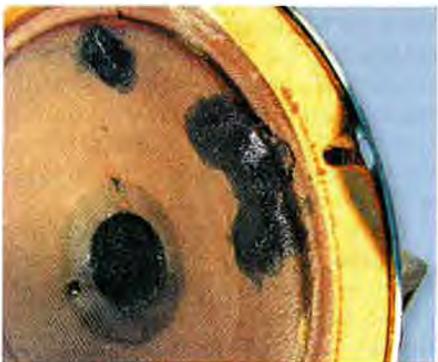
The loudspeaker had several tears in its cone (top) and these were repaired using several layers of nail polish. Despite its age, the repaired speaker still worked quite well.

Most of the wiring under the chassis had also perished and so had to be replaced. This was done one lead at a time (as with component replacement) to prevent any wiring mistakes and took almost a day to complete. In addition, the speaker had a few tears in its cone and this was repaired using several coats of nail polish. The cone moved in and out of the annular gap quite freely and did not appear to be poling, so the speaker was still OK.

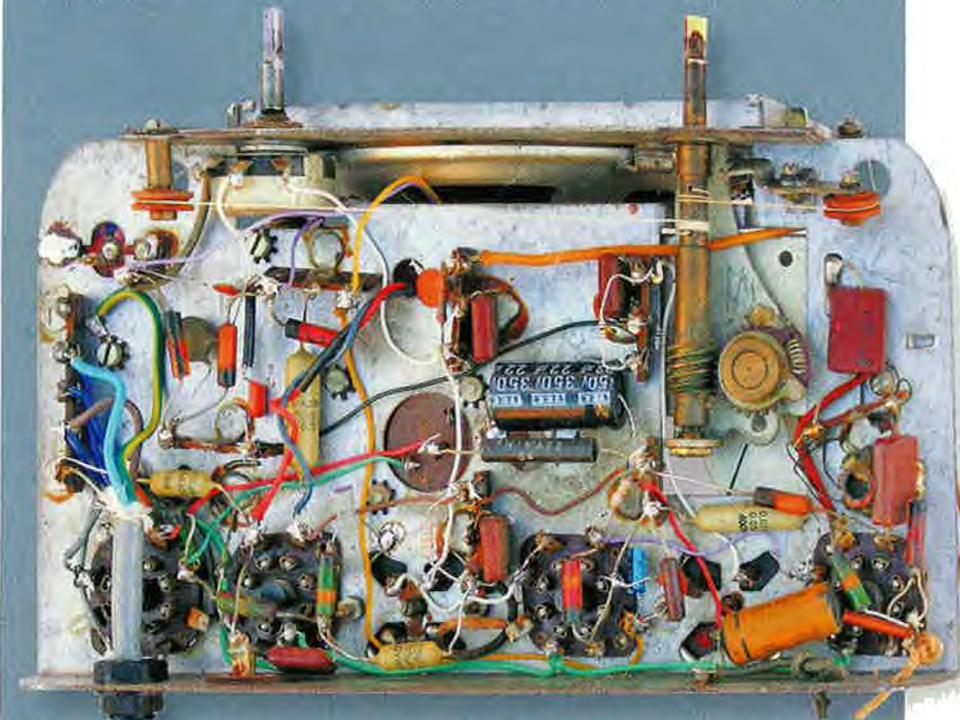
The unit after restoration. All but one of the original paper capacitors has been replaced, some resistors changed, the dial restrung and a new 3-way mains cord fitted and anchored using a cable clamp. In addition, the chassis is now earthed, in the interests of safety.

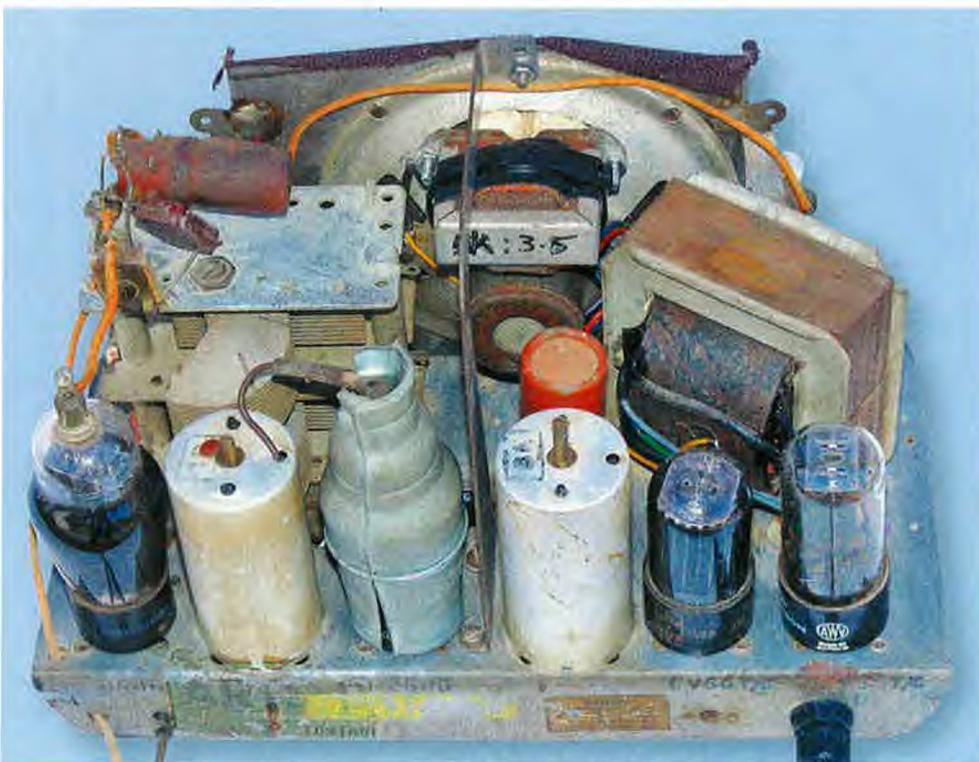
This top-of-the-chassis view shows the Astor KM receiver after restoration. The chassis was cleaned using a kerosene-soaked kitchen scourer, while the valves were cleaned by washing them in warm soapy water.

Removing these parts gave reasonable access to the chassis and the loose dust and fluff was brushed away from under and on top of the chassis using a small paintbrush. I then got busy with a kitchen scourer soaked in kerosene and some cleaning rags and thoroughly cleaned the chassis and any large components mounted on it. This is a straightforward task and the kerosene does a great job when it comes to loosening the muck.

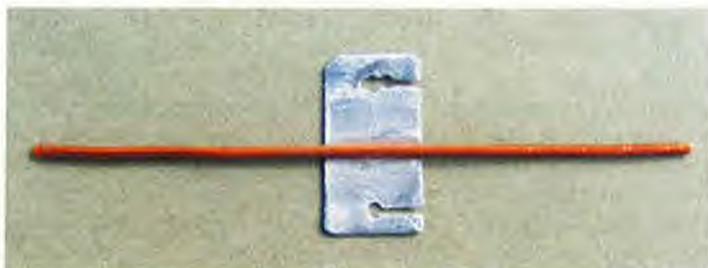
A new dial pointer was made by gluing a length of thick copper wire to an aluminium bracket. The pointer was then painted white.

Eventually, I decided to make one using a small scrap of aluminium roof flashing and a short length of thick copper wire. I cut two slots in one side of the flashing and de-burred them to make sure the edges would not cut the dial cord when it was routed through these slots. I then laid the wire across the flashing and secured it in place using superglue along the join (see photo).

Finally, the pointer was painted white to show up against the speaker cloth. It looks just like the original.

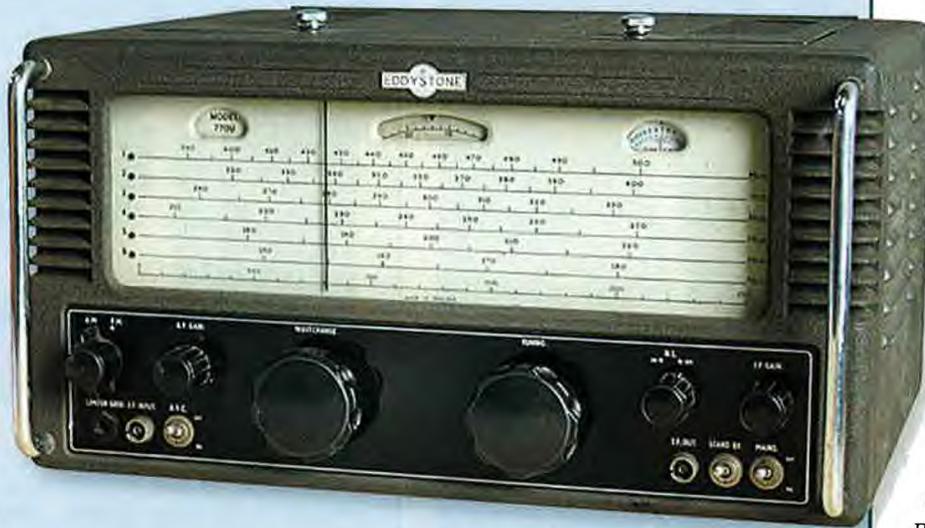
## Photo Gallery: Eddystone 770 VHF/UHF Receiver

**ONE OF THE BEST RECEIVERS** ever made, the Eddystone 770U VHF/UHF set was often found in radio manufacturers' test departments. It employs a total of 17 miniature 9-pin and 7-pin valves and two octal valves in the power supply. It tunes from 150MHz to 500MHz over six bands and its sensitivity is quoted at better than  $10\mu\text{V}$  for 15dB over all bands. The unit shown here outperformed its specifications. Apart from performance, a feature is the flywheel-weighted tuning which allows the operator to spin the dial knob and travel rapidly to each end of the dial, even though it is highly geared. Photo supplied by the Historical Radio Society of Australia Inc (HRSA), PO Box 2283, Mt Waverley, Vic 3149. [www.hrsa.net.au](http://www.hrsa.net.au)
