# Vintage Radio

## The Raycophone Broadcast-Band "Pee-Wee" Midget

Manufactured by Raycophone around 1933, the Pee-Wee Midget is an early superhet receiver with a regenerative IF stage. It's an interesting set but it does have a few design problems that limit its performance.

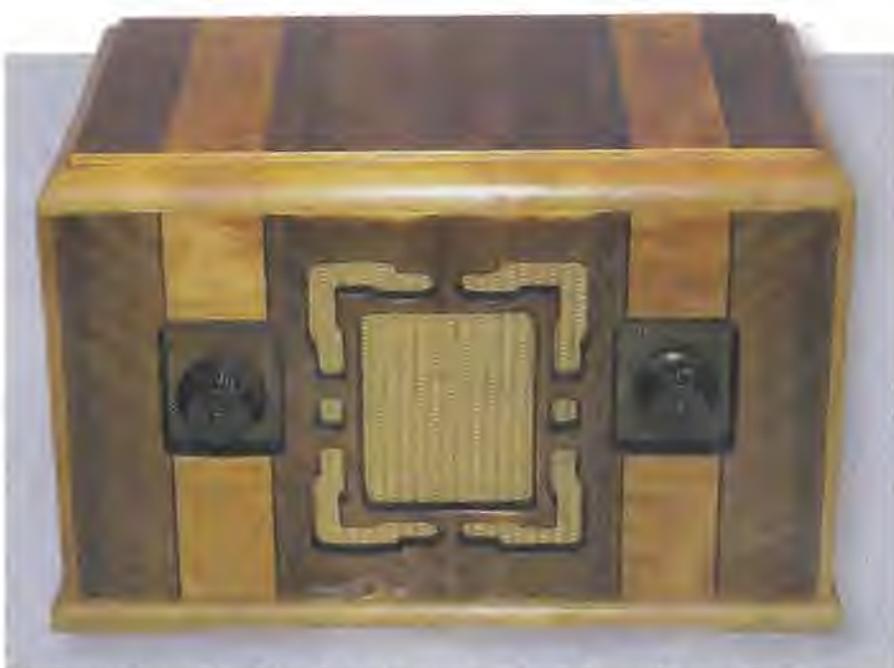
The Raycophone "Pee-Wee" is a compact unit that's housed in an attractive wooden cabinet. The lack of a dial and indistinct markings around the tuning knob makes it difficult to tune to a wanted station.

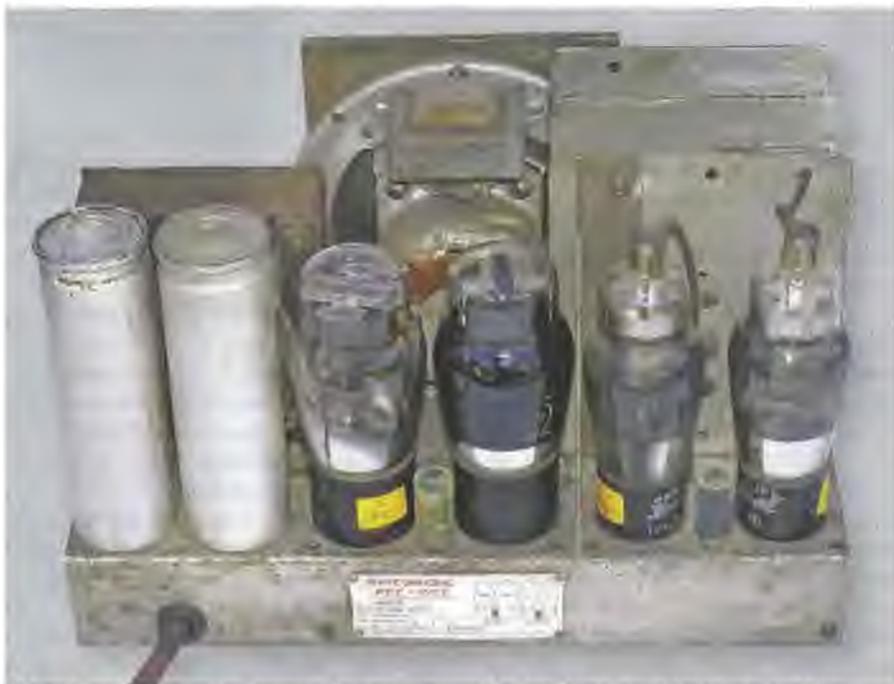
The chassis is easy to remove but care must be taken to avoid damaging the under-chassis components. The parts mounted on the top of the chassis are all easily accessible.

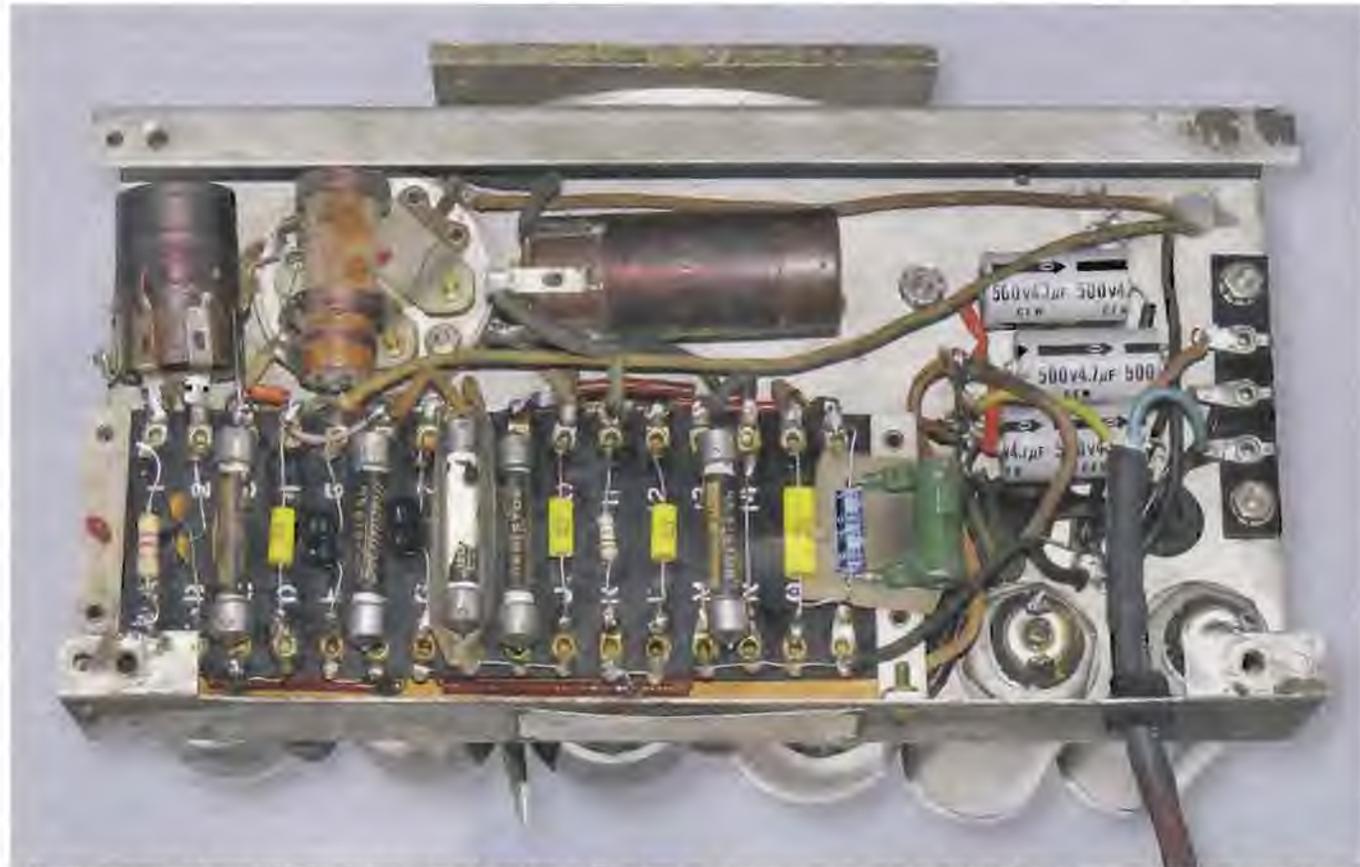
The parts are laid out quite neatly under the chassis but the long component strip is difficult to remove. This means that the parts under it can only be accessed for service after a lot of work.

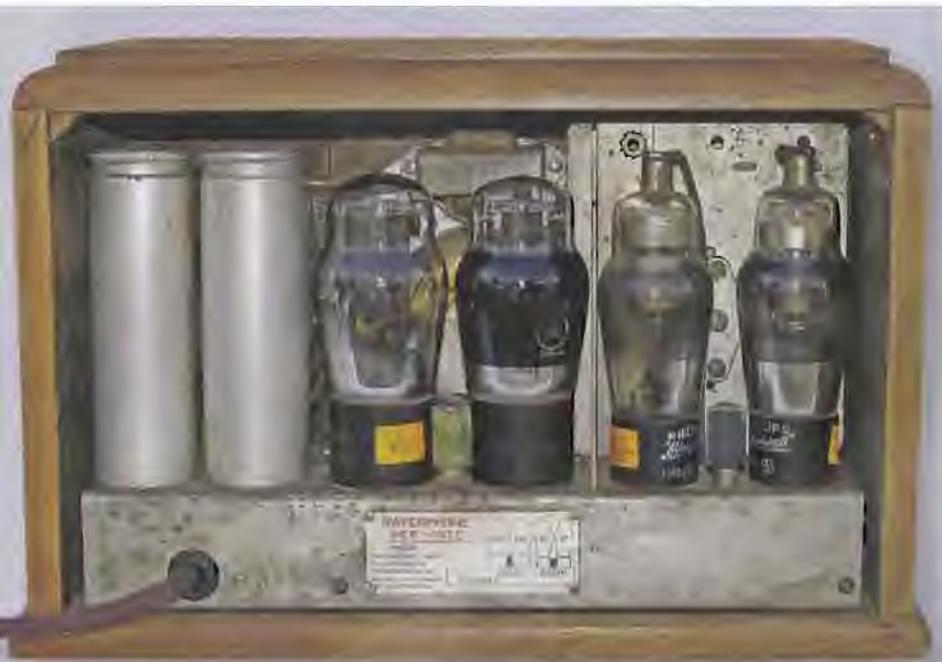
There's not much room left inside the cabinet when the chassis is slid into place, although the valves can still be replaced. Note the thickness of the timber used to make the cabinet.

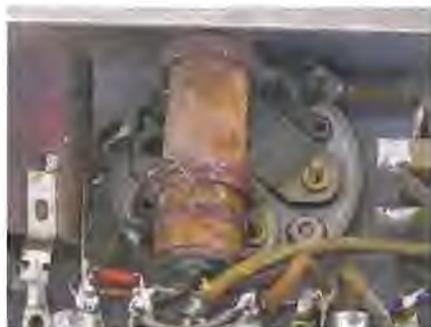
This view shows the unshielded 465kHz IF transformer windings. The leads are easily damaged when the chassis is removed.
