Vintage Radio

The AWA Radiola 653P AC/Battery Portable

First released in 1954, the AWA Radiola 653P was a 6-valve portable receiver that could operate from both batteries and mains power. It's a good performer that's easy to restore and get going.

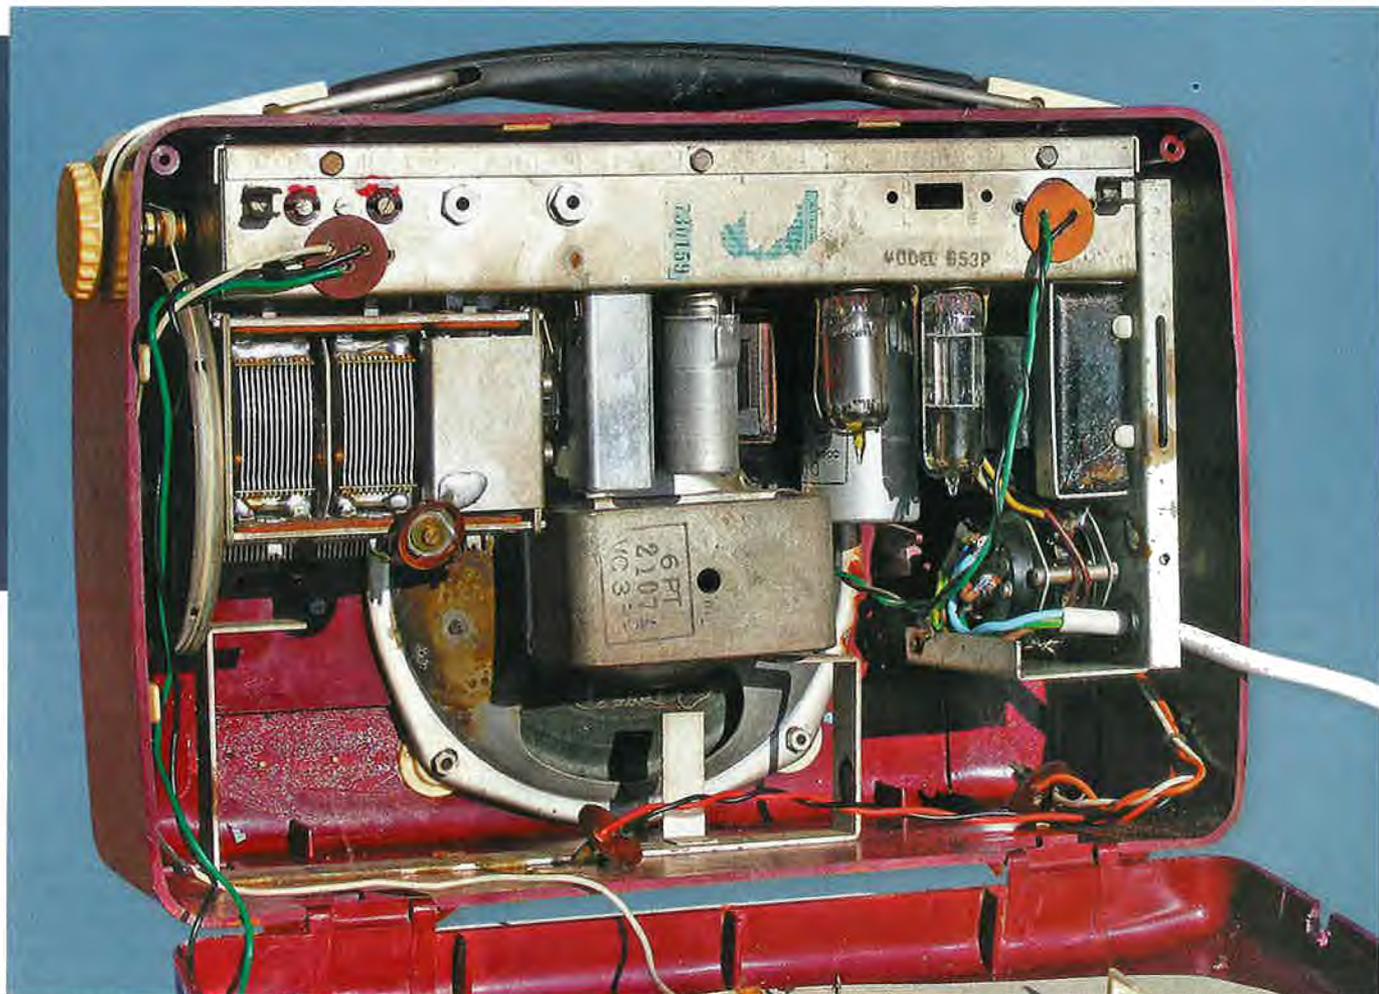
This is the view inside the Radiola 653P 6-valve portable. Note that the chassis is mounted upside down, with the valves secured in place using valve clips. The batteries are normally stored in the space at bottom left.

Turning two screws at the back through 90° and then laying the back down gives access to the inside of the set and to the batteries and AC power lead. As can be seen in the photos, the chassis is mounted upside down at the top of the cabinet, with the AC power supply at the right. The valves are all

held in position by clips, so that they don't fall out.

The six-inch speaker is in the centre of the cabinet against the front, while the two batteries sit on the bottom lefthand side of the case and are held in place by brackets. The AC power cord is stored in the space to their right, beneath the power supply transformer.
