Vintage Radio

The Leak TL/12 Plus Valve Amplifier

British manufacturers built some superb high-end audio amplifiers during the 1950s and 1960s and the Leak TL/12 was one of these. It's a 5-valve mono amplifier with some interesting design features and is reasonably easy to service.

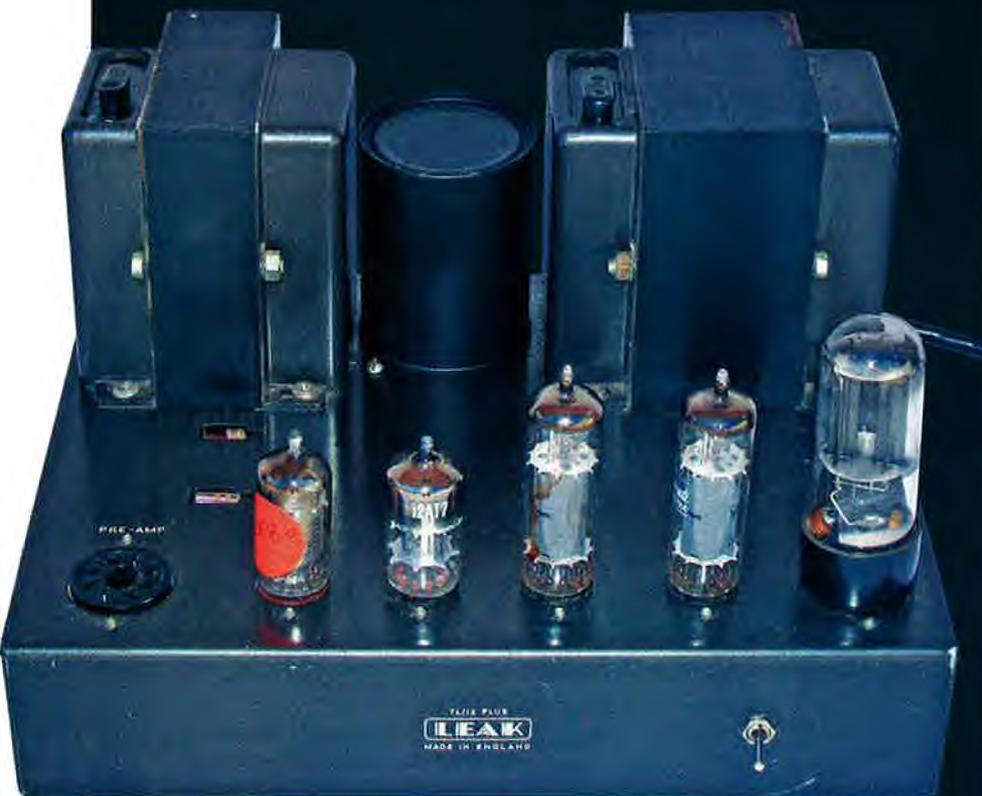
This view shows the fully restored audio amplifier. Note the new capacitor can at the back, between the two transformers.

Next, I decided to improvise a chassis-mount can to house the fresh 32 μ F capacitors (C13 & C14). A small can of mushrooms was just the right size for this job.

Having consumed the mushrooms and cleaned the tin, I soldered two solder lugs to it at the open end, so that I could later bolt it down to the chassis. The can was then sprayed with matt black spray paint to match the rest of the amplifier.

Next, I cut a small section of perforated board to mount underneath the chassis, directly below where the capacitor can would sit. The new electrolytic capacitors were then installed inside the can and held in place with contact adhesive, foam plastic sheet and electrical insulation tape. That done, I mounted the new can, complete with the capacitors, onto the chassis and wired the components into circuit via the perforated board (see photo).

The top of the chassis now looks almost the same as it did when the amplifier was new.

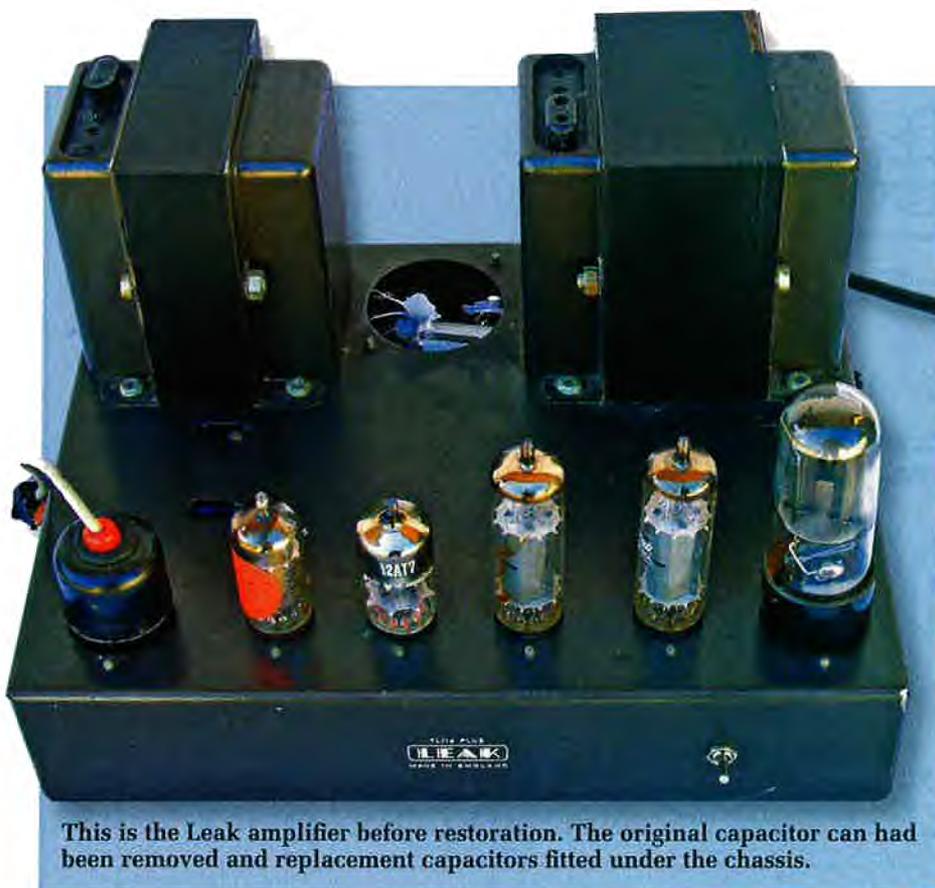
This is the Leak amplifier before restoration. The original capacitor can had been removed and replacement capacitors fitted under the chassis.

piece of equipment. For example, the main supply electrolytic capacitors had been replaced but instead of being fitted into a can above the chassis, had been attached to the underside of the chassis with silicone sealant. However, since the repair, they had subsequently parted company with the chassis, so that they were just floating on their leads.

It's worth noting that the ones I removed didn't suit the amplifier, although they were still working OK. For example, C13 and C14 (the main supply filter capacitors) were both 100 μ F capacitors instead of 32 μ F, as specified on the circuit. In particular, C14 should not have been increased to 100 μ F as the peak charging current through rectifier valve V5 would have exceeded its rating and shortened the life of the valve.

My first step was to replace all the

high-voltage electrolytic capacitors with more suitable values and voltage ratings. At the same time, I made sure that these were installed in a much more professional fashion.

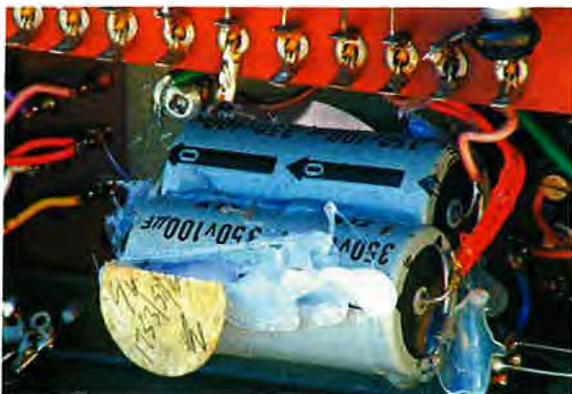
They looked terrible and would have still looked terrible even if the silicone had held fast.

The replacement capacitors had been secured with silicone sealant but this had since parted company with the chassis.

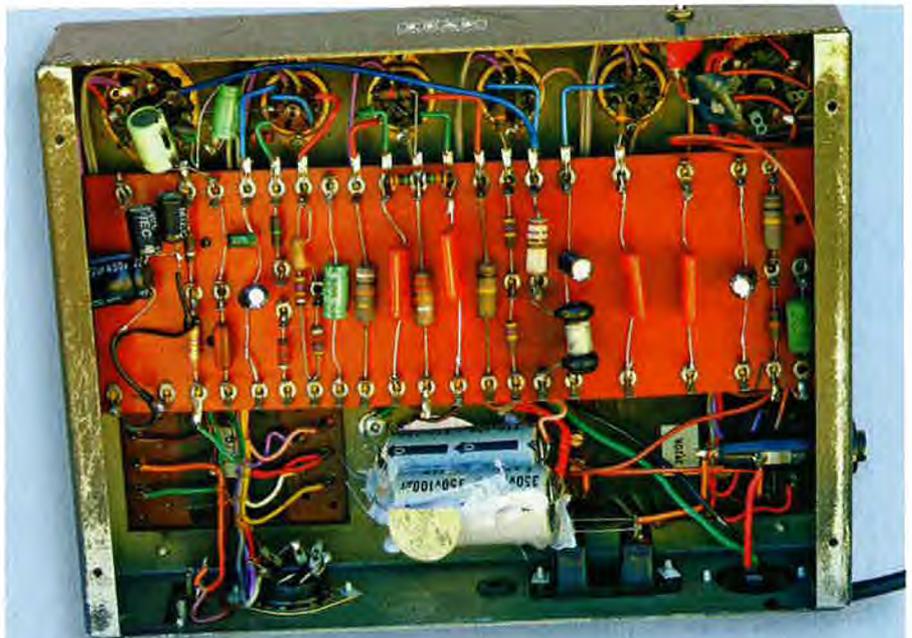
Other electrolytic capacitors looked as though they had just been “thrown in” too, in various other parts of the amplifier. In fact, it looked like all the electrolytic and paper capacitors had been replaced.

This under-chassis view shows the amplifier before restoration. Note how the replacement electrolytic capacitors at the bottom had come adrift, giving an untidy appearance. The parts on the tag board are easy to replace.

While the paint was drying, I checked all the resistors in the amplifier. A number of these were considerably out of tolerance and so were replaced. These components are all mounted on a large tag strip and are quite easy to get at. However, for some strange reason, many of the components are not grouped close to the valve stage that they attach to.

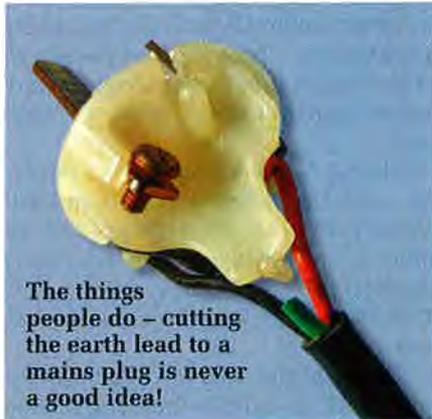
The things people do - cutting the earth lead to a mains plug is never a good idea!

Before going for the smoke test, I carefully checked all the wiring, terminals and components and all looked to be in order – with one critical exception. When I checked the wiring to the power plug, I found that there was no continuity between its earth pin and the chassis.

A quick check at the amplifier end showed that the earth lead was securely attached to the chassis so I removed the cover from the 3-pin mains plug. And that revealed the problem – as shown in one of the photos, the earth lead had been cut off.

Of course, it couldn't be left like that, since that would leave the chassis without an earth which would be dangerous. Cutting the end off the mains cable and re-attaching the plug quickly solved that problem.
