Vintage Radio

The American Philco 52-545 5-Valve AC/DC Mantel Receiver

Manufactured in the US in the early 1950s, the Philco 52-545 is a 5-valve broadcast-band superhet. It's a transformerless AC/DC that runs directly off 115V AC and so a care must be exercised when working on it.

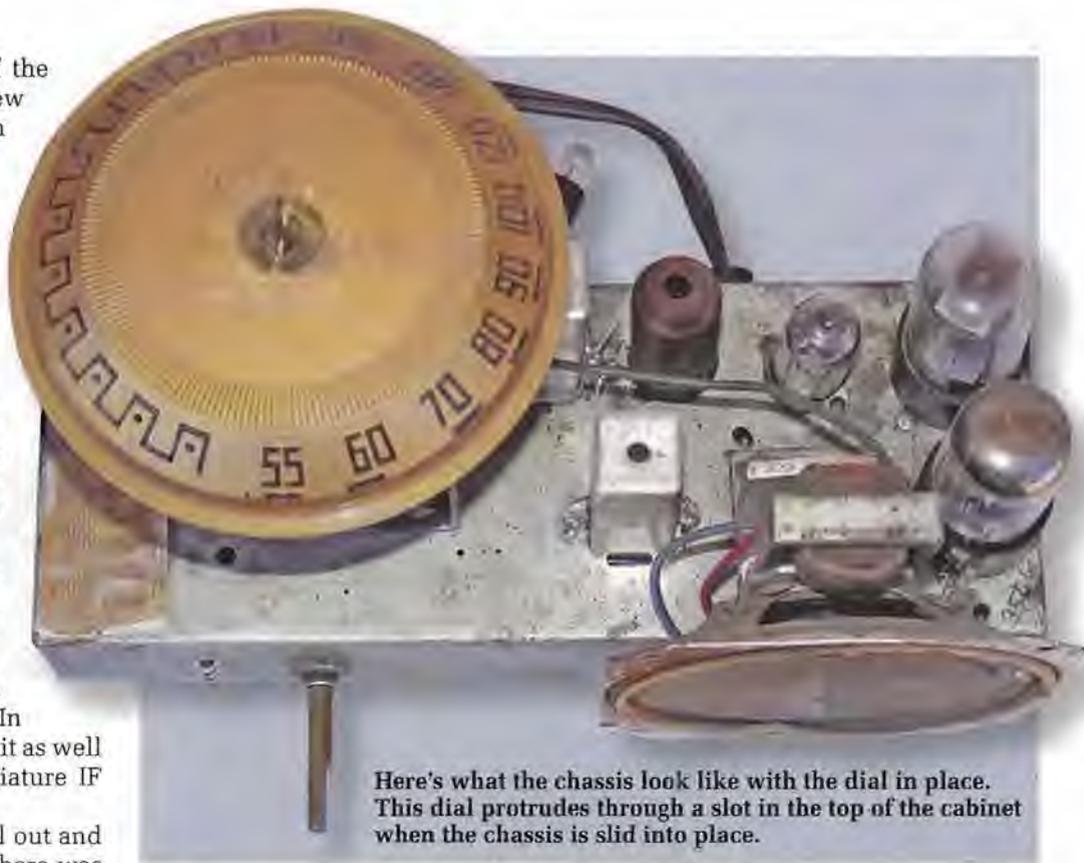
Here's what the chassis look like with the dial in place. This dial protrudes through a slot in the top of the cabinet when the chassis is slid into place.
