Vintage Radio

The AWA 693P 3-Band 8-Transistor Portable

. . . the transition from valves to transistors

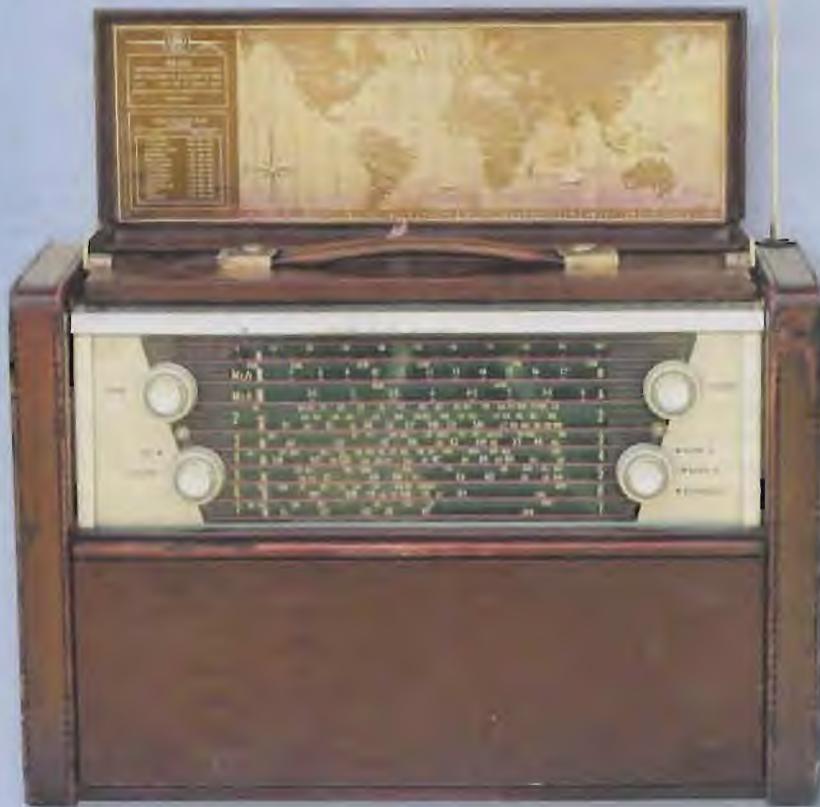
The AWA 693P is an impressive 3-band 8-transistor set that was manufactured by AWA in Australia during the early 1960s. It doesn't use a PC board but instead employs point-to-point wiring, just like the valve radios of that era.

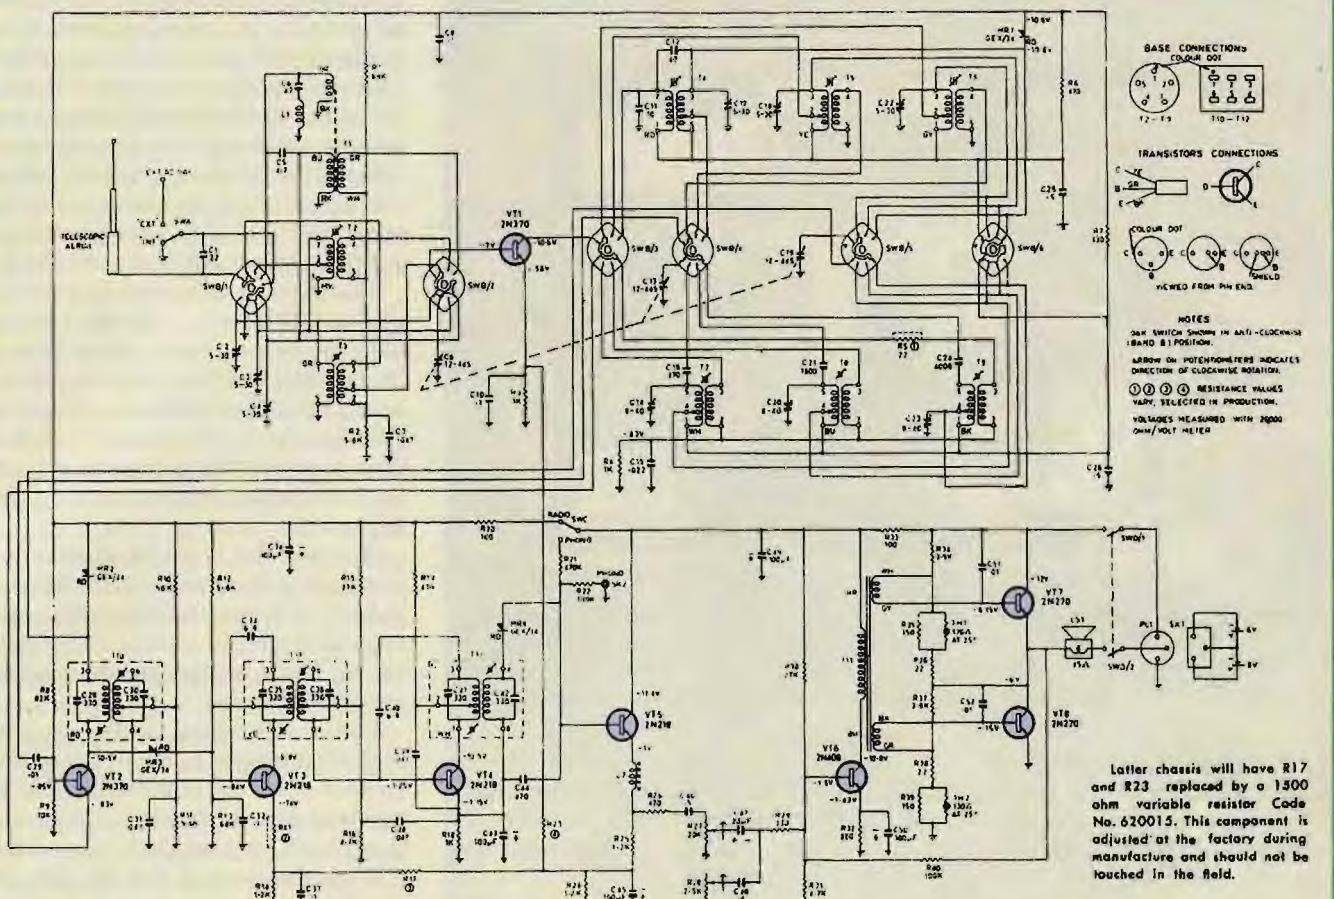
Fig.1: the circuit is a conventional 8-transistor superhet design, with transistor VT1 functioning as an RF amplifier stage, VT2 as the converter, VT3 & VT4 as IF amplifiers and VT5-VT8 as the audio stages. Diode MR4 is the detector.

The circuit (see Fig.1) is really quite conventional for a set of that era. As shown, the antenna input consists of a network that allows the use of either the in-built telescopic antenna or an external long-wire antenna on all bands.

RF transistor VT1 (2N370) amplifies the input signal from the antenna and passes it via further tuned circuits to an autodyne converter stage based on VT2 (2N370). The output from this stage is then applied to the first IF transformer and thence to a 2-stage IF amplifier consisting of transistors VT3 & VT4 (2N218). Both stages are neutralised by C33 & C40 respectively.

From there, the signal passes to a detector and AGC diode (MR4), after which the detected signal is fed to VT5 (2N218). This stage acts as both an AGC amplifier and first audio am-

plifier. The resulting AGC is directly applied to VT3 and VT1 and also from VT3 to the first two IF transformiers via MR3 to control the gain through the amplifier.

The detected audio signal at the emitter of VT5 is fed through an RF choke (L2) to filter out any remaining IF signals in the audio. The audio is then applied via volume control R27 and tone control R28 to audio driver stage VT6 (2N408).

VT6 is turn feeds a driver transformer with three windings. One goes to the collector lead of VT6, while the other two drive the base leads of output transistor pair VT7 and VT8 (2N270).

As shown, these two output transistors are wired in series and each has a thermistor in its base-bias circuit to

stabilise the quiescent current against variations in temperature. Germanium transistors are particularly sensitive to heat and will draw considerably more current as the transistor junction temperature rises unless precautions are taken. If the current rises to any extent, a runaway situation can occur where more and more current is drawn until the transistor finally destroys itself.

The emitter-collector junction of VT7 & VT8 drive the speaker's voice coil, the other side of which goes to the centre tap of the power supply. Assuming that the output transistors and their base bias networks are matched, then there will be no current through the loudspeaker when no audio signal is present.

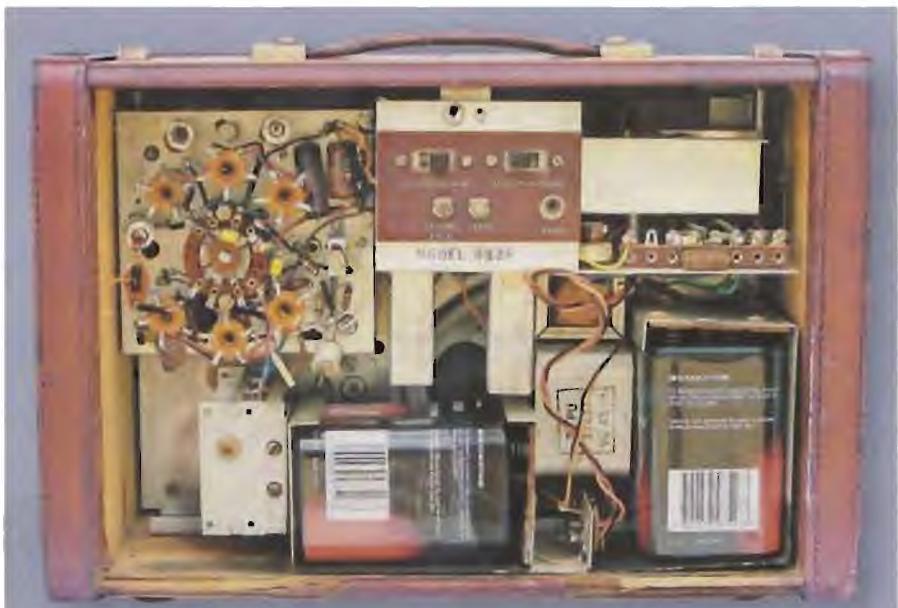
This is the view inside the back of the set with the two 6V lantern batteries in place. Note the point-to-point wiring and the components around the band-change switch at top left.

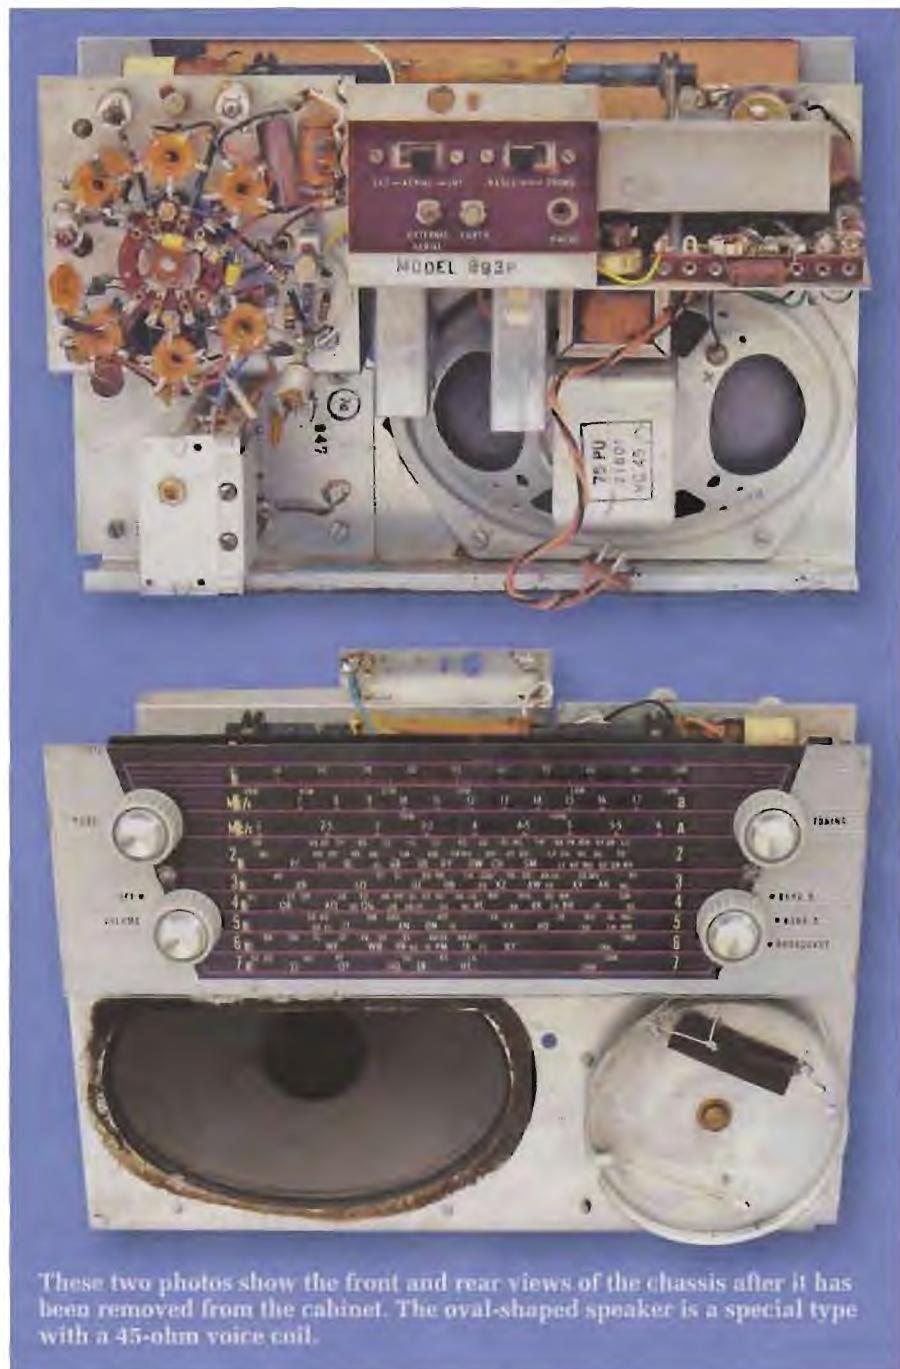
These two photos show the front and rear views of the chassis after it has been removed from the cabinet. The oval-shaped speaker is a special type with a 45-ohm voice coil.

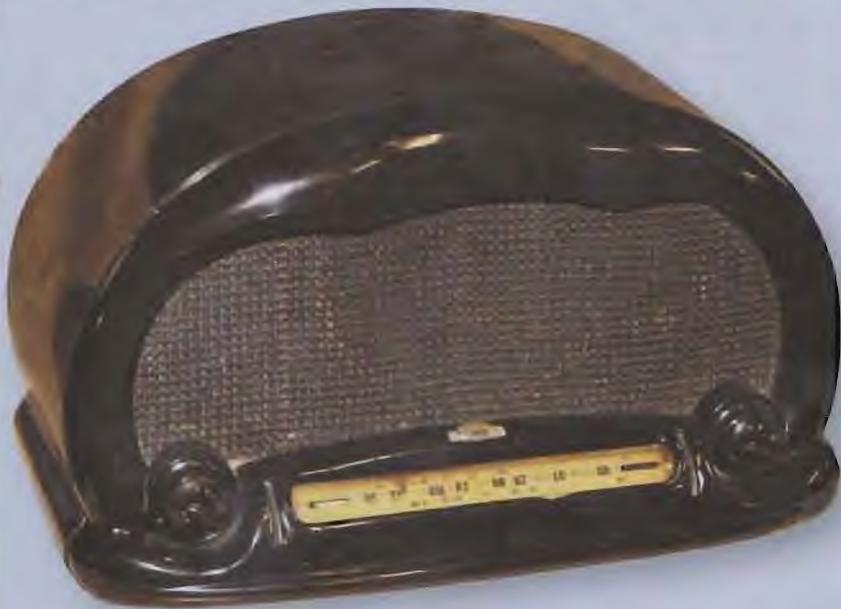
Photo Gallery: Astor JN Dual-Wave Receiver

NICKNAMED "SYDNEY HARBOUR BRIDGE" after its smooth arch shape, the Astor JN dual-wave receiver was housed in an attractive, dark-chocolate bakelite cabinet with a faint embedded pattern. Its copious size enabled Astor to enclose a quality chassis with power and performance comparable to a radiogram, so this model is on most enthusiasts' must-have list.

An unusual feature is the roll-tuning dial. The station tuning is a normal linear action but turn the thumbnail dial and the stations from another state appear. It's interesting to note that the Victorian dial also has Devonport shown, such was the performance of the chassis with an external wire antenna (there was also lower electrical interference in the 1950s).
