# Vintage Radio

## The unnamed console – an orphan from the 1930s

Orphans have always been with us and that includes products with no identifiable manufacturer. This month, we take a look at a rather interesting 6-valve console receiver from the 1930s. It's a well-made set with no name but is one that any manufacturer would have been happy to claim.

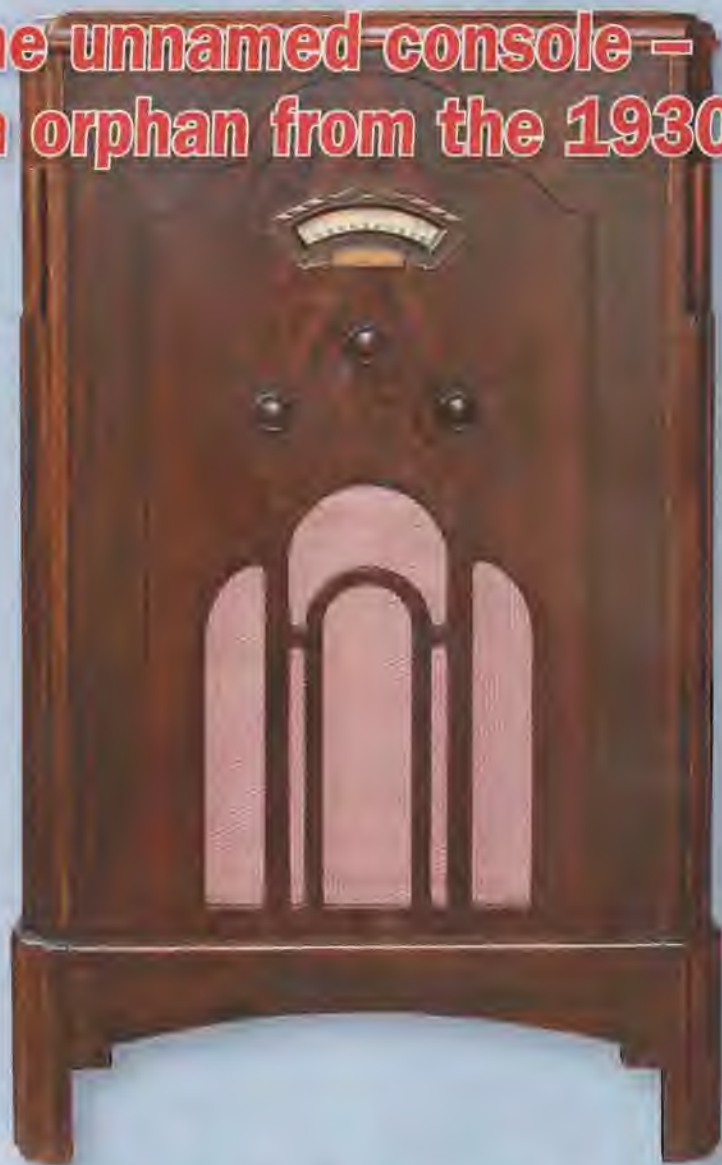
The cabinet of the old console was in remarkably good condition and according to Mark, required very little to make it look almost like new. The controls on the front of the set are, from left to right: Tone, Tuning and Volume. However, like most sets of the era, it had no On-Off switch.

Next, teak oil was applied to the outside of the cabinet using a soft cloth, while the inside of the cabinet was treated with linseed oil diluted with mineral turps. A fresh speaker cloth was then fitted as the original was in poor condition.

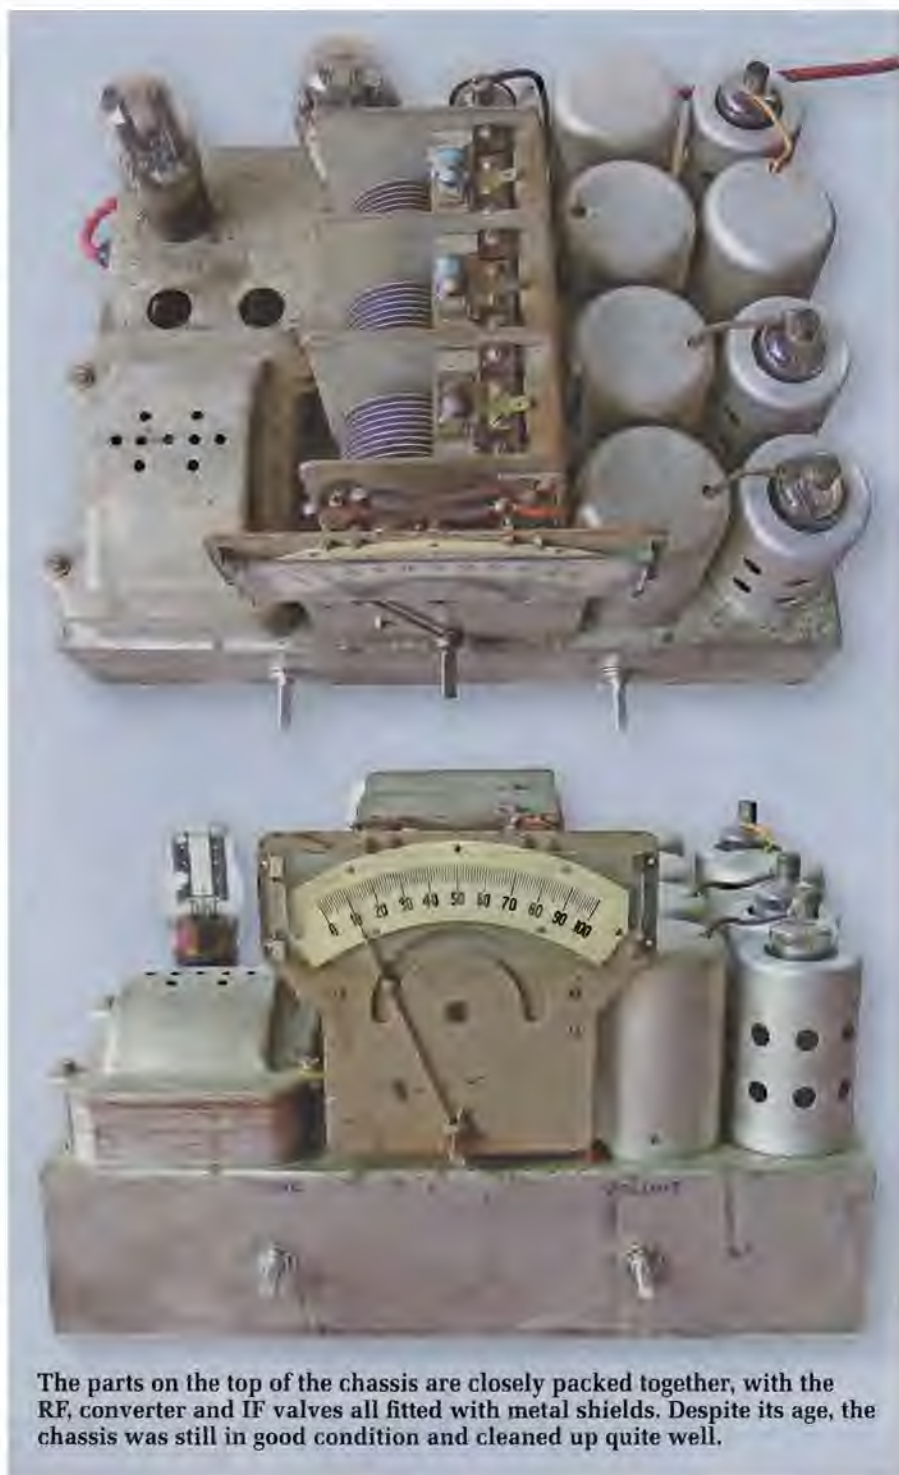
The parts on the top of the chassis are closely packed together, with the RF, converter and IF valves all fitted with metal shields. Despite its age, the chassis was still in good condition and cleaned up quite well.

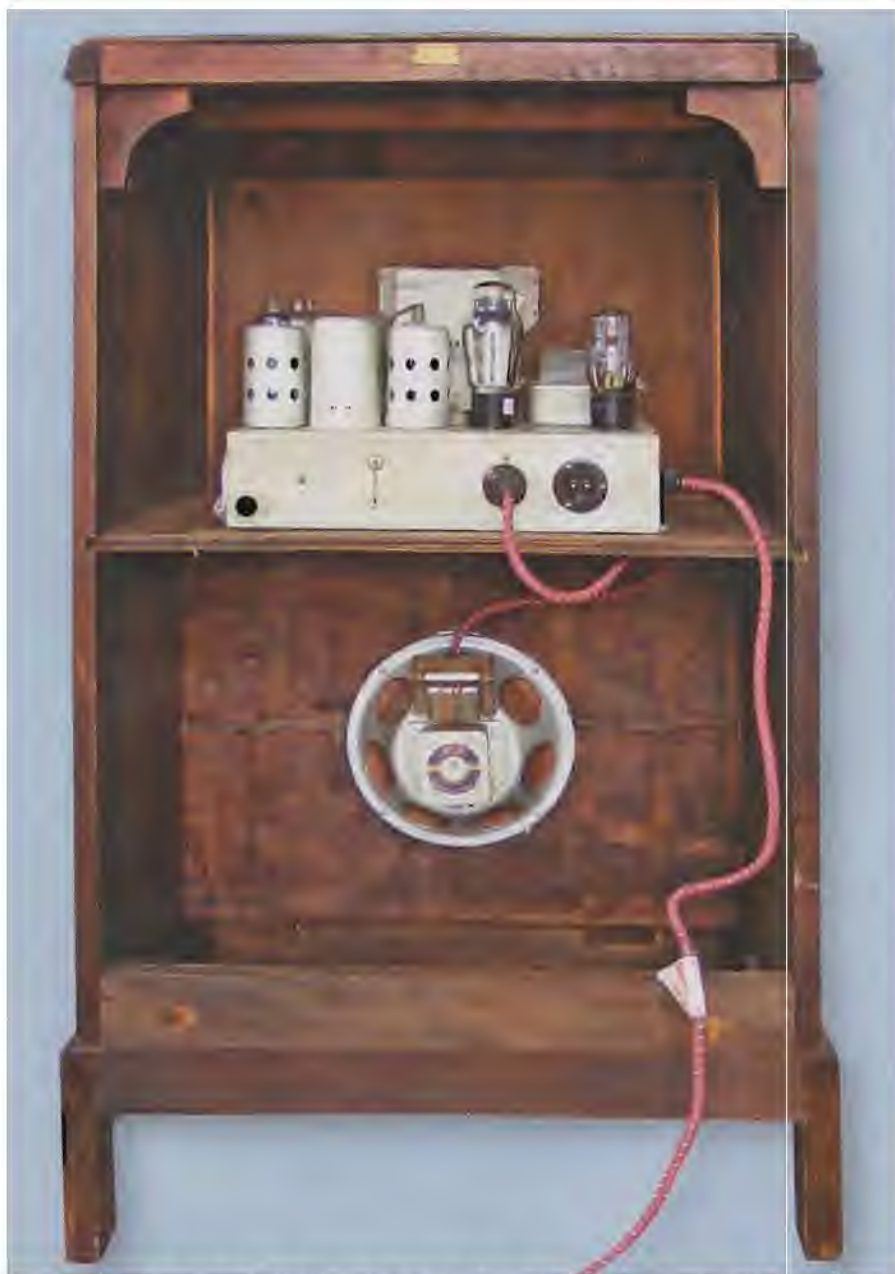
The chassis sits on a shelf about half-way down the cabinet, while the speaker mounts on a baffle below it. The original electrodynamic speaker was defunct and was replaced with a more modern permanent-magnet unit.

First, Marcus found that the original electromagnetic speaker had been replaced with a permanent-magnet "Amplion" speaker. There is nothing inherently wrong in changing the speaker type but in this case, the 2500-ohm speaker field coil resistance had not been taken into account and no resistance had been fitted to the HT line in place of the field coil.

Marcus replaced the 2500-ohm resistance of the field coil with two 4.7k $\Omega$  wire-wound resistors wired in parallel. Another wirewound resistor was used to replace the damaged 15k $\Omega$

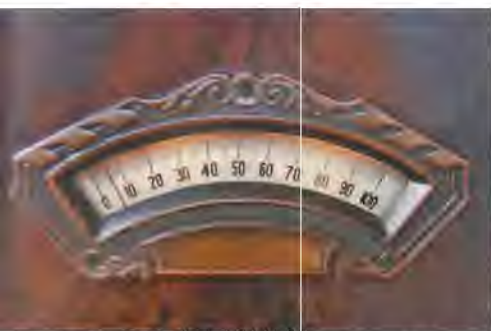
This close up view shows the dial fitted to the receiver. There are no station markings. Instead, it's simply marked with a 0-100 scale.

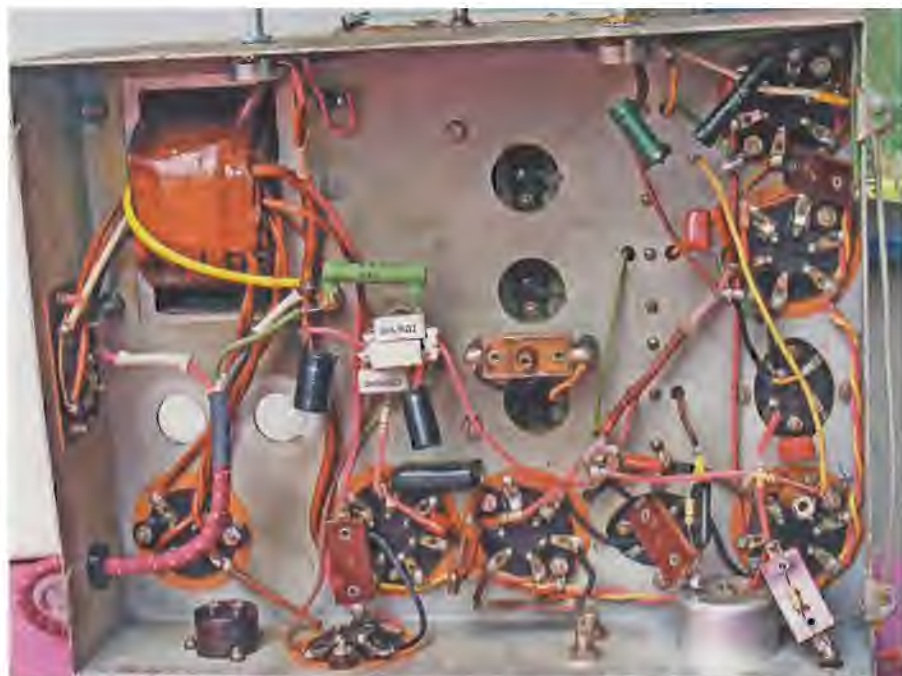
Most of the carbon resistors and all the paper capacitors were faulty and had to be replaced, along with the electrolytic filter capacitors. The wiring to the mains output socket at bottom left was disconnected in the interests of safety.

Having replaced the electrolytics, Marcus then checked the carbon resistors. Most were out of tolerance and were replaced, as were all the paper capacitors. To keep the chassis looking authentic, the leads of these components were sleeved in fabric-

One potential problem was a mains socket on the rear of the chassis, presumably for a turntable motor. This had exposed (recessed) pins which presented a serious safety hazard. As a result, the mains leads to this socket were removed to render it inoperative and so it is now purely a cosmetic item to help maintain the original appearance.
