Vintage Radio

Kellogg TRF receiver: home made or manufactured?

This simple little receiver is an excellent example of a 3-valve TRF set from the mid-1920s and has quite reasonable performance. Its exact origin is somewhat obscure, however.

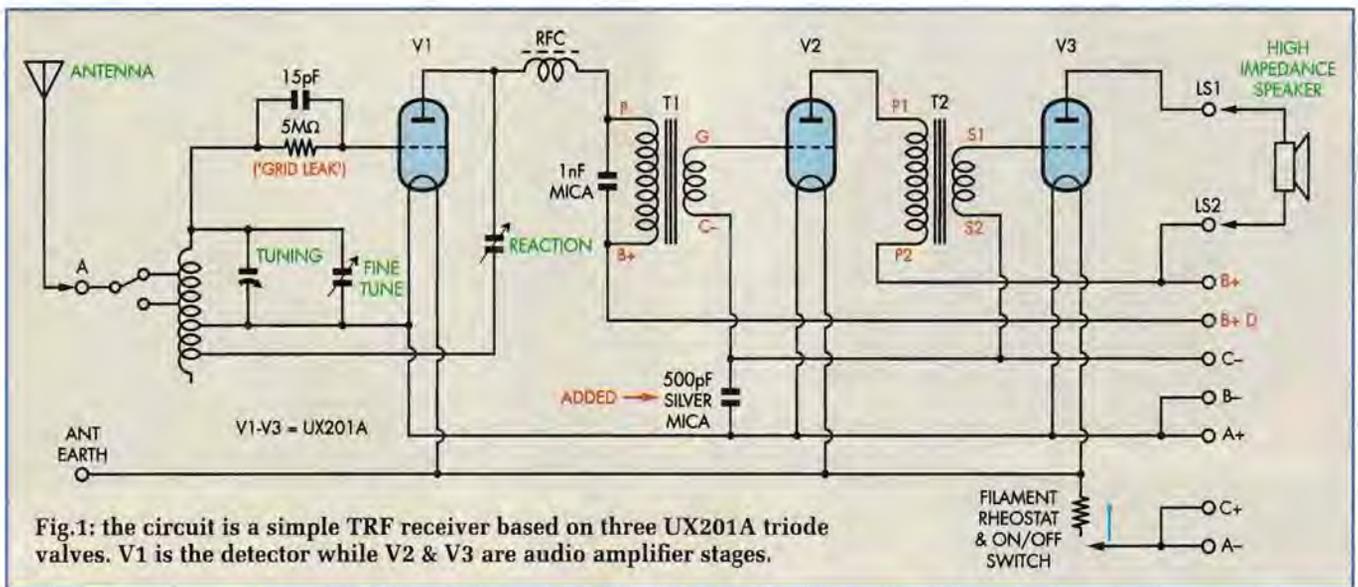
The Kellogg, for want of a name, is a conventional 3-valve TRF receiver from the mid 1920s. The antenna tuned circuit consists of a single winding that is tapped for different-size

antennas. It also has a tapped feedback winding for regeneration (or reaction).

The top of the tuned section feeds a parallel 150pF mica capacitor and 5MΩ resistor. This combination forms a "grid leak" and is connected to the grid of V1, a UX201A valve used as a regenerative detector. Regeneration is controlled by the variable capacitor connected between its plate and the tuned circuit.

Following detection in V1 the audio component of the signal appears at the plate of the valve and is fed through a radio frequency choke (RFC) to the primary of T1, an iron-cored 1:3 step-up transformer. A 201 valve has a nominal gain of around eight and by feeding its output to this transformer, the overall

From there, the signal is applied to V2 where it is amplified and applied via another audio iron-cored 1:3 step up transformer (T2) to a third UX201A valve (V3). The amplified audio signal is then fed to a high-impedance horn speaker.

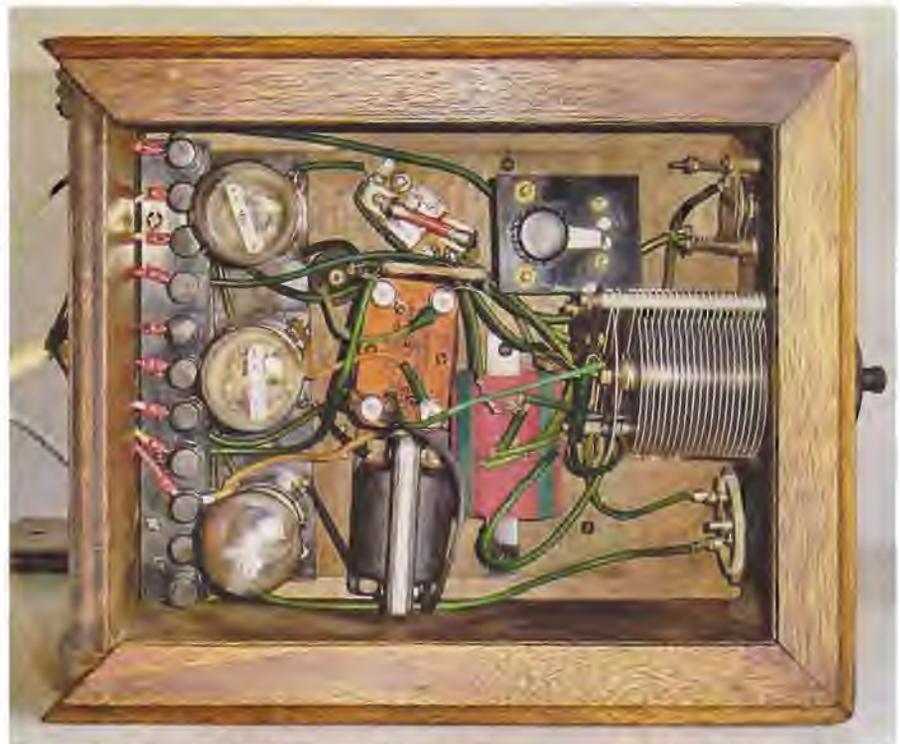
This is the view inside the set with the top cover removed. Note the breadboard style of construction, with all parts readily accessible from the top.

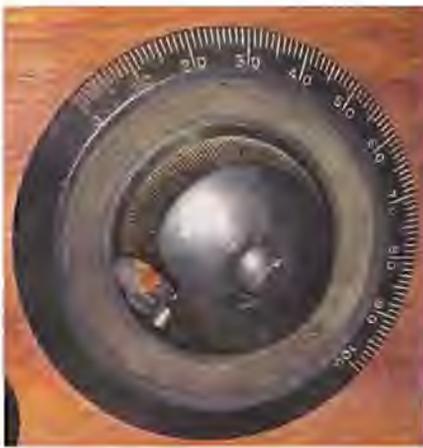
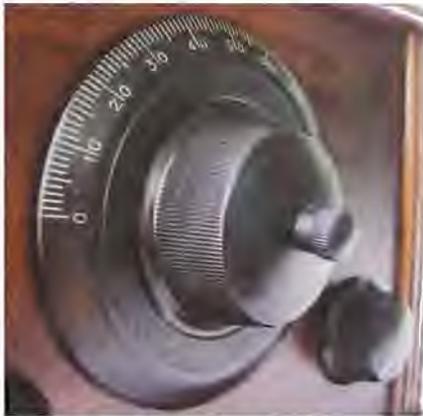
These two photos show the tuning knob before (top) and after repair (bottom). The small central knob is the vernier fine-tuning control.

that is exactly what had happened in this case – the set had been dropped at some stage and had landed on its tuning knob. As a result, a section had broken out of the knob and although this was easy enough to repair, considerable damage had also been done to the tuning capacitor shafts.

Suffice to say that the repairs to the dial mechanism were not done in five minutes. On the contrary – professional machine-shop equipment was needed to drill and realign the mechanism. The earthing braid that was on the centre shaft had fatigued and broken off too. It was replaced but it appears as though it will be a continuing problem that requires routine repair.

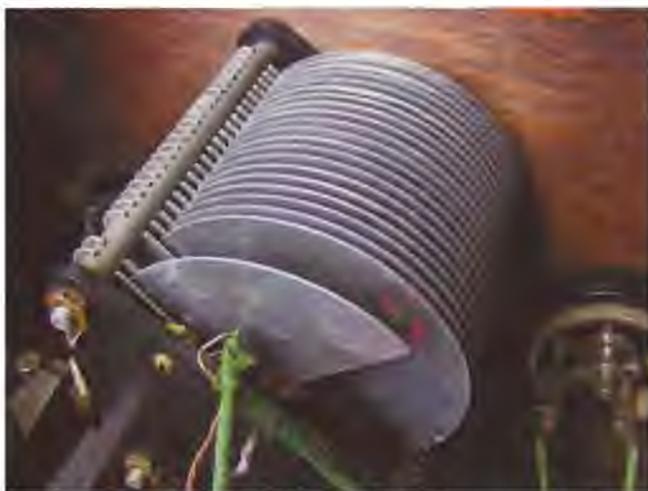
The tuning gang is unusual in that it features an additional single moveable plate at the back which is controlled by a separate shaft inside the main tuning shaft. This allows the station frequency to be precisely adjusted when tuning.

The dial had a section that had broken away but fortunately, the broken piece was supplied with the set. The dial, the dial shafts and the tuning capacitors are rather unique. As usual, a large knob turns the main part of the tuning capacitor but now we come to the unusual part of this tuning gang – a separate shaft inside the main tuning shaft controls a vernier plate at the back.

The tuning knob for the vernier is the small knob in the centre of the main dial. It's a very clever way of doing the job but it would have required more precision during manufacture than a more conventional tuning gang and so would have been more expensive.

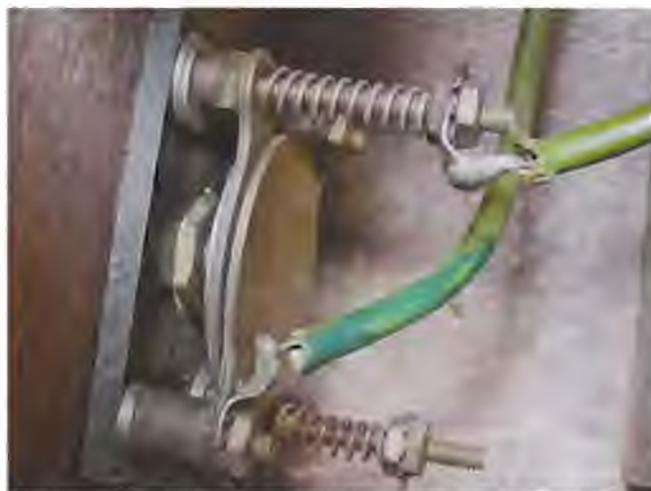
The regeneration (or reaction) control resembles a mica pad capacitor. Rotating the control knob varies the distance between the plates and thus the capacitance and the amount of regeneration.

The regeneration winding has one tap so that either it or the end of the winding can be selected to ensure regeneration with either a 22.5V or 45V supply. The regeneration control is rather unusual and is constructed somewhat like a mica pad capacitor. When the plates are brought closer

together by rotating the control, the amount of capacitance increases and the regeneration increases.

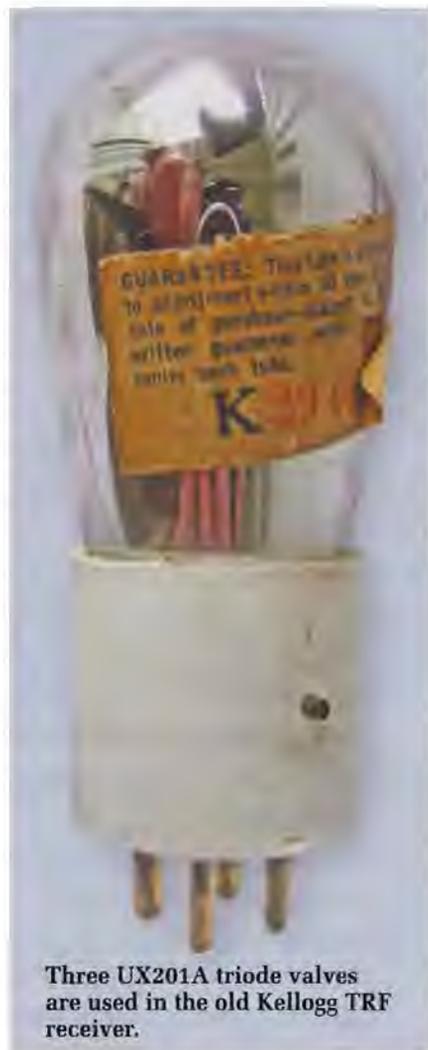
Three UX201A triode valves are used in the old Kellogg TRF receiver.

The set was obtained with just one valve in place and this proved to be a Philips A415. However, although a variety of valves could be fitted to the set (the valve base arrangements at that time were reasonably standardised), it was decided to fit UX201As to the receiver. They weren't cheap but are more applicable to this American-style set than Philips valves.

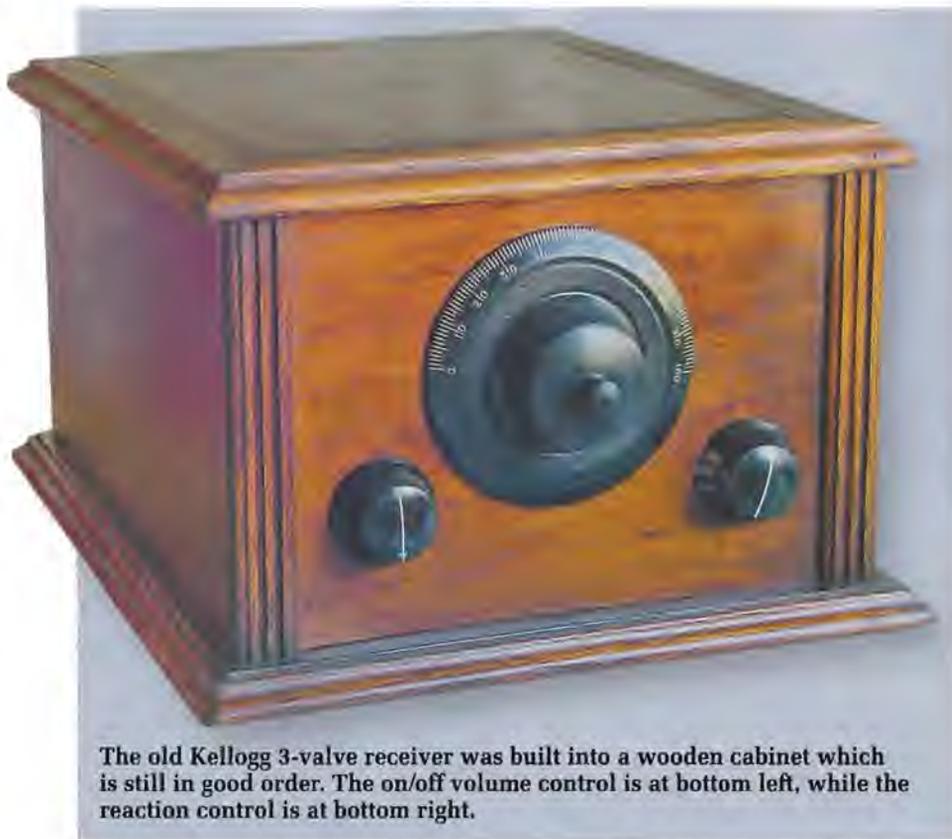
The old Kellogg 3-valve receiver was built into a wooden cabinet which is still in good order. The on/off volume control is at bottom left, while the reaction control is at bottom right.

Like almost all "ancient" radios, the Kellogg TRF receiver wasn't exactly in pristine condition when Mark obtained it some time ago. The cabinet, however, was still in remarkably good condition. It was dusted out with a brush and a vacuum cleaner and then rubbed down with linseed oil to make it look almost new again.

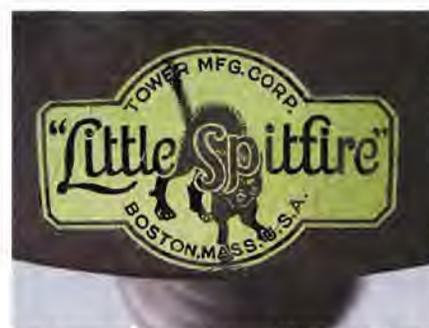
that would have been used with it. This item was obtained separately but unfortunately its high-impedance winding was open circuit.

A close-up view of the "Little Spitfire" decal that's attached to the horn-loaded loudspeaker that's now used with the Kellogg receiver.

Rewinding the coil to get the speaker going again wasn't worth the effort. Instead, its internals were removed from the base and its mounting points modified so that a small line-to-voice-coil transformer could be fitted, along

with a 50mm speaker mounted above it. As a result, it still looks original and its performance is pretty much as expected of a horn speaker, as it still has the original horn baffle.
