# Vintage Radio

## The impressive STC Capehart A8551 Radiogram

**T**HE 5-BAND A8551 was probably the most up-market monophonic radiogram produced by STC. It dates from the mid 1950s and as can be seen from the photos, it is quite a big unit.

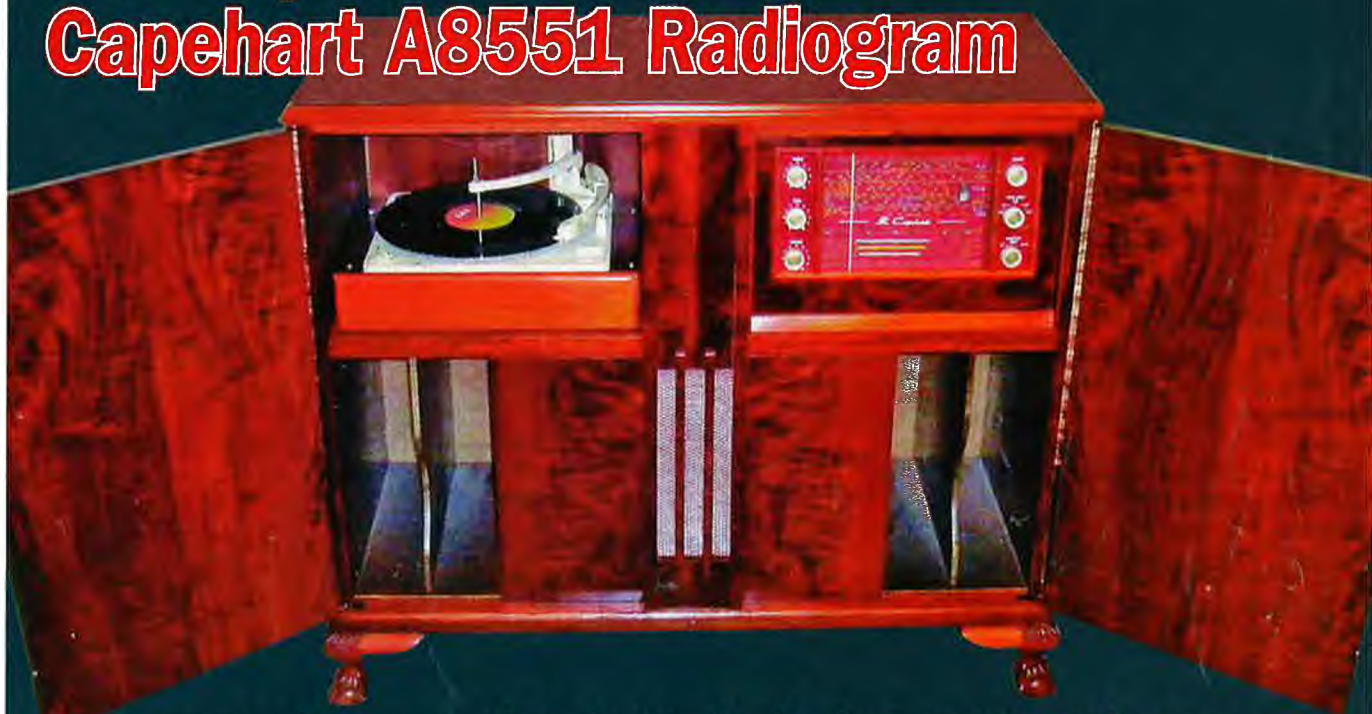
In terms of construction, it is basically a large rectangular box with ball & claw feet on it. It is a beautiful piece of furniture and the owner of this magnificent deluxe radiogram, Peter Henstridge (see last month's Vintage

A feature of the cabinet is that the doors can fold right back alongside the end panels, so that they are out of the way when the radiogram is in use. When closed, the speaker grill is still visible so that the set can continue operating without the sound being muffled.

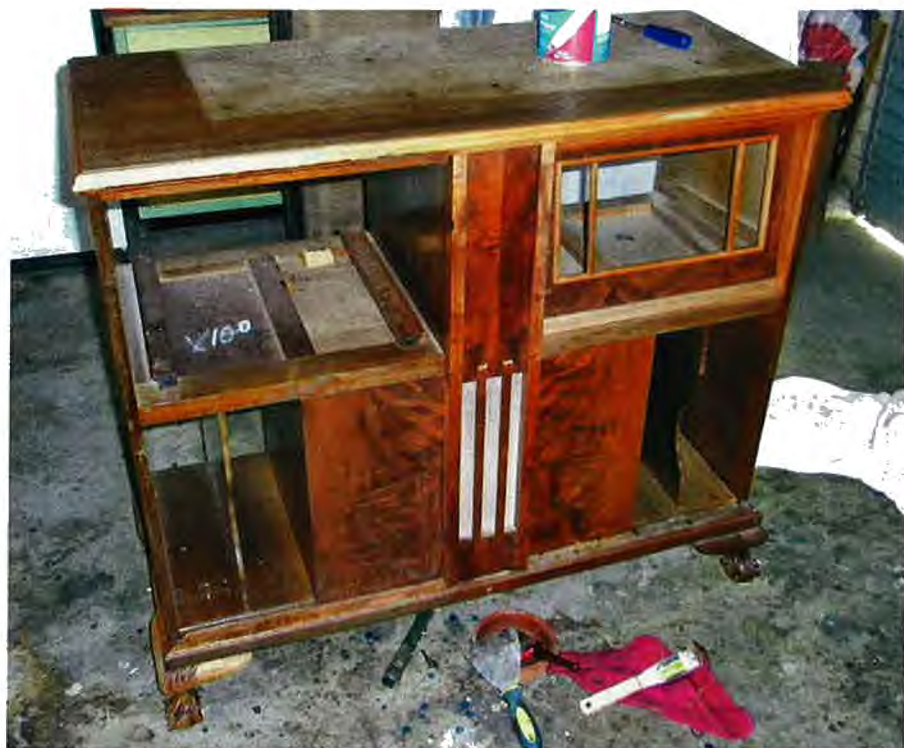
This view shows the A8551's cabinet during restoration. The timber was in good condition but the finish had deteriorated quite markedly over the years.

The cabinet finish wasn't exactly in good condition when Peter obtained the old STC. As indicated earlier, veneered solid timber is used in its construction, so there were no short-cuts to be taken here.

First, the chassis and other internals of the unit were removed and set aside, as were the doors, hinges and handles. Peter then set about stripping the finish off the timber with Accent Paint Stripper. This stripper is relatively mild and doesn't stain the timber like some other paint strippers do. The cabinet was then lightly sanded with a fine grade of abrasive paper.

brew stain to match the radiogram's original maple colour. Peter used a spirit-based Wattyl product, which is unfortunately now unavailable. This was mixed with an orange base stain and a little bit of black tint. However, some areas of the cabinet required a deeper tint than others, as these areas were almost white in colour after the paint stripper had done its job.

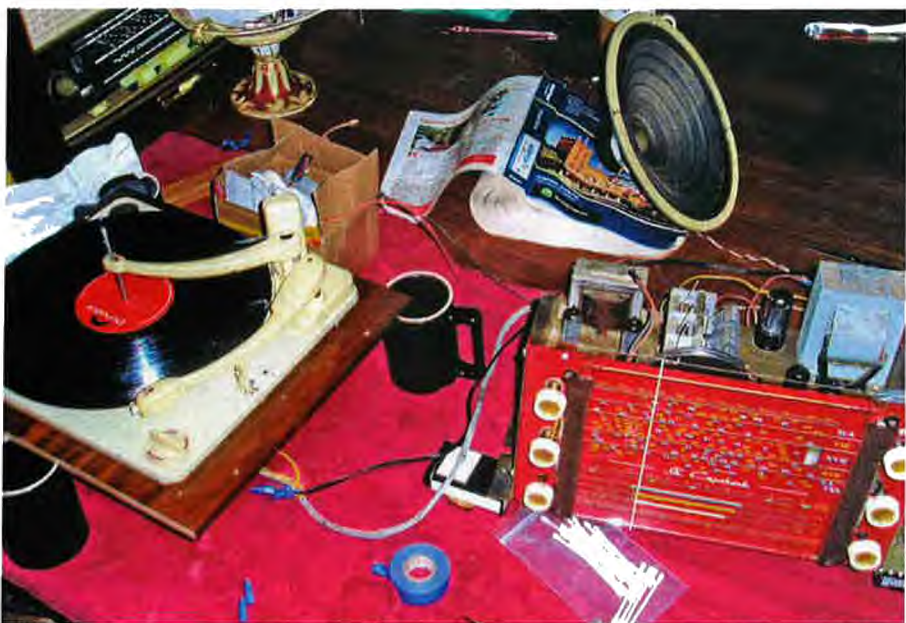
The record changer, chassis and loudspeaker were all removed from the cabinet to make the restoration easier.

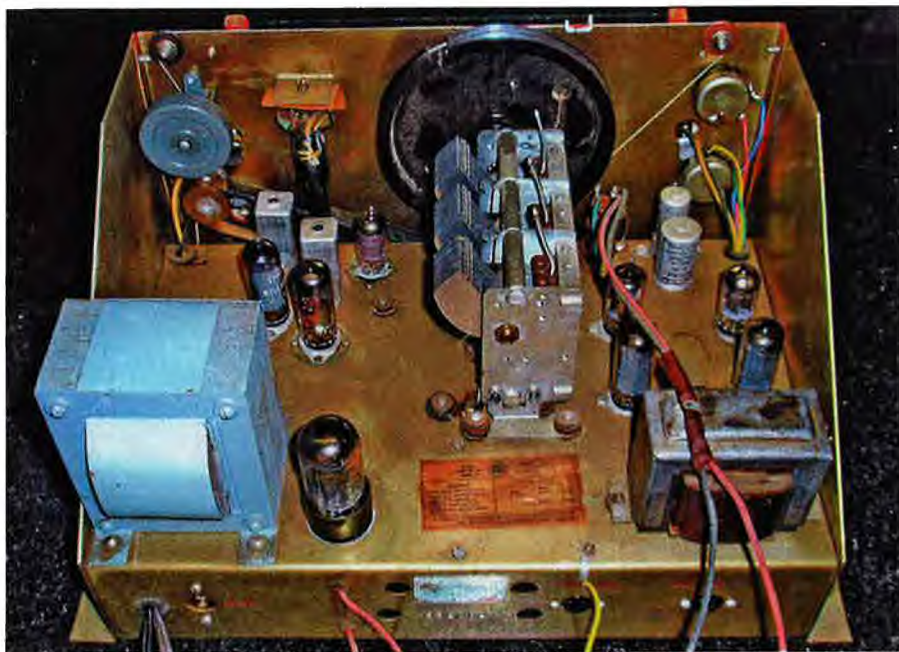
Despite its age, the chassis was in remarkably good condition and looked almost new after it was cleaned up. It's a well-made unit and the top layout is clean and uncluttered.

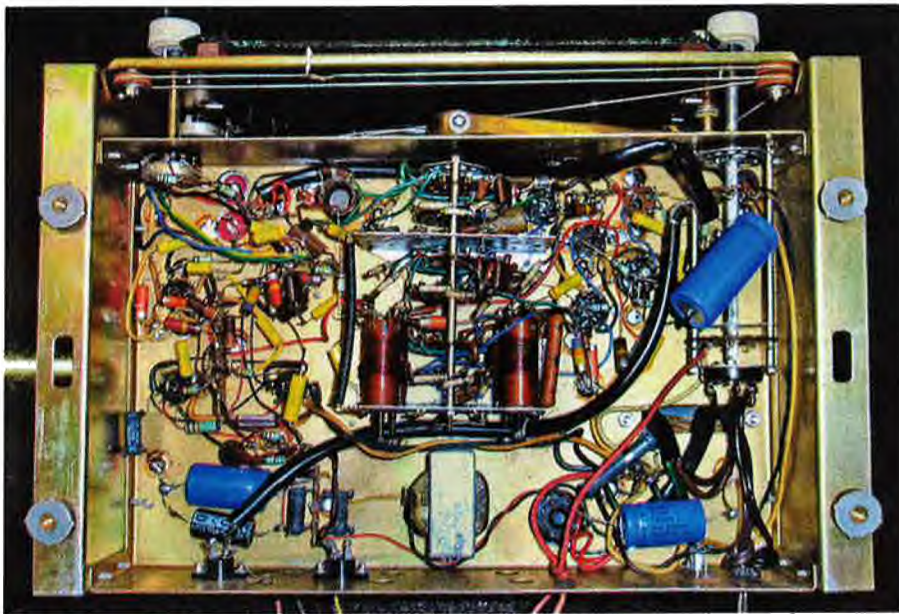
All parts under the chassis of the STC A8551 radiogram are readily accessible despite the circuit complexity. Replacing the dial cord, the paper & electrolytic capacitors and two resistors restored the unit to full working operation.

The paper and electrolytic capacitors were all replaced so that no unexpected problems would arise in the future. The resistors were largely within tolerance and only one or two needed replacement. The dial cord also needed replacement as it had broken but the valves were all in working order.

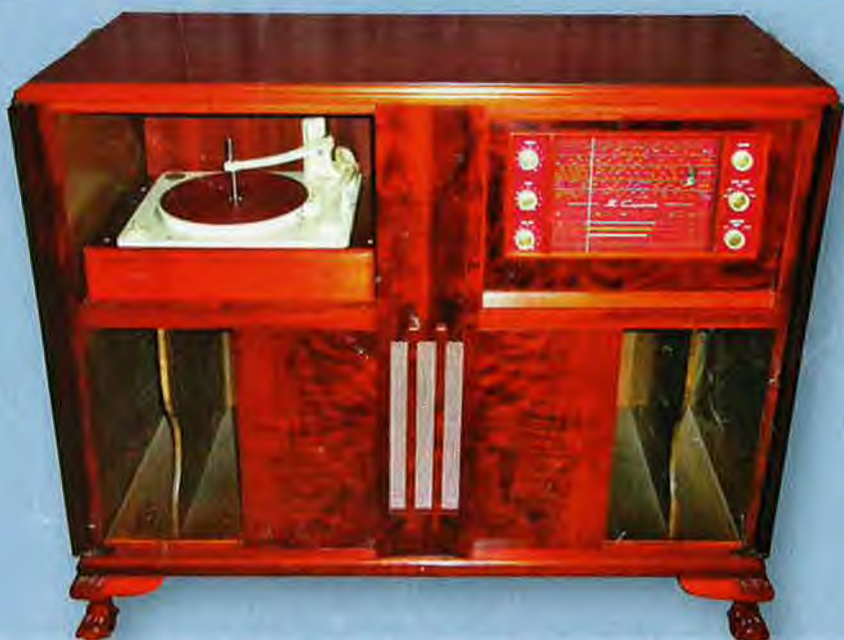
This view shows the fully-restored unit with the doors open and swung fully back along the sides of the cabinet. Note the two record storage areas.

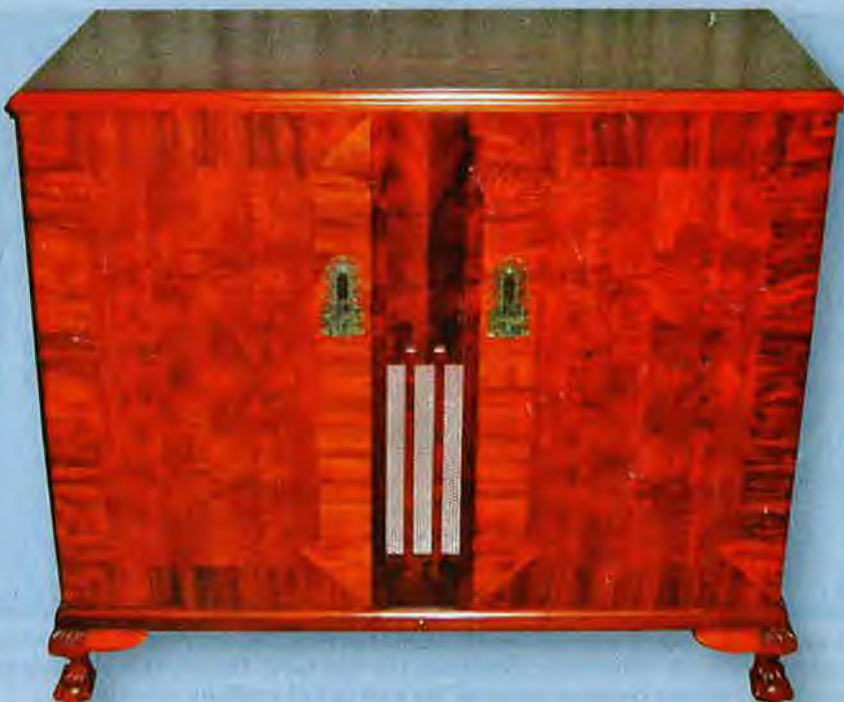
When the doors are closed, the speaker grill is still visible so that the set can continue operating without the sound being muffled. The cabinet finish is excellent and the old STC now looks like new.

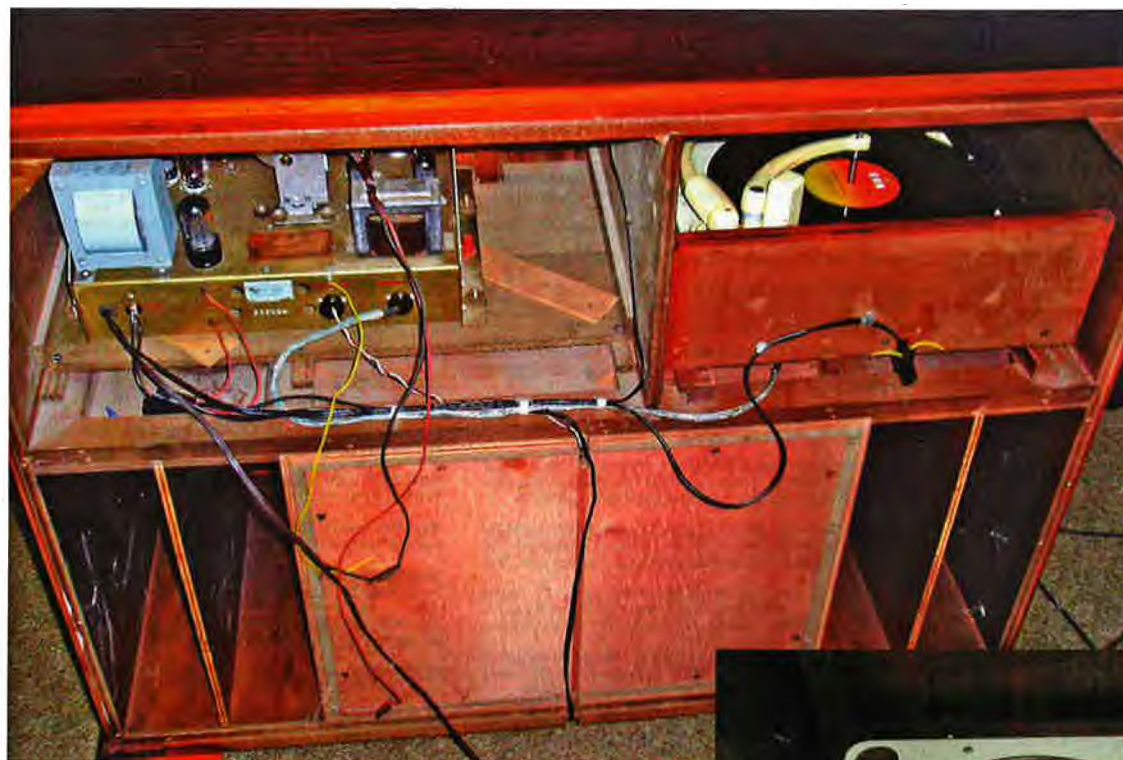
A rear view of the cabinet with the record changer and radiogram chassis mounted in position. The connecting cables between them run along a shelf at the back of the unit. This unit is much more elaborate than the average radiogram of the mid-1950s era.

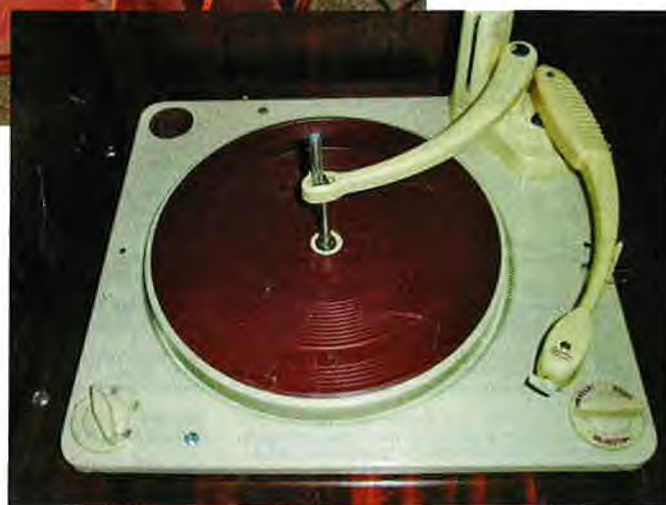
**The Collaro 3-speed automatic record changer required a good clean-up plus some fresh lubrication to make it run smoothly again. The pick-up cartridge and styli were also replaced.**

The old grease was removed using kerosene, after which lanoline spray was used to lubricate the bearings and other parts. Some light machine oil was then applied to any bearings and shafts. In addition, oil was applied to the felt wick around the phosphor-bronze motor bearings and this now runs smoothly again and will last for many years.

Fortunately, the plater was in good condition and there were no flat spots on the rubber idler pulley. The latter was cleaned with methylated spirits on a clean cloth and the whole assembly given a light coat of lanoline to keep everything operating smoothly.

Finally, the pick-up cartridge and styli were replaced. The mechanism was then tested and it all worked perfectly.
