Vintage Radio

The Mullard Meteor 600 4-Valve Mantel Receiver

A great variety of valve receivers were designed and produced for the domestic market in Australia. These ranged from complex, multiband receivers to relatively simple sets designed for the bottom end of the market. This little receiver falls into the latter category and although it's a reasonable performer, it could have been much better.

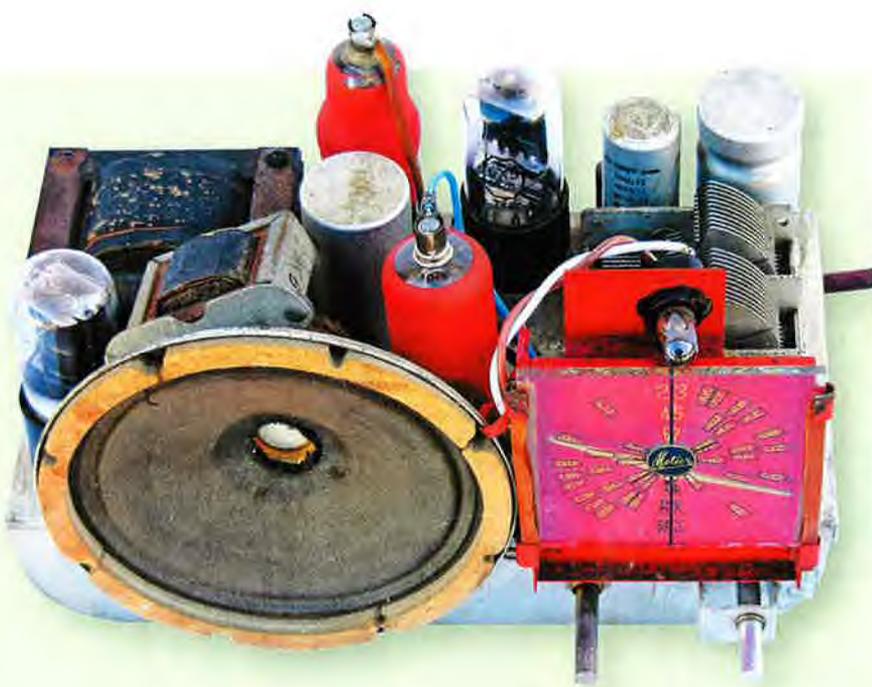
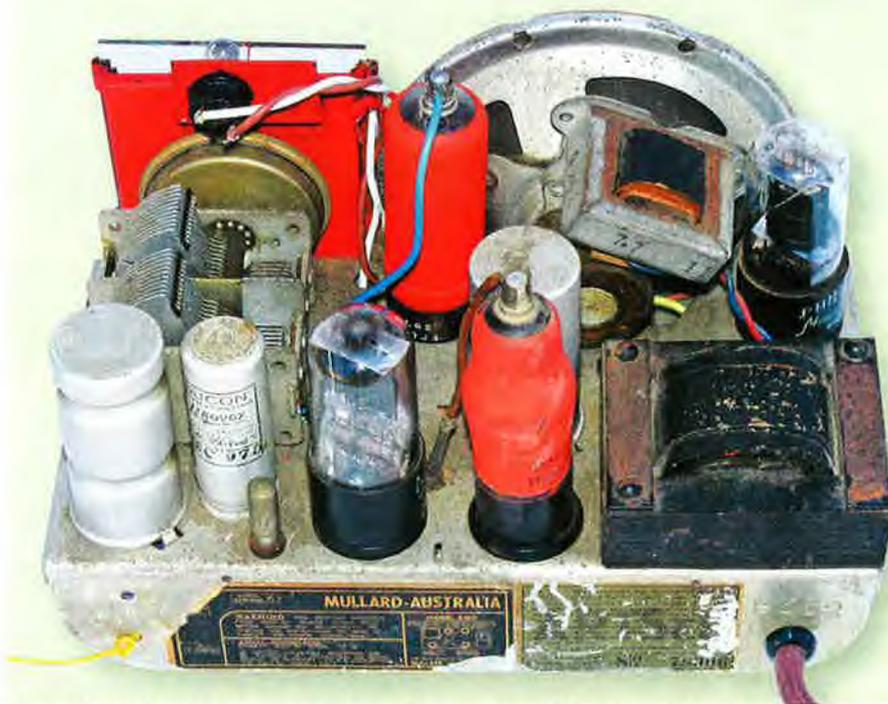
The old Mullard Meteor 600 cleaned up quite well, as is evident from these above-chassis views. The parts on the top of the chassis are easy to access.

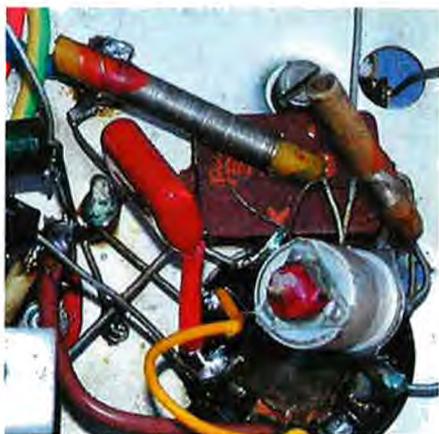
This photo shows the three trimmer capacitors around the oscillator & antenna coils. Two are semi-fixed tubular types while the third is a Philips "beehive" type.

This set (and some Philips sets) uses custom-made semi-fixed capacitors which act as trimmers in the tuned circuits. A couple of these trimmers can be seen in the photo of the oscillator/antenna coil assembly, with one towards the top of the picture. It consists of a thick wire inside a ceramic tube, with many turns of fine wire on the outside of the tube. The number of turns of wire wound on the ceramic tube determines the capacitor's value.

To adjust these trimmers (or semi-fixed capacitors), it is necessary to initially wind on more turns than required, then gradually remove turns until the circuit is tuned to the correct frequency (it's too bad if you take too many turns off). This set has five of these trimmers and the only trimmer not of this type is C9 which is a Philips beehive-type trimmer.

First, I adjusted C9 so that the set tuned to the local Italian station on 1629kHz, then checked the alignment of the IF stage.

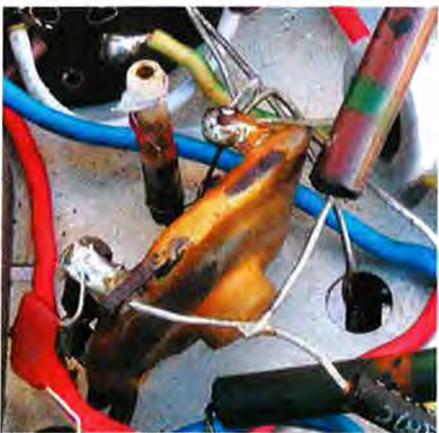
The first 455kHz IF tuned circuit consists of coil L5 & its parallel semi-fixed trimmer C10.

The circuit seemed to be roughly tuned to 455kHz but the response to nearby frequencies was greater than expected, indicating that the IF stage needed alignment. I assumed that the capacitors had been adjusted correctly when the set was made so to make the adjustments a bit easier, I placed small 10pF mica capacitors across each tuned winding. I then set the signal generator to 455kHz and gradually removed turns of wire from each trimmer until the peak response had just been reached and was beginning to dip again.

Because both C10 and C16 are live to around 110V (with respect to the chassis), extreme care is needed to ensure that nothing shorts when pulling the wire off to adjust these trimmers. And although I thought I was being careful, I wasn't careful enough and did get a "bite" off the 110V.

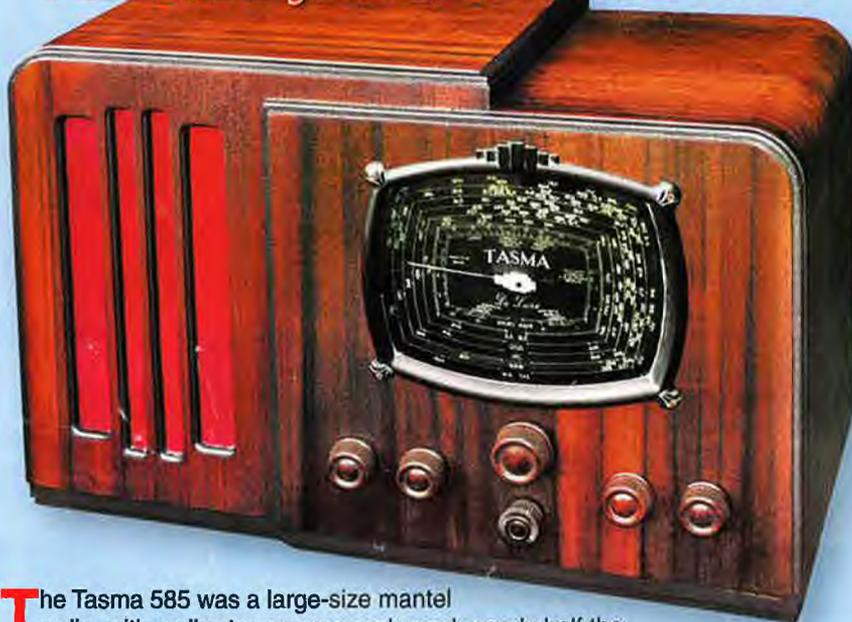
Photo Gallery: Tasma 585 Mantel Radio

The Tasma 585 was a large-size mantel radio, with a vibrator power supply pack nearly half the size of the radio itself and powered by a 6V accumulator. The valve line-up was as follows: IM5G RF stage, IC7G mixer, IM5G IF amplifier, IK7G detector/first audio amplifier and IL5G audio output. The intermediate frequency (IF) was 458kHz. Features included dual-wave tuning, a permanent magnet speaker and a handsome wooden case. Photo by Kevin Poulter for the Historical Radio Society of Australia (HRSa). Phone (03) 9539 1117. www.hrsa.net.au
