# Vintage Radio

## The 1933 Airzone 503 5-Valve Mantel Set

By the early 1930s, some manufacturers were producing quite good superhet radio receivers for the domestic market. The Airzone 503 was designed for the low-cost end of the market but still came in an attractive wooden cabinet and offered good performance.

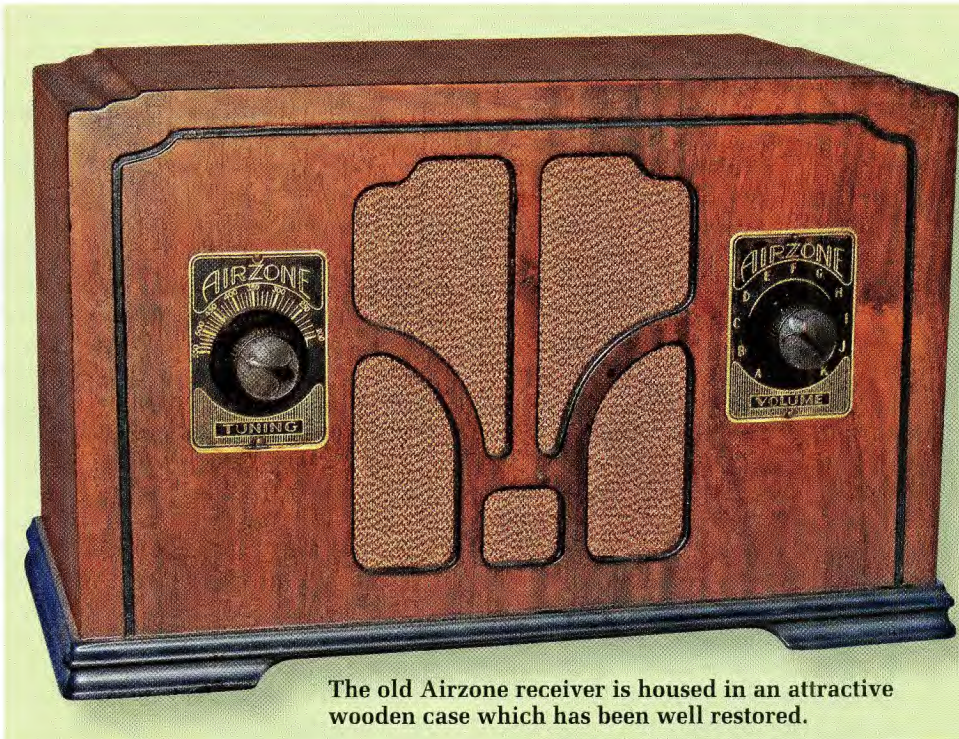
The old Airzone receiver is housed in an attractive wooden case which has been well restored.

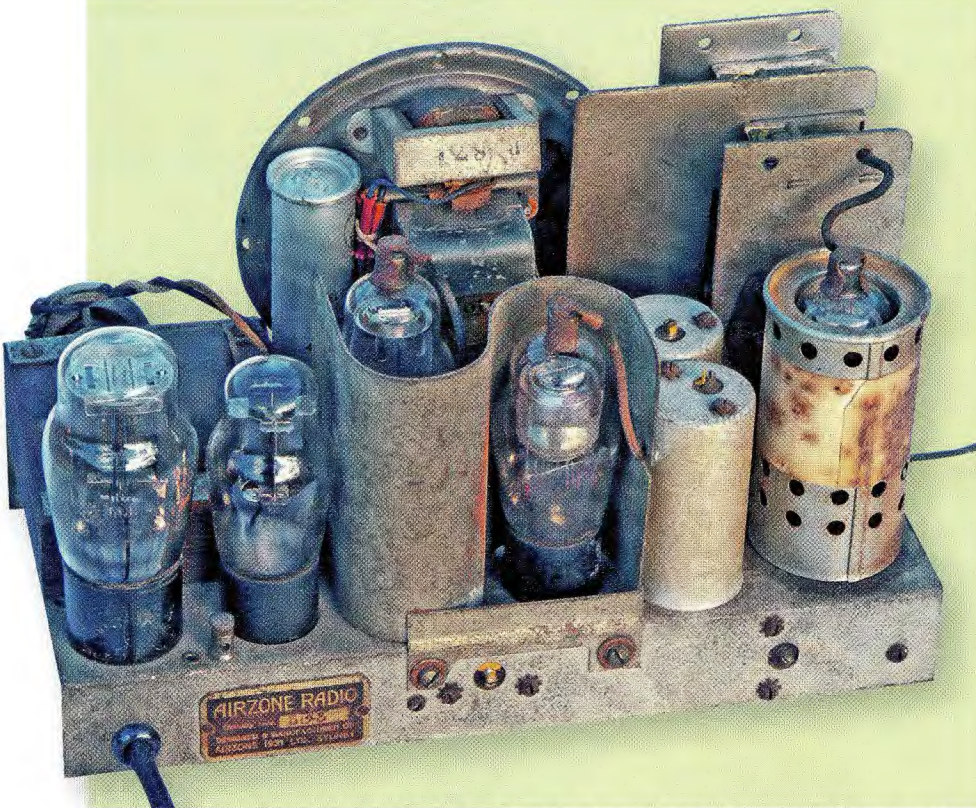
The top of the chassis is well laid out, with all parts easy to access for service. Note the unusual S-shaped metal shield between the IF amplifier (78) and detector (77) stages. A separate shield is also fitted to the mixer/oscillator stage.

sealed with a dab of yellow paint. The S-shaped shield used on the top of the chassis is unusual but effective in shielding the various sections from each other.
