Vintage Radio

The Astor DL 4-valve mantel receiver

An austerity model for the post-war era

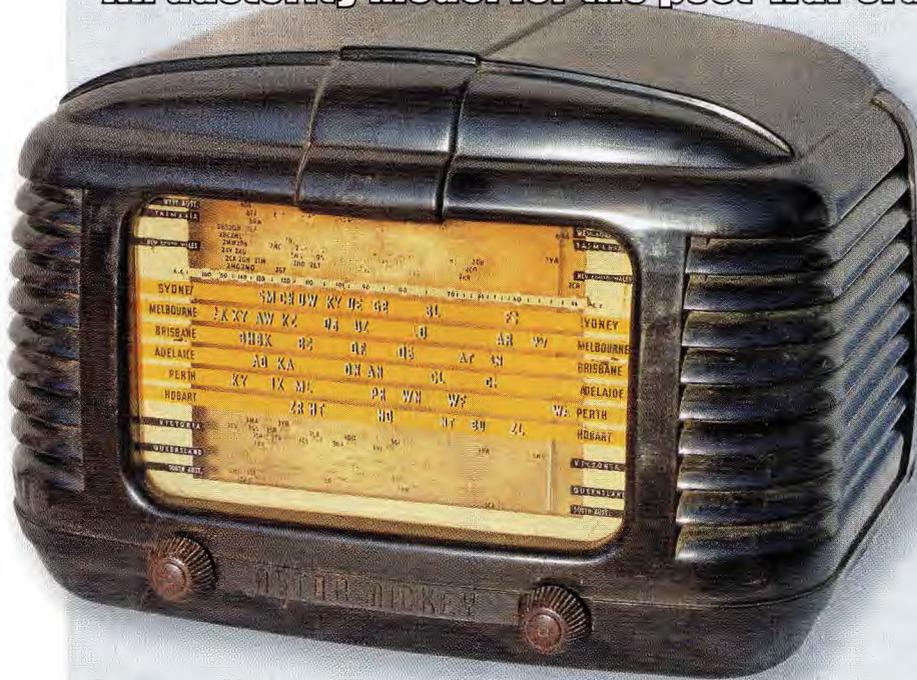
The Astor DL is a little broadcast-band 4-valve mantel receiver that's housed in a bakelite case. The circuit is quite simple but it still had quite a few challenges in store for me.

As can be seen from the photos, a small brown bakelite cabinet was used to house the Astor DL chassis. Indeed, this same cabinet style was used for many 4-valve Astor sets.

In terms of appearance, it is quite an appealing little receiver with a large dial scale. This dial scale has no slots in it, unlike many other dial scales. As

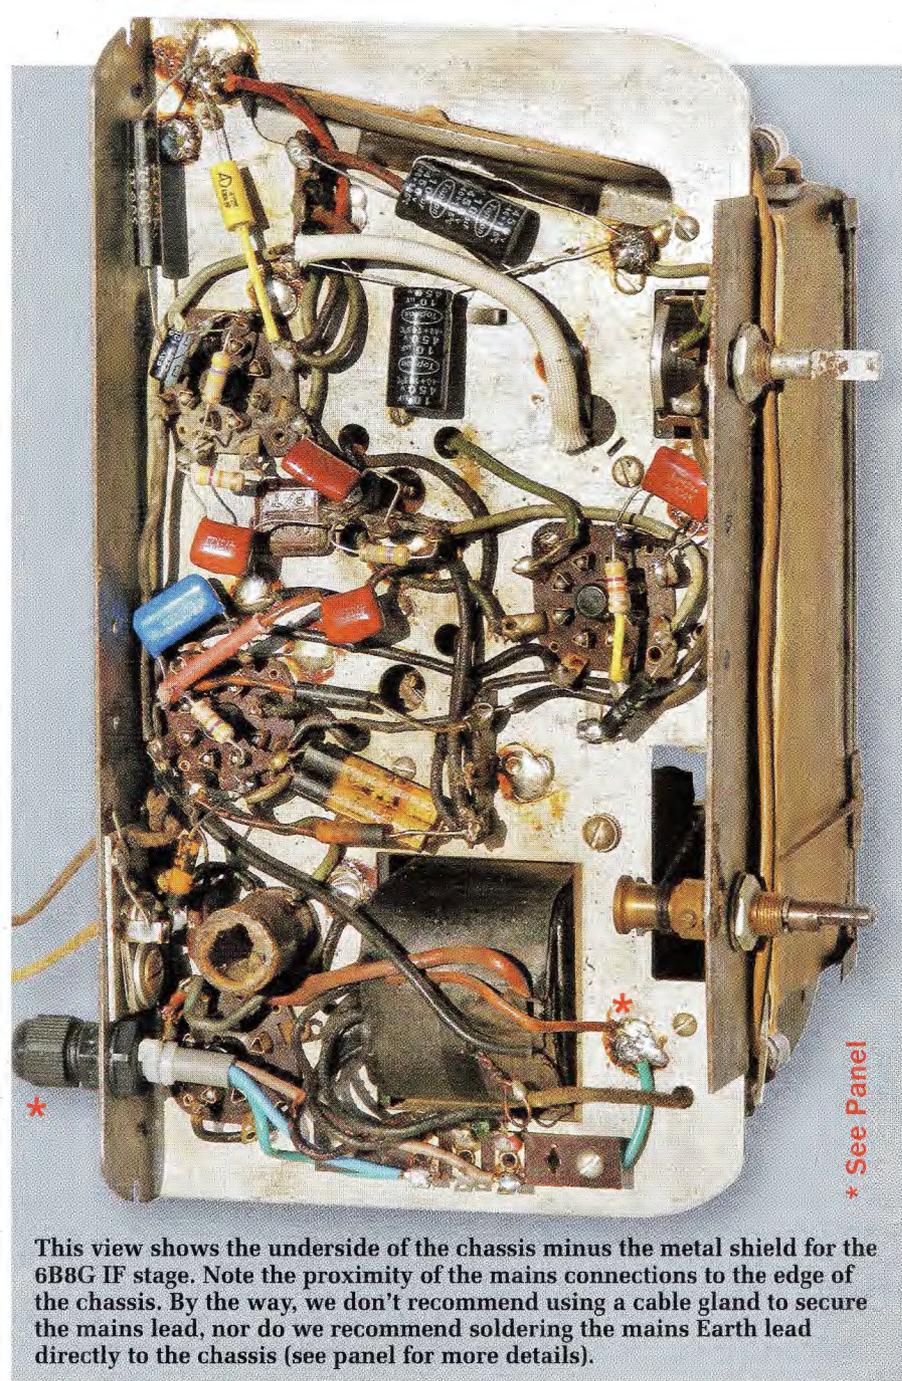
This view shows the underside of the chassis minus the metal shield for the 6B8G IF stage. Note the proximity of the mains connections to the edge of the chassis. By the way, we don't recommend using a cable gland to secure the mains lead, nor do we recommend soldering the mains Earth lead directly to the chassis (see panel for more details).

The under-chassis parts are all easily accessed, although the 6B8G has a shield over the socket to minimise any IF feedback that could lead to instability. **One thing you do have to be mindful of when tipping the chassis over for service is that the mains terminations are easily touched, since they are quite close to the edge of the chassis.** If the set is connected to power, then it's all too easy to receive a potentially fatal electric shock.

As shown in the photos, the mains cord has been secured to the Astor DL's chassis using a cable gland. However, we don't recommend this method as it's too easy to undo the nut securing the gland from outside the case.

Instead, we recommend that an approved cordgrip grommet be used to secure the mains cable to the chassis. This must be fitted to a correctly profiled hole to ensure it securely locks the mains cord into place.

We also note that the mains Earth lead has been soldered to the chassis and again we don't consider this as being safe and secure (the solder could easily separate from the chassis). Instead, we recommend that restorers purchase a mains lead with an eyelet lug pre-cripped to the Earth lead which can then be bolted to the chassis and secured using a star washer and two lock nuts.

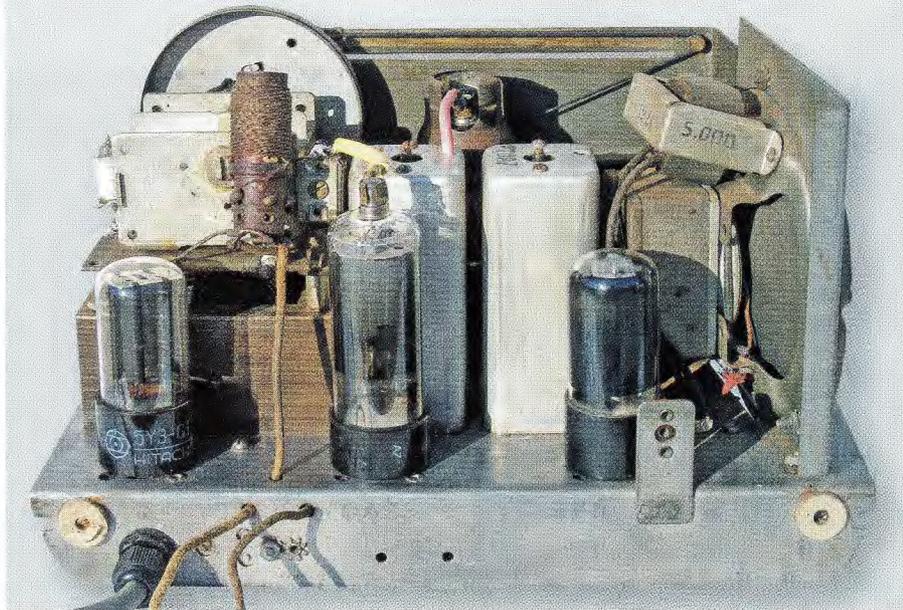
The parts on the top of the chassis are readily accessible but mounting the aerial coil so high up leaves it prone to damage during servicing.

The loudspeaker and its transformer are mounted at the other end of the chassis to the power supply. This is good practice as it minimises any hum induction into the speaker transformer from the power transformer. The IF valve is near the front of the chassis, making it difficult to access when the chassis is in the cabinet. In addition, the “up-in-the-air” mounting arrangement for the antenna coil makes it vulnerable to damage when the set is being serviced or restored.

ing terminals for safety reasons. They should also have positioned the antenna coil better so it could not be so easily damaged during service.

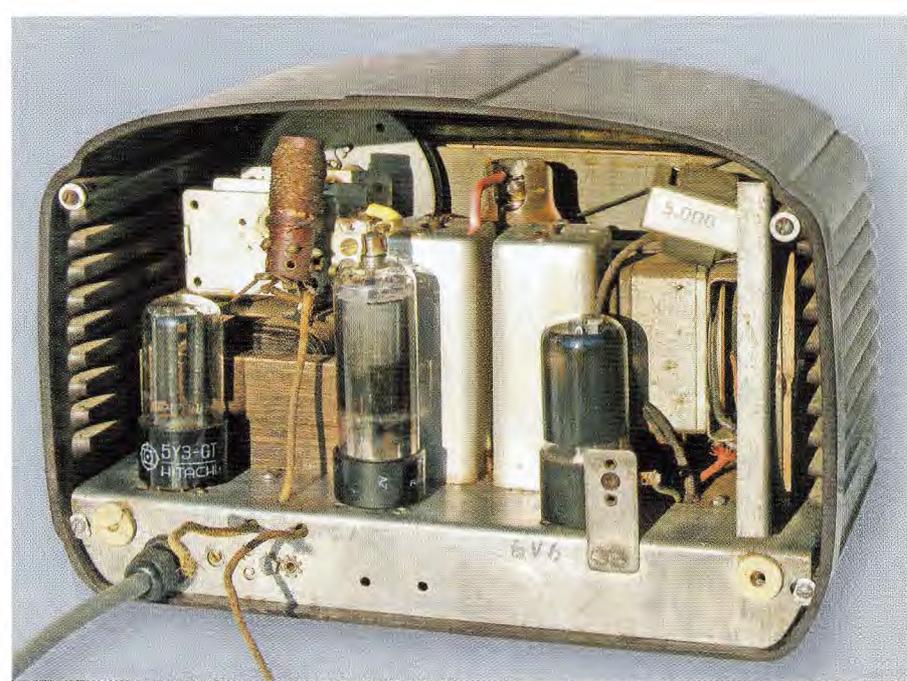
The chassis is easily slid out of the Bakelite case for servicing. Use a cordgrip grommet to secure the mains cord, not a cable gland as shown here (see panel).

The chassis is easily removed from the cabinet. First, the four screws holding the Masonite back on the set are removed, then the two control knobs and finally the two retaining screws that attach the back edge of the chassis to the cabinet. The set can then be slid out of the cabinet.
