Vintage Radio

An insight into the manufacture of quality valve radios in the USA nearly 100 years ago

Radio Manufacturing in 1925: the Wells Gardner story

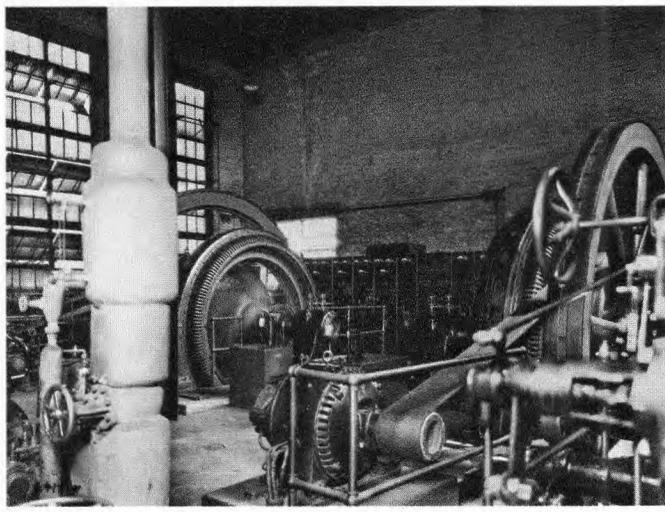
The 'engine room' generated all of the electric power required by the factory and offices, due to the generally unreliable reticulated power at the time.

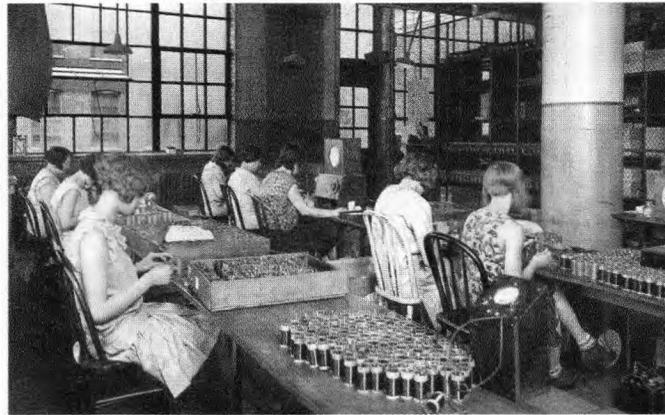
Many components were made in-house, though most likely not valves nor capacitors, as they were more specialised. Transformers and coils were definitely made in the plant, as they often were in Australian factories of the era. Here women wind and assemble coils.

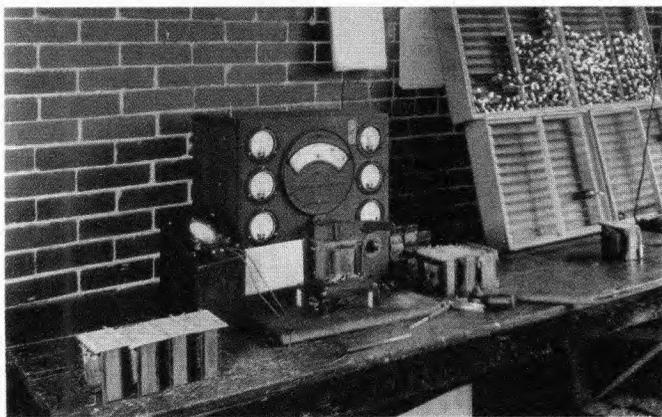
Transformers made in the factory were tested in a jig, with seven meters plus an auxiliary meter. The jig's contacts match the pins on the transformer, and the lever in the centre applied a little pressure to ensure all contacts were sound. So the test was essentially automated - place the transformer upside down on the jig, push on the lever and switch on.

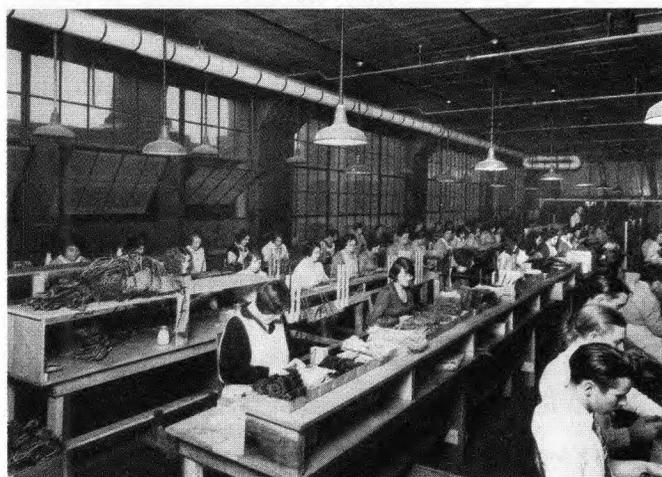
In the foreground, wires are being cut to length, stripped on their ends and pre-tinned with solder. Some would have heat-resistant sleeving added. Prepared wires were

included in looms or used singularly for direct links between components.

The following photographs show the construction of a nine-valve receiver. All the radios were assembled using the factory jig, with handles to enable easy roll-over of the chassis.

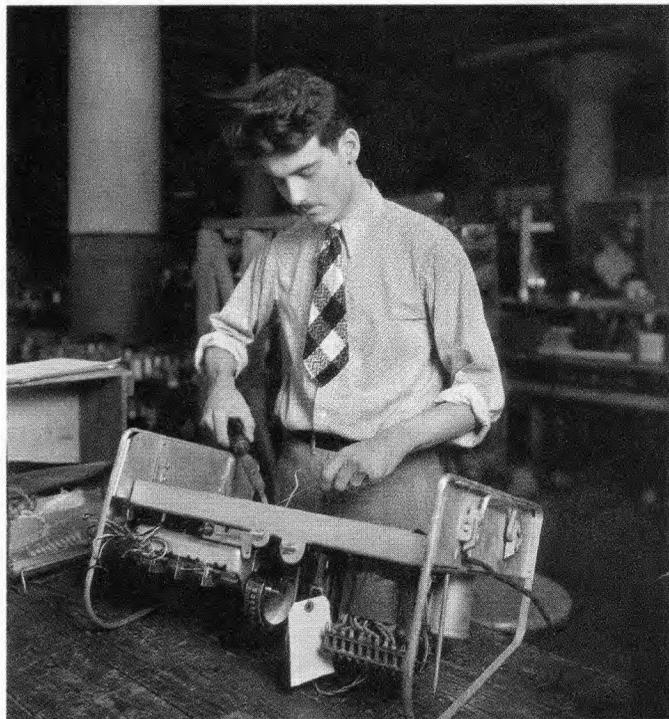
Looms were made in factory, to connect most of the components together electrically. A loom jig was a piece of wood with the loom plan drawn on paper and attached. Conventional building nails in the wood guided every bend and other nails indicated the end of each wire's course.

When a wire was run through to its destination, it was terminated by winding once around the end nail and then cut off. On completion, the entire loom was hand-stitched together and/or bound with cloth strip.

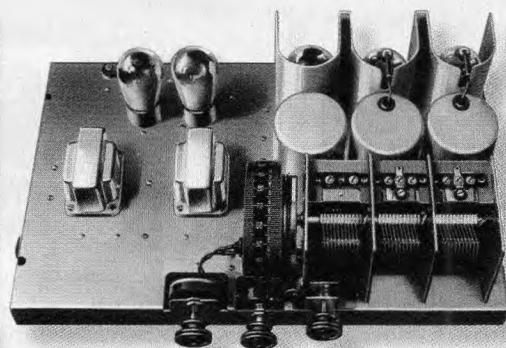
Five valve chassis WG-30-126-2

These chassis were photographed in a studio, printed to a large size, air-brushed and retouched, then the retouched image photographed again, resulting in the final negative and print. Today we use Photoshop, saving an immense amount of time and cost.

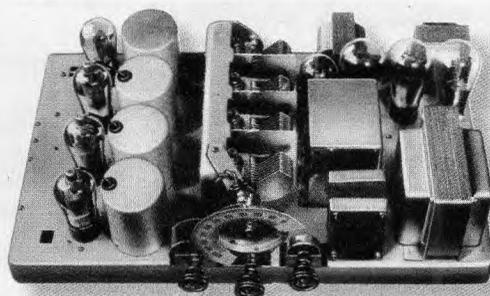
Eight-valve WG-30-106-3 showing top side and underchassis

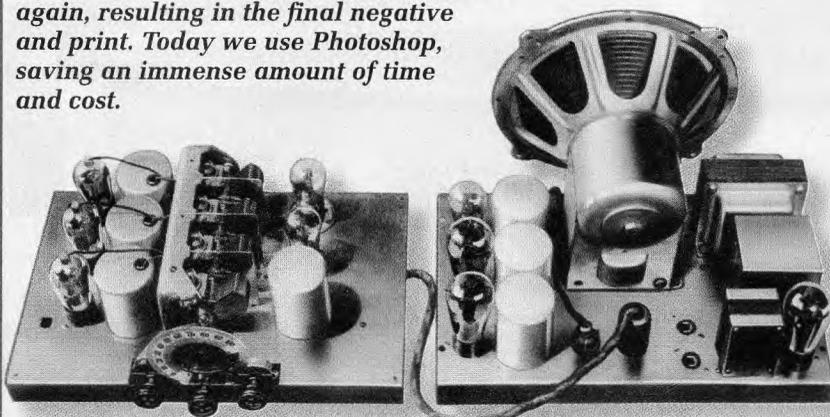
The connection loom between the two chassis appears to be covered by winding a fabric strip over, an early version of the tape used in later looms.

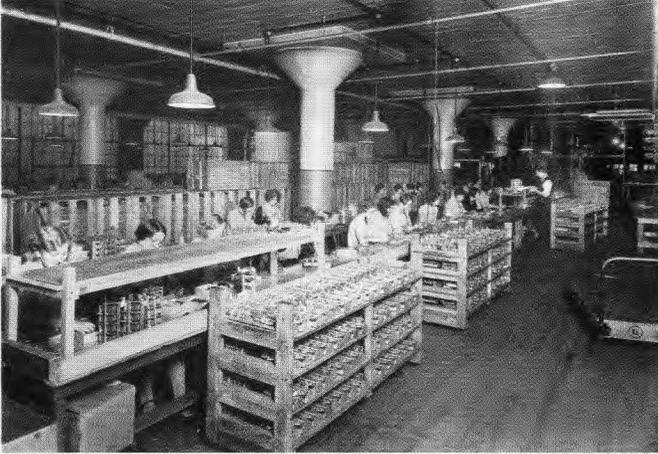
Production was not easy for the staff. Conditions were high-pressure and the area poorly lit. Note the 4-gang variable condensers and the age of the women – from teens to seniors. The caged area in the rear is most likely a lockable store.

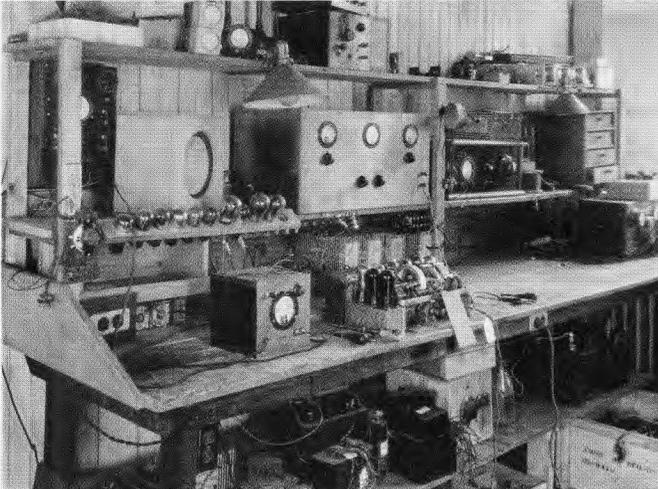
The final test bench has custom-built test equipment, Burgess "B" batteries, plus wet cells near the floor and spare valves if needed. The photograph is so clear, some boxes of RCA UX-280 valves can be seen at the top and a row of valves in the centre. There's a screwdriver, radio pliers, soldering iron and an open end spanner on hand too.

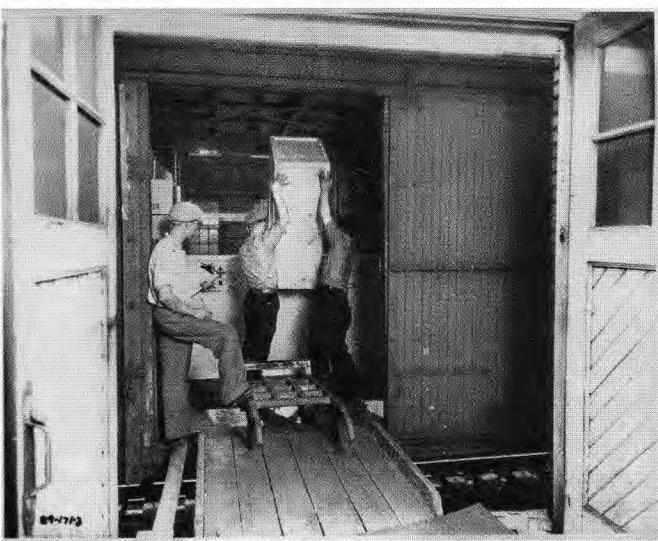
On completion, the radios were packed in wooden boxes, then when ready for shipping, were loaded into a rail car at the company's own rail siding.
