Vintage Radio

The Hotpoint Bandmaster J35DE console radio

Restoring The Hotpoint Bandmaster J35DE console radio; Pt.2

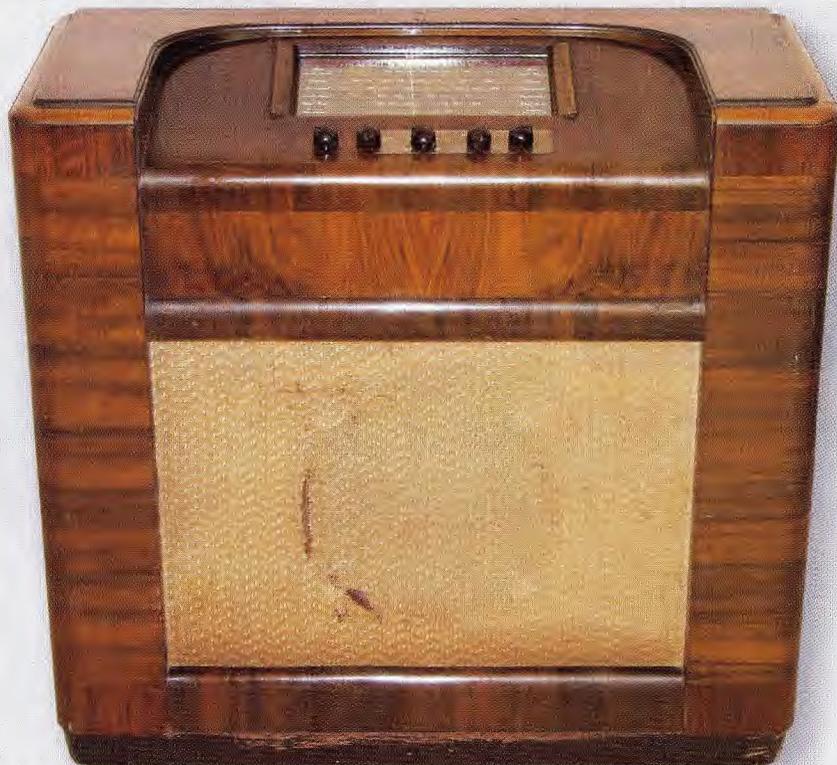
The Hotpoint Bandmaster J35DE was a 1940s console radio that offered quite good performance in its day. This example is still in good condition, although the grille cloth needs replacing and the cabinet requires work.

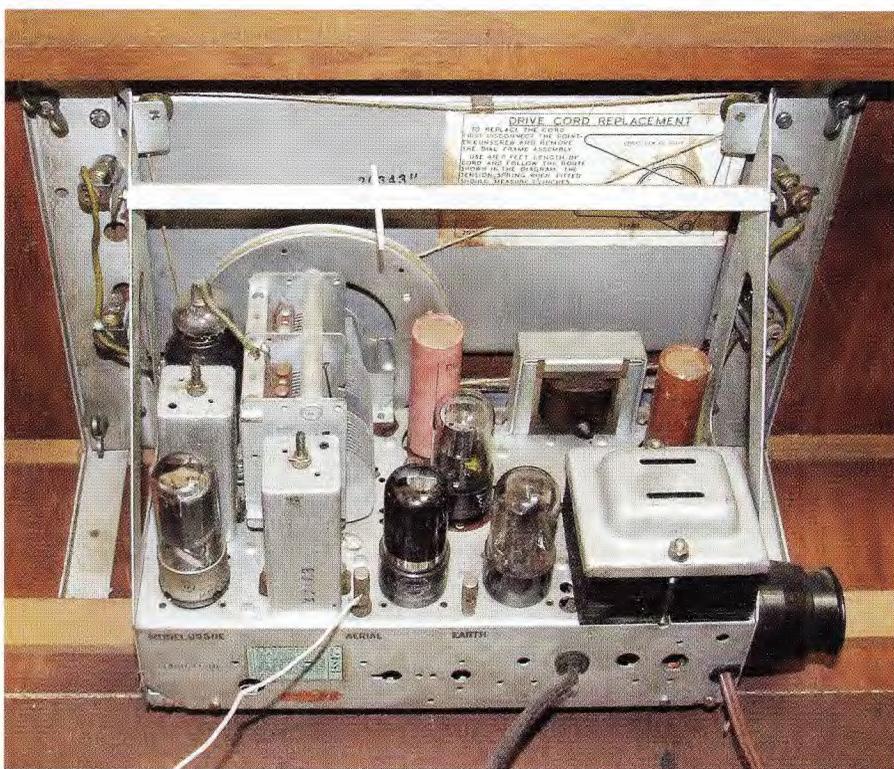
This view shows the neat arrangement of the major components on the top of the chassis. A label on the dial backing plate shows the drive cord arrangement.

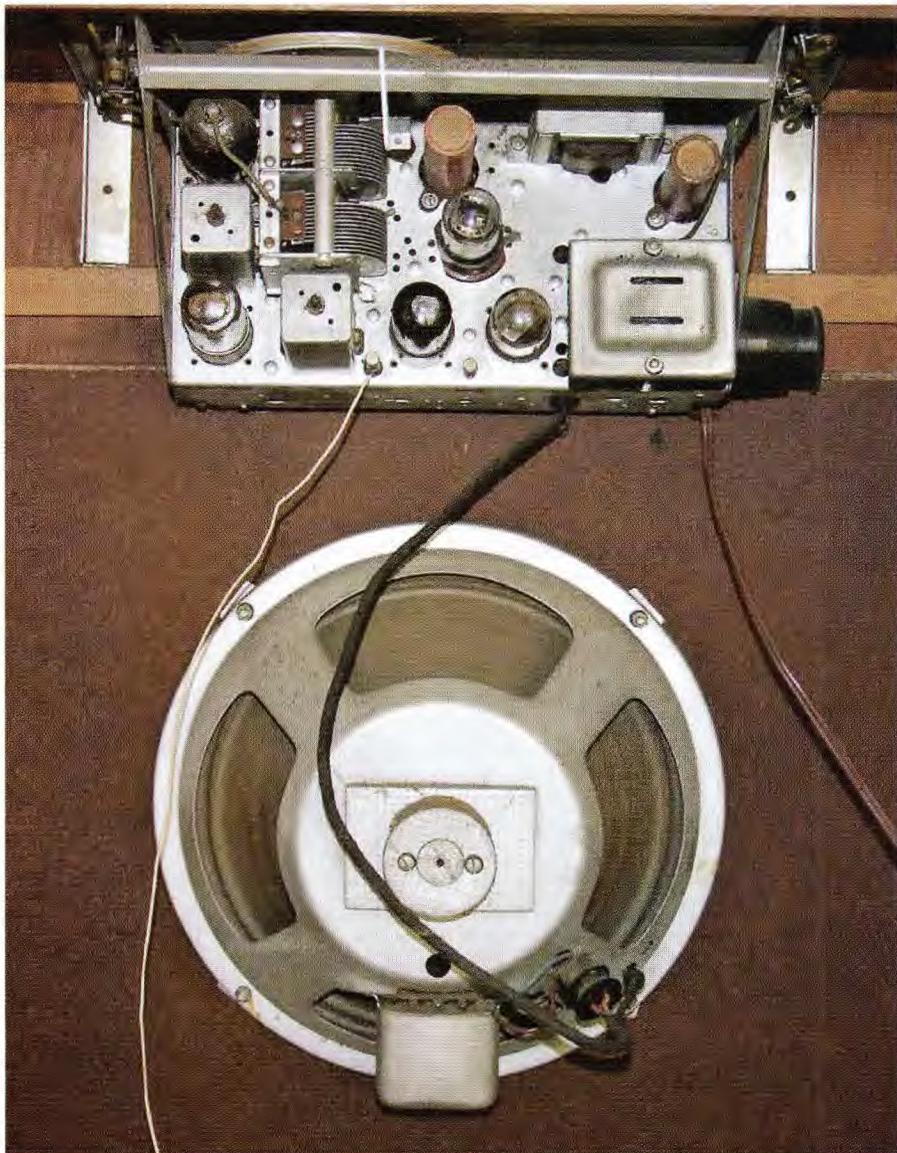
This circuit has a serious design fault concerning the arrangement for connecting the speaker. The output transformer is mounted on the back of the speaker and is connected to the output valve via a plug and socket arrangement on the chassis. As a result, if the set were to be accidentally switched on without speaker connected, the 6V6-GT screen current would be very high and this would probably ruin the valve.

The chassis vertically inside the cabinet, so that the glass dial and control shafts face upwards. Note that the output transformer is mounted on the speaker frame. This means that the 6V6-GT output valve could be destroyed if the speaker cable is disconnected from the chassis while power is applied.

A better arrangement would be to have the speaker transformer permanently mounted on the chassis and the voice-coil leads extended. Alternatively, a solution such as that described on page 91 of the August 2010 issue

of SILICON CHIP, for an Airzone 612 console radio, could be adopted. This is what we eventually did with this Hotpoint set.

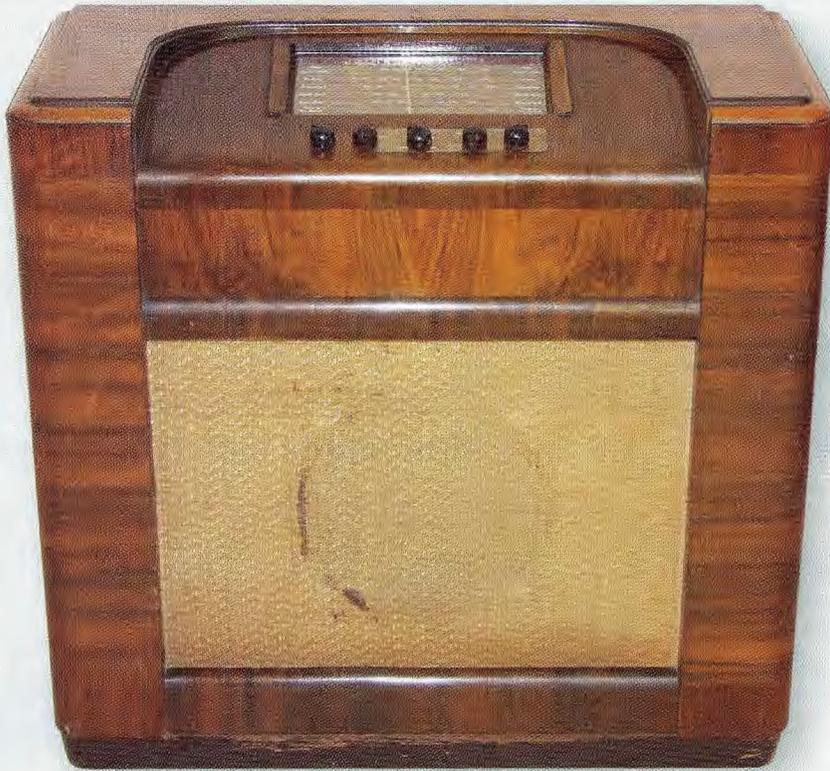
Last month, we discussed the Hotpoint Bandmaster J35DE in general terms. This month, we describe how it was restored to its original performance. The only instrument required was an inexpensive digital multimeter and the same general ideas can be applied to most vintage sets.

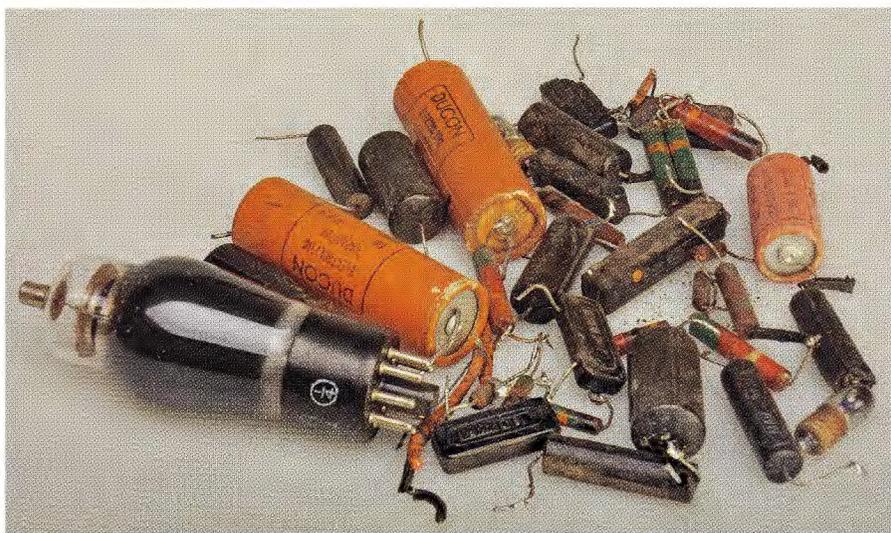
These faulty parts all had to be replaced in the old Hotpoint Bandmaster radio. Most are capacitors but there are also quite a few resistors, a couple of dial lamps and the 6J8G mixer valve.

Ultimately though, most of the paper capacitors were replaced with modern metallised polyester types (greencaps etc) as the leads of the originals were so fragile.

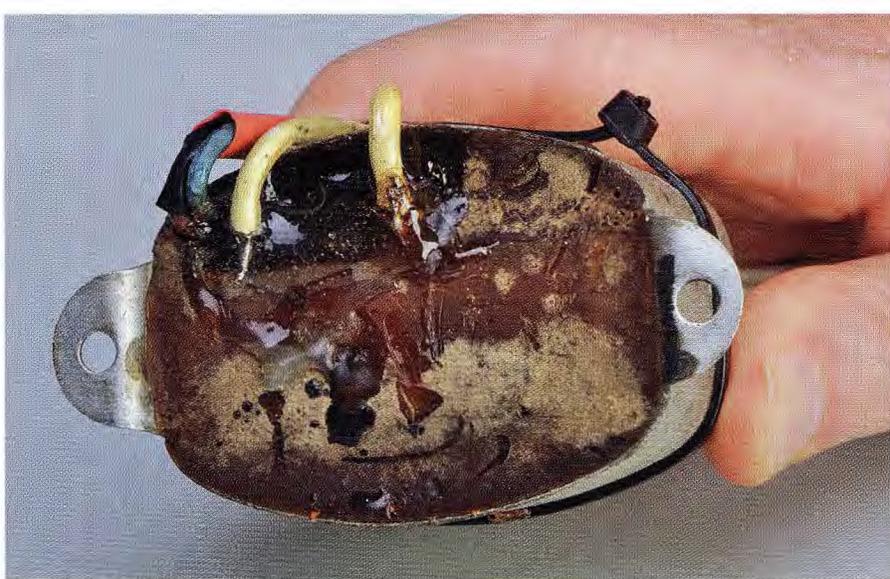
Some of the leads of the speaker transformer had broken off at the base. It was repaired by digging away some of the pitch-like sealant, joining new leads to the exposed wire ends and then resealing the unit.

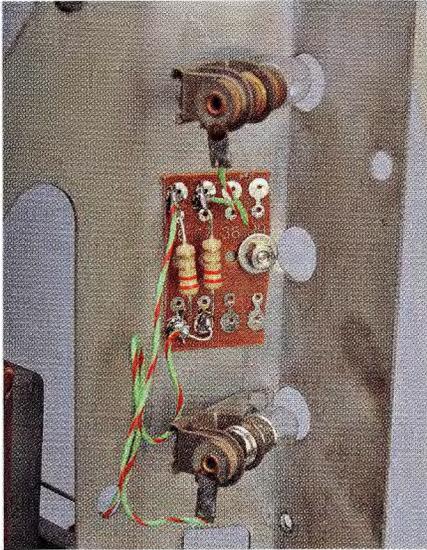
A 2.2Ω resistor was wired in series with each dial lamp to improve its reliability. This gives only a slight reduction in brightness.
