Vintage Radio

Restoring The Hotpoint Bandmaster J35DE console radio; Pt.2

Last month, we discussed the Hotpoint Bandmaster J35DE in general terms. This month, we describe how it was restored to its original performance. The only instrument required was an inexpensive digital multimeter and the same general ideas can be applied to most vintage sets.

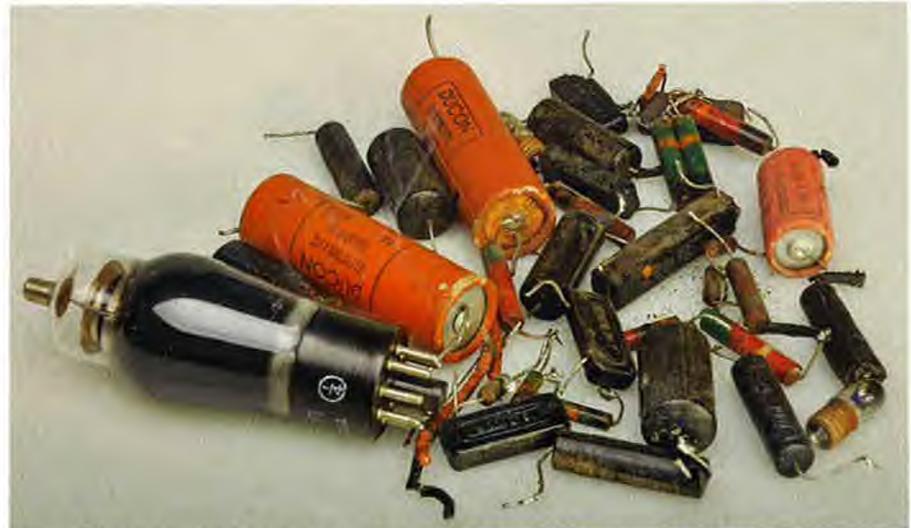
These faulty parts all had to be replaced in the old Hotpoint Bandmaster radio. Most are capacitors but there are also quite a few resistors, a couple of dial lamps and the 6J8G mixer valve.

Then we could have a detailed look at the components underneath. One manufacturer produced paper capacitors in a black plastic which melted at soldering temperature. Servicemen in the 1950s referred to them as the "black death". It was expected that most of these would be leaky. Surprisingly though, most of the capacitors were OK, both with regard to leakage and capacitance, except for a couple where the ends broke off when the multimeter was connected!

Ultimately though, most of the paper capacitors were replaced with modern metallised polyester types (greencaps etc) as the leads of the originals were so fragile.

In this particular case, the $4.7\mu F$ and $16\mu F$ capacitors were salvaged from a junk box and reformed using the electrolytic capacitor tester described in the August and September 2010 issues of SILICON CHIP.

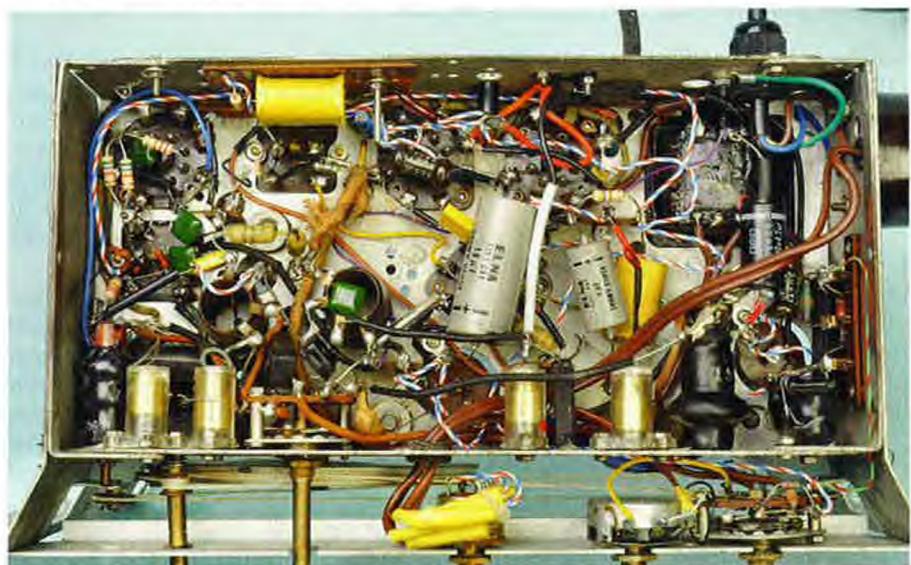
This under-chassis view shows the radio after the above parts were replaced. It's normally fitted with a perforated steel cover.

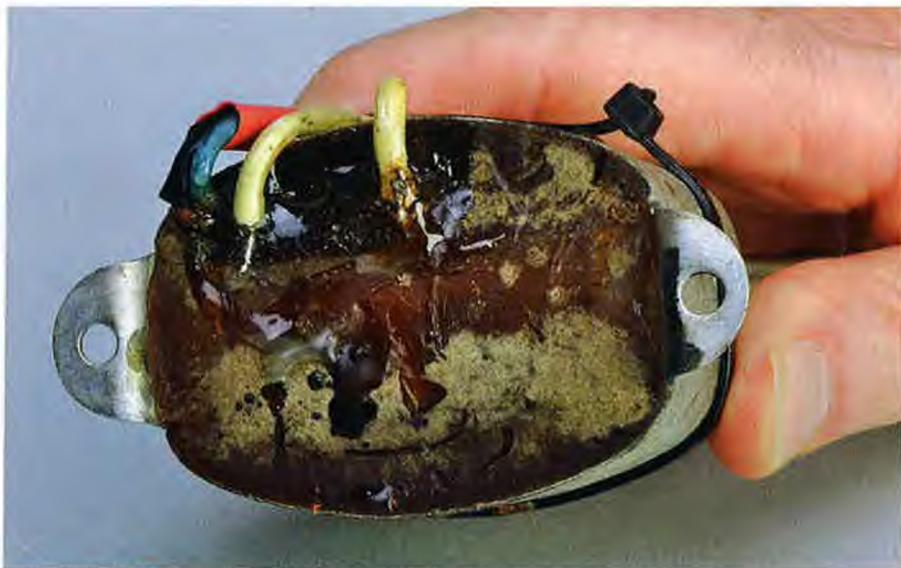
Some of the leads of the speaker transformer had broken off at the base. It was repaired by digging away some of the pitch-like sealant, joining new leads to the exposed wire ends and then resealing the unit.

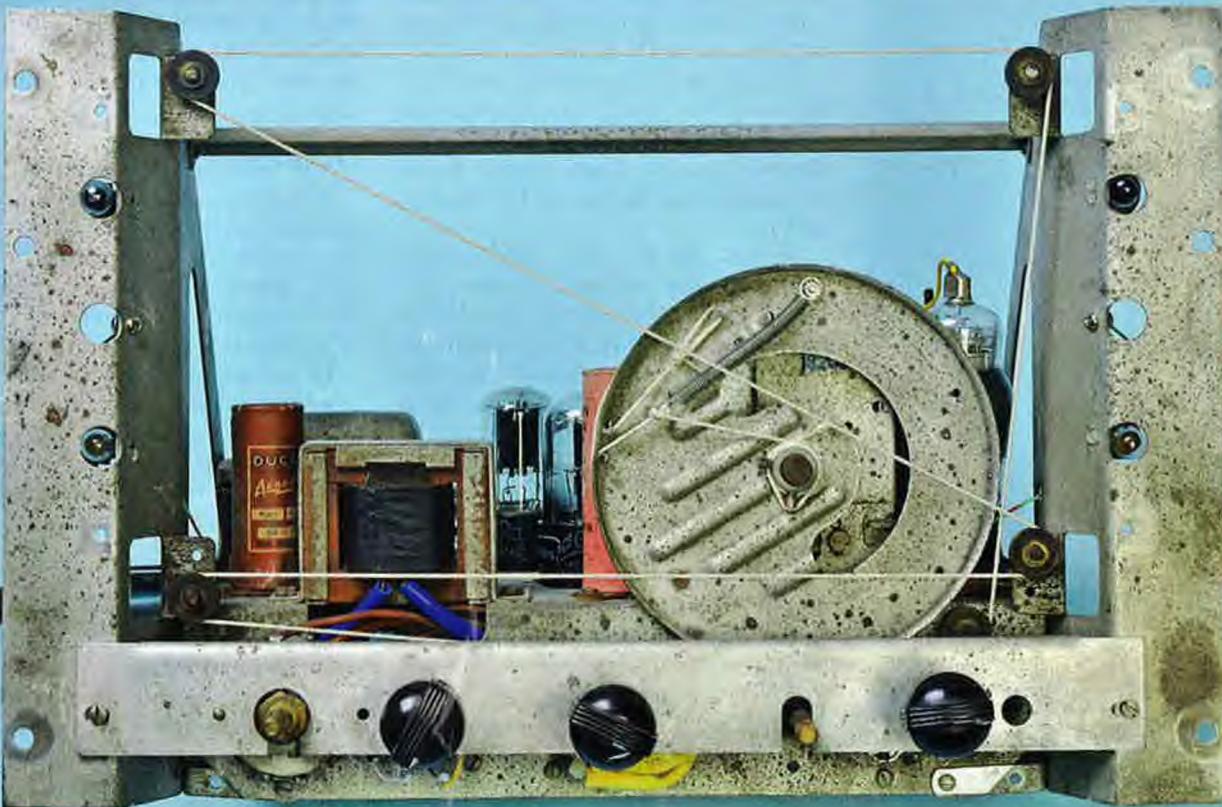
This view shows the complicated dial stringing arrangement, necessary to ensure that the top and bottom horizontal sections both travel in the same direction to carry the long vertical pointer. About 2.4 metres of dial cord is required to complete the job.

The dial cord had at some time been re-strung with ordinary string and it just wasn't working as it should. Ordinary string doesn't work as it is too slippery to provide enough friction around the pulley for the tuning knob. And it has to be tensioned properly.

In the case of the Hotpoint, the dial cord arrangement is quite complicated since it supports the long pointer at both the top and bottom of the dial. Cord sections going in the same direction at top and bottom are provided by the special stringing arrangement. In fact, it requires about 2.4m of dial cord.

line used by bricklayers. A third possibility is to use dental floss. Fortunately, the Hotpoint chassis has a diagram for the dial stringing on the back of the dial-plate.

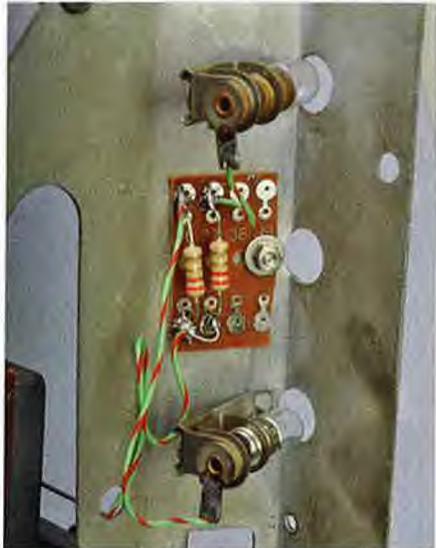
A 2.2Ω resistor was wired in series with each dial lamp to improve its reliability. This gives only a slight reduction in brightness.

Dial lamps in typical vintage radios present a reliability problem if operated at the full heater voltage of 6.3V. They get very hot and they can even lead to cabinet discolouration in those with Bakelite cases.

In the case of the Hotpoint, I decided to wire a 2.2Ω resistor in series with each of the four lamps. This results in a slight reduction in brilliance but also reduces the amount of heat they produce.

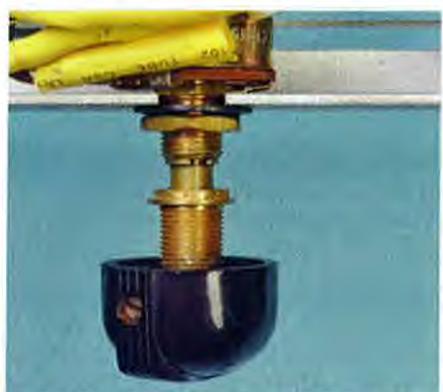
The shaft of the replacement switch pot was extended using a short section of shaft from another pot. The two were joined using a threaded bush from another pot, the lot held together with JB Weld epoxy adhesive.

The next step was a resistance measurement of the primary of the power transformer. Measured via the power plug pins it was about 50Ω and from the plug pins to the chassis it was a large number of megohms. So that was OK but the set has a double-pole rotary power switch operated by one of the front-panel knobs and it seemed very tired. Turning the switch backwards and forwards produced an occasional flicker on the meter but not the original 50Ω reading. So it had to be replaced but obtaining the same switch was impossible.

A used switch potentiometer with a double-pole switch rated at 240VAC 2A was found and fitted as a replacement but its shaft was too short. This was extended using a short section of shaft from another pot. They were joined using a threaded bush from yet another pot, the whole lot being glued together with JB Weld epoxy adhesive.

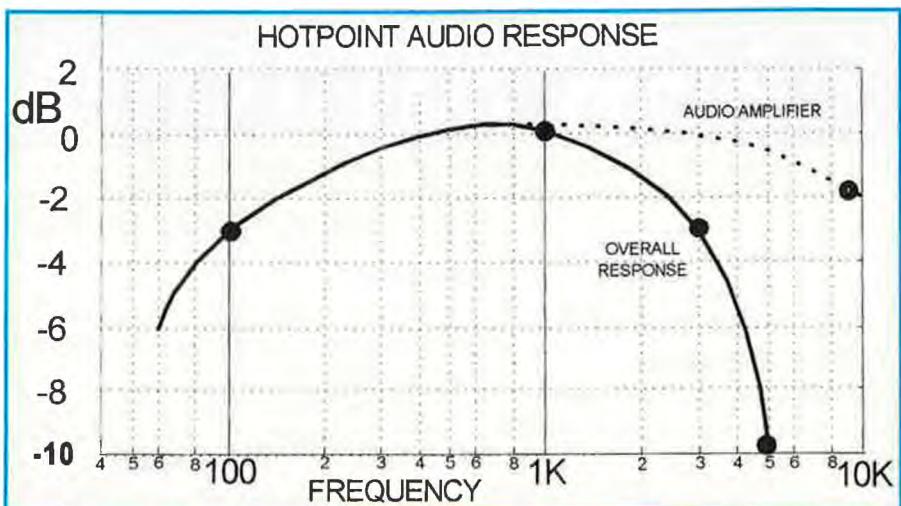
Fig.1: the audio response curve for the Hotpoint J35DE radio. It's 10dB down at 5kHz but most people were happy with a "mellow" tone in the 1950s.

Audio Output.....	Max. 3W; undistorted 1W.
Frequency Response	-3dB @ 100Hz & 3kHz, -10dB @ 5kHz.
Receiver Sensitivity.....	12µV @ 600kHz; 8µV @ 1500kHz; 20µV @ 10MHz
(Signal level at receiver aerial terminal: AM signal 30% modulated @ 1 kHz for 50mW output)

The performance of the receiver is listed in the accompanying panel. The poor audio response is due to the narrow selectivity of the 455kHz IF stage attenuating the sidebands and is typical of AM receivers manufactured in the 1940s and 1950s, when people were happy with a "mellow" tone. The sensitivity, although not outstanding, is adequate for receiving local stations given about 5m of aerial wire extended away from shielding objects.
