Vintage Radio

The Astor P7G 8-Transistor AM Portable Radio

Australian manufacturers built some excellent transistor radios during the early-to-mid-1960s. The Astor P7G was one such set. It boasted no less than eight transistors and even included an RF stage to lower noise and boost sensitivity.

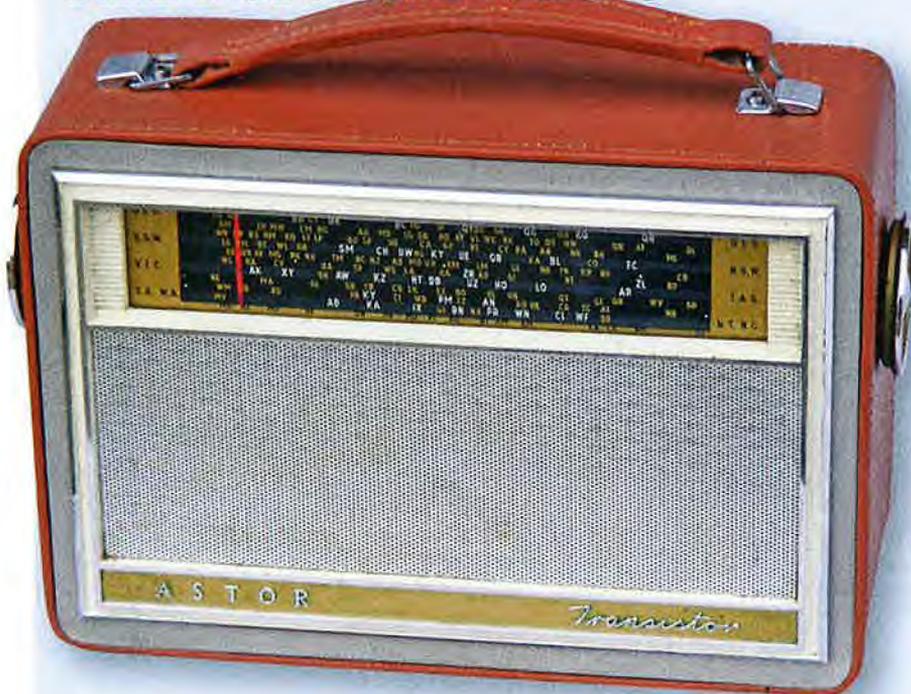
The old Astor P7G's leatherette cabinet is still in good condition, although the stitching is starting to give way in some places. The antenna and earth terminal screws are at top right and top left respectively.

I also found a number of greasy marks and dirt along the metal front panel. This was also scrubbed using a nailbrush and it now looks very acceptable. The cabinet now looks quite good even though some of the stitching along the cabinet edges has given way over the years.
