Vintage Radio

The AWA PA1002 50W PA Amplifier

Boasting a power output of 50W RMS, the AWA PA1002 is a typical valve PA amplifier from the mid-1960s. It's a rugged, well-made unit with many useful features and is easy to troubleshoot and restore.

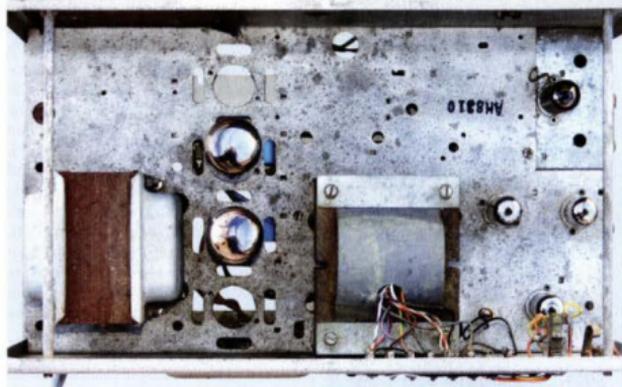
These above-chassis views show the simplicity of the layout. The two large vacant holes are for additional output valves, as used in the 100W version.

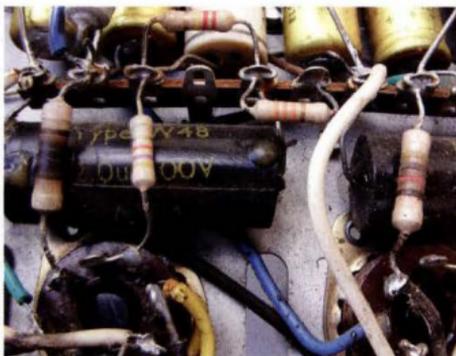
Three badly overheated resistors were the most obvious fault when I removed the bottom cover from the amplifier. Two were on the screens of the 7027A output valves, so it was quite possible that these had also been damaged after such abuse.

This view shows the two badly overheated resistors on the screens of the 7027A output valves. Fortunately, the cathode resistors had gone open circuit and saved the output valves from damage.

With the unit now disconnected from power, I checked the cathode resistors and found that they were both open circuit. In addition, both of the 2 μ F capacitors in the grid-to-cathode circuits were leaky, as were the 100nF coupling capacitors from the two 12AU7 valve plates to the respective grids.

Surprisingly, the screen resistors were still intact and measured 4.7k Ω and 5.6k Ω . In the end, I replaced all these resistors and capacitors. The original capacitors were paper and metallised-paper types and it was known that they eventually became leaky. In fact, it would have been better if AWA had used the more reliable polyester or polystyrene capacitors in this section of the amplifier, just as they had done in the front-end.

Fortunately, it appears that the output valves suffered little in the way of damage and there's no point replacing them. They were probably saved from destruction by the 470Ω cathode resistors going open circuit.
