Vintage Radio

Philips 196A 4-Valve AC/ Battery Portable Receiver

Designated the 196A, this interesting little portable radio from Philips uses valves and can be run from either batteries or mains power. It was designed as a low-cost set but is still quite a good performer.

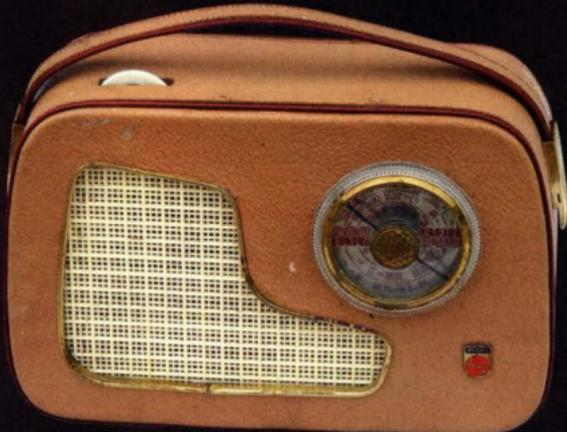
As can be seen from the photos, the case is a little unusual. According to the supplied information (on the inside of the set), it's made from sandstone-coloured, rippled leatherette over stiff cardboard sheets, a style that was used for many portables

The 196A valve portable has just three controls: a partly-recessed volume control at top left, a hand-span dial on the front panel and a small lever located under the lefthand end of the carrying strap. This lever controls a 3-position switch which switches the set on or off and selects between battery and AC operation.

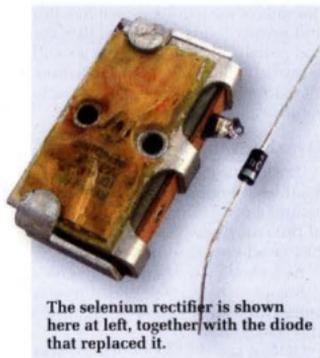
As stated above, this set uses a half-wave selenium rectifier block and this is bolted to the chassis. They are not very efficient and do get quite hot. In addition, their impedance tends to go high, which lowers the loaded output voltage considerably.

the output voltages from the power supply were indeed around 7.5V and 90V. This showed that the filament voltage was around 3.5V, while the high tension (HT) was just 65V. These readings were both much too low and from experience, it pointed to the selenium rectifier being faulty.

The selenium rectifier is shown here at left, together with the diode that replaced it.

I decided to leave the existing rectifier block in place and connect a 1N4004 diode in series with a 3.3kΩ resistor across it. This gave slightly higher voltages out of the power supply but they were still too low so I progressively reduced the 3.3kΩ resistor in series with the diode until I got the correct voltages.

Unfortunately, while I was wiring these parts in place, one of the lugs broke away from the selenium rectifier block. As a result, it was removed and a small tagstrip fitted in its place, with the diode and resistor wired to it. The series resistor value came down to 135Ω before I got the correct voltages for the filaments and plate supplies (ie, 7.5V and 90V). In practice, this 135Ω resistor was made up of using a 180Ω 5W wirewound resistor and a parallel 470Ω 1W carbon resistor.

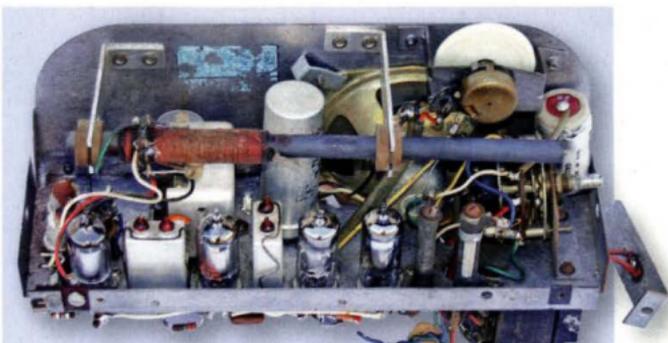
The top of the chassis is neatly laid out, with all parts readily accessible. The rotary switch at right provides on/off switching and selects between battery and mains power.

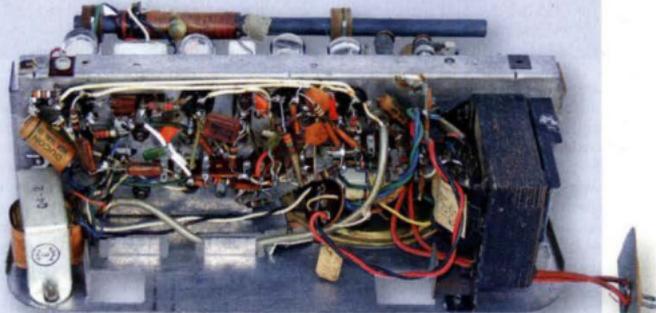
By contrast with the top side, many of the parts under the chassis are difficult to access. This view shows the chassis after restoration, with all but two of the paper capacitors replaced.

Having proved that it worked (in a fashion), it was now time to replace any leaky paper capacitors that might affect the set's operation. In the end, I replaced all these capacitors except for a 100nF low-tension RF bypass and a 4.7nF top-cut filter on the plate of the 3V4. The capacitors that were removed had between 1.5MΩ and 7MΩ of leakage resistance, so it was no wonder that the audio was distorted.

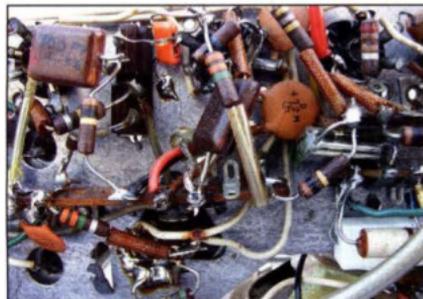
This receiver is generally quite good to work on but sometimes you have to dig down through up to three layers of components to get at the parts. As a result, it can take quite some time to replace or test some components – not that you have to do that often.

Many of the parts under the chassis are "buried" two or three layers down, which can make replacement difficult and time-consuming.
