Vintage Radio

The National SW5 Battery-Powered “Thrill Box” Receiver

A classic American shortwave radio from the 1930s

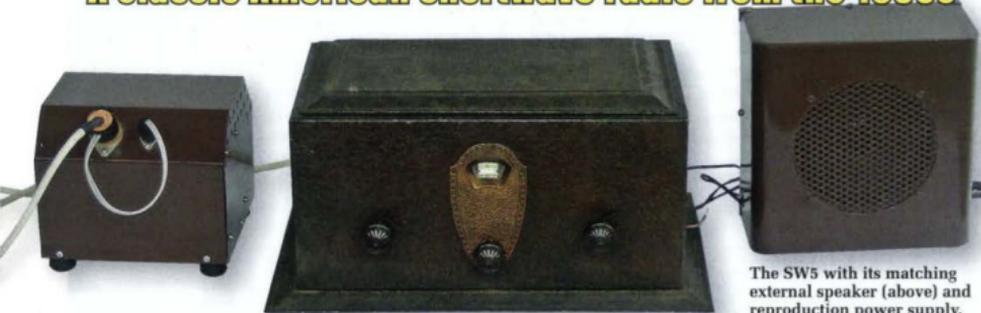
The SW5 with its matching external speaker (above) and reproduction power supply.

lead was made up. This exits from the back edge of the chassis and runs to a home-made mains power supply, as batteries are either very expensive or now unobtainable. This AC mains power supply was built into a case that resembles the original 110V AC power supply, with all the necessary output voltages catered for.

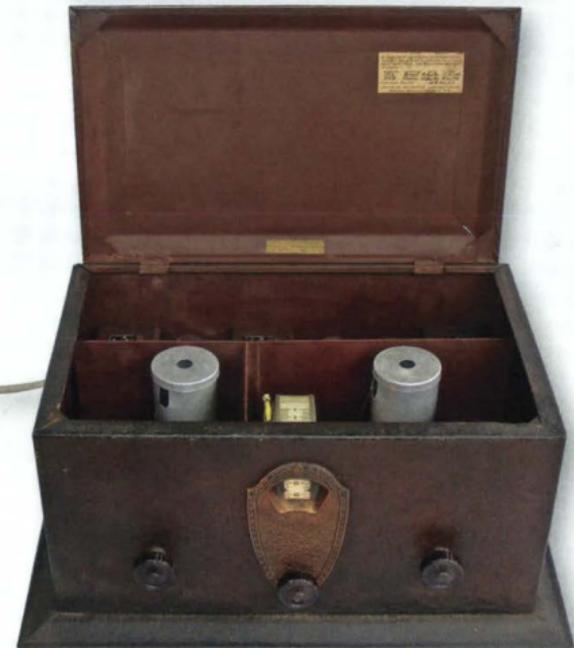
As shown in the photos, the SW5 shortwave receiver was housed in a metal coffin-style cabinet with a crackle finish (although it looks more like a crinkle finish). The dark brown was very much the colour of choice for most radios of the era.

The three controls are laid out neatly across the front panel, with the regen-

eration control at left and the tuning control at centre with a numbered dial-scale immediately above it. Frequencies were not directly marked on dial scales at this stage of radio development and so listeners usually made a list of where the various stations appeared on the scale. With the “Thrill Box”, several lists were necessary as this is a multi-band receiver.

The final control (at right) is for antenna peaking and this was simply adjusted for best reception of an incoming signal.

The lid of the SW5's cabinet is hinged at the back, so that it can be opened to change the plug-in coils for different bands. There are just three front-panel controls: regeneration (left), tuning (centre) and antenna peaking (right).

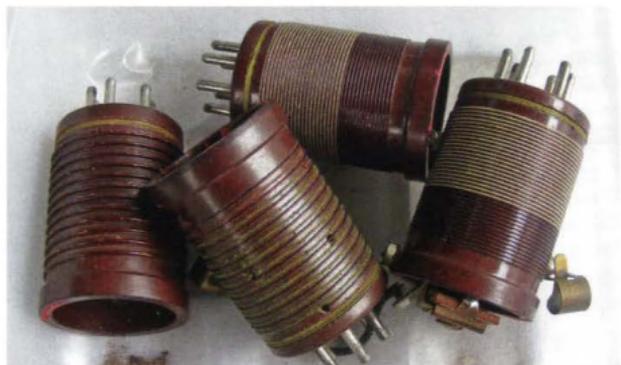
Despite tuning several bands, there is no band-change switch on the SW5. Instead, in order to change bands, it is necessary to remove two plug-in tuning coils and swap them for another pair that correspond to the wanted frequency band. A selection of tuning coils is shown in one of the photos.

With the four pairs of plug-in coils normally supplied, the receiver can be tuned from 2609kHz to 19.355kHz. Another three pairs of coils could also be purchased which extended the tuning from 2729kHz down to 526kHz, giving seven pairs of coils for a full set (ie, 14 separate plug-in coils).

This photo shows just some of the plug-in coils used with the receiver. Four pairs of coils were supplied as standard and additional coils could also be purchased.

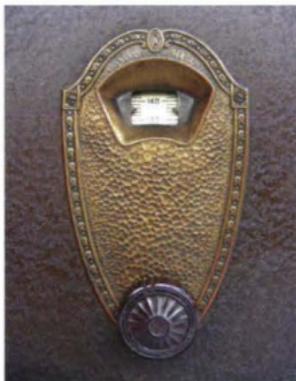
A simple numbered dial-scale was used in the SW5 receiver, so users normally kept a list showing where various stations appeared.

It didn't take long for the next problem to crop up. After tuning across the band a few times, the dial cord broke so that also had to be replaced.

This set has one of the early cord-drive systems and the dial-cord used was quite coarse, being much larger in diameter than the dial-cord available today. However, for sets of this vintage, nylon builder's line makes good dial-cord and so that was used to restringing the dial.
