# Vintage Radio

## Seyon 2D 2-valve “wireless” & an old single-valve receiver

This month, we take a look at a Seyon mid-1920s wireless set and another set of unknown age that was probably built (or rebuilt) between the 1920s and the late 1930s. Both sets are owned by Mark Bennett and I have used the term “wireless” deliberately, as these sets are definitely from the era when the term “wireless” was used instead of “radio”.

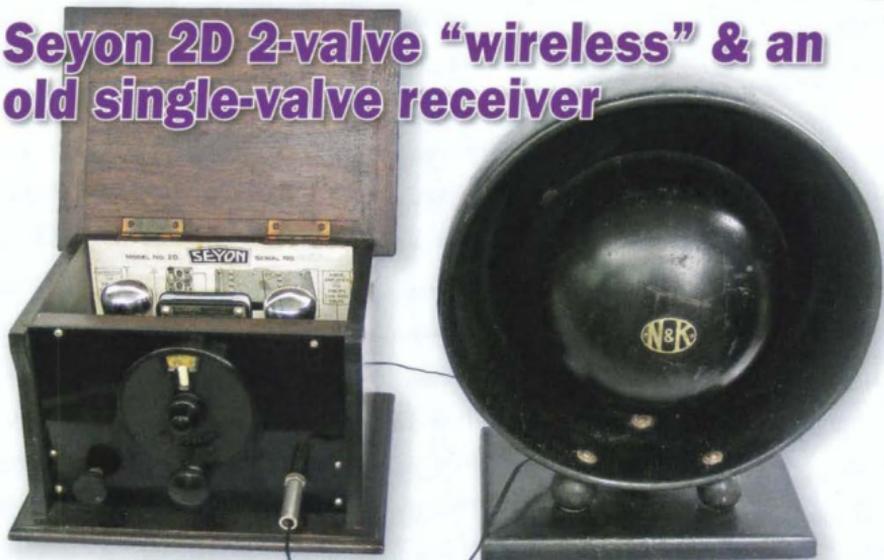
The front-panel photo clearly shows the lack of control markings, something that was common during the early days of radio. The tuning dial is an "Indigraph" with a simple numbered dial scale.

The lefthand side of the front panel carries the regeneration control, which is a Bakelite-enclosed 360°-rotation variable capacitor. Next comes the main tuning dial and this is adjusted using a vernier drive on its lower edge. The only other front-panel component is a jack socket, used for connecting either headphones or a sensitive loudspeaker.

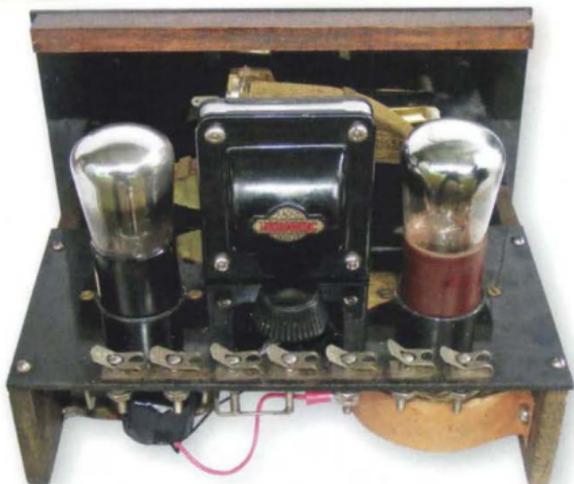
An above-chassis rear view of the 2-valve Seyon receiver. Note the large interstage audio transformer between the two valves and the row of spring terminals along the rear edge to terminate the battery connection leads.

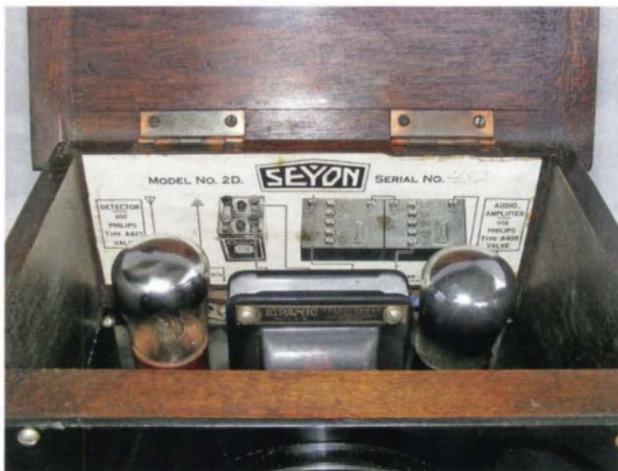
A card inside the back panel of the set shows the various connections for the batteries, antenna and earth. In fact, it’s rather unusual for such an old receiver to have such useful information attached to it, although it’s not as

Inside of the Seyon receiver with the lid raised. The label attached to the rear panel shows how the batteries, antenna and earth are connected to the set.

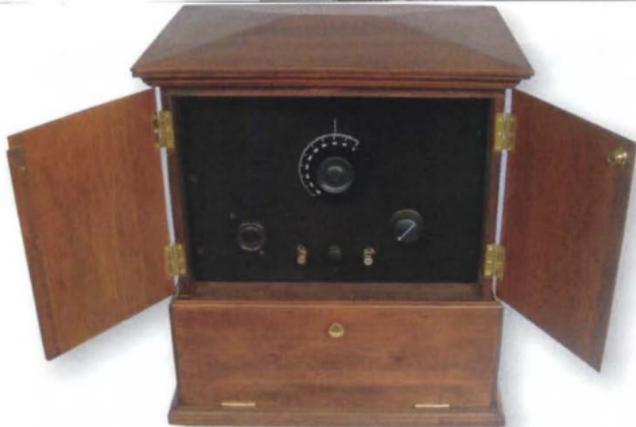
The cabinet for the 1-valve set was restored by stripping off the gold paint, then sanding and staining the timber. The doors and hinges were replaced.

The cabinet restoration required a considerable amount of work. The original cabinet (doors included) was covered with ugly, gold-coloured paint which really looked out of place, especially as the timber underneath was quite attractive. As a result, the cabinet was dismantled along all hinged edges, so that all the corners and edges could be easily reached during the restoration work.

poor condition. These were replaced by two new doors made by Dennis, a friend of Mark, while another friend (Marcus) turned up a new catch. In addition, all the old hinges were discarded and new brass hinges of the same general style obtained to go with the cabinet.

The rest of the cabinet was restored by first applying paint stripper to remove the gold paint. The cabinet was then sanded down along the wood grain using progressively finer grades of sandpaper to obtain a smooth finish. A product called "Feast Watson" (a wax-enriched timber oil) was then applied to the cabinet using a soft cloth and this gave the timber a rich golden-brown finish.

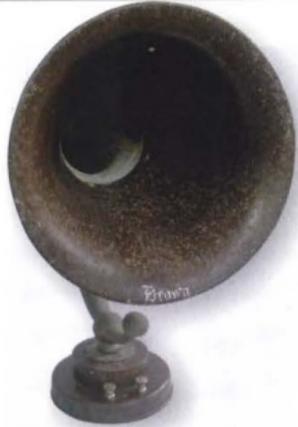
This Browns horn speaker is often used by Mark with the 1-valve set.

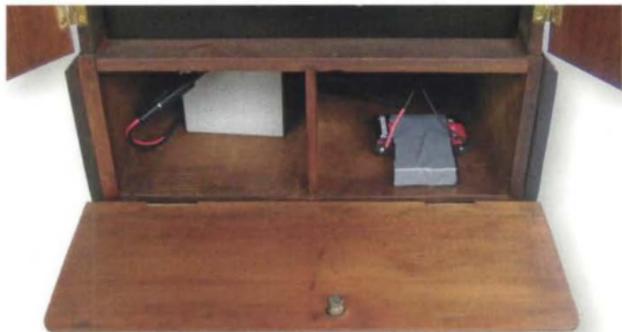
By contrast, the 45V HT for the plate circuit is provided by five 9V 216 batteries wired in series. These are daisy-chained together to give a spare terminal at each end which is then connected to the receiver. A battery snap connector cut in half makes the

connections to the battery terminals. As shown in one of the photos, the 9V batteries are taped together and sit in the cabinet's battery compartment.

The batteries for the 1-valve set sit in a special battery compartment at the bottom of the cabinet.
