Vintage Radio

Restoring an AWA B15 AM broadcast receiver

Housed in a unique plastic case with a concave front panel, the AWA B15 Radiola is a 5-valve set that's easy to troubleshoot and restore. This particular set had several unusual faults though.

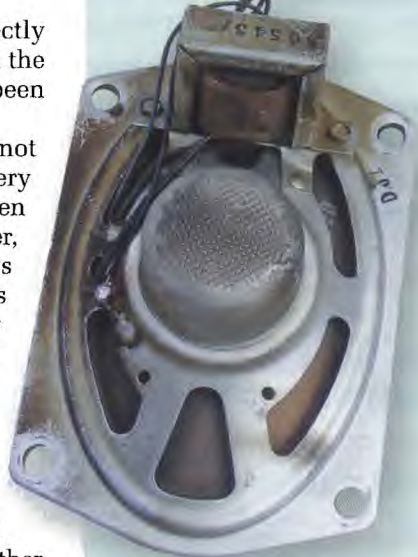
By gently pressing on the speaker cone, I could feel voice coil grating against dust and other debris. As a result, I removed the speaker and peeled back the felt cover over the centre of the speaker so that I could take a look inside.

There was quite a bit of dust and some rather sharp grains of abrasive material in there. This was removed but foreign material was still present in other sections of the voice coil/magnet assembly. In the end, there was nothing for it but to replace the speaker.

The faulty loudspeaker was replaced with an identical unit salvaged from another B15 chassis that was unreparable.

As shown in the photos, the speaker is a special type with large mounting

holes that go over plastic spigots on the rear of the front panel. However, as luck would have it, I just happened to have a spare on hand. It had been salvaged from an identical receiver with a burnt-out power transformer some years ago and I had saved the ferrite-rod antenna as well.

The new speaker worked perfectly and I could have also substituted the ferrite rod if the original had been beyond repair.
