Vintage Radio

**Rescued from the junk pile
& fully restored . . .**

A 1925 Freed-Eisemann Neutrodyne Radio

Salvaged from an old storage shed in outback Queensland, this rare 1925 Freed-Eisemann neutrodyne set was in poor condition, with a dilapidated, water-damaged cabinet and missing parts. Restoring it to as-new condition proved quite a challenge.

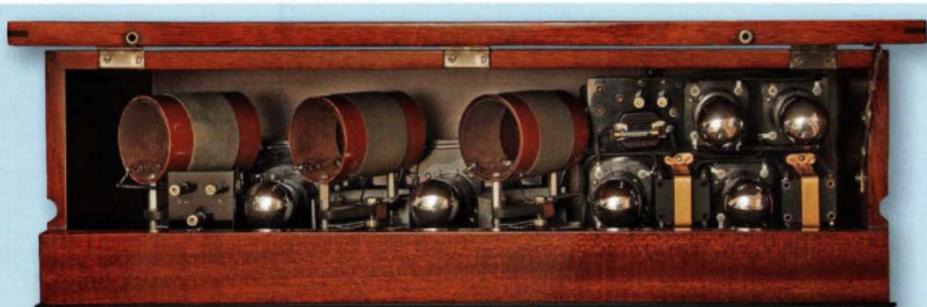
This is the view inside the cabinet of the fully restored receiver. The RF section is at the left, while the detector plus audio stages are at the righthand end. Note the two gold-finished interstage transformers in the audio section.

The most difficult items to acquire were the two interstage transformers. Only originals could be used, as Freed-Eisemann wound their own. They were autograph embossed on the metal band around the transformer and finished in gold plating, so they really looked the part! Once again, the internet came to the rescue.

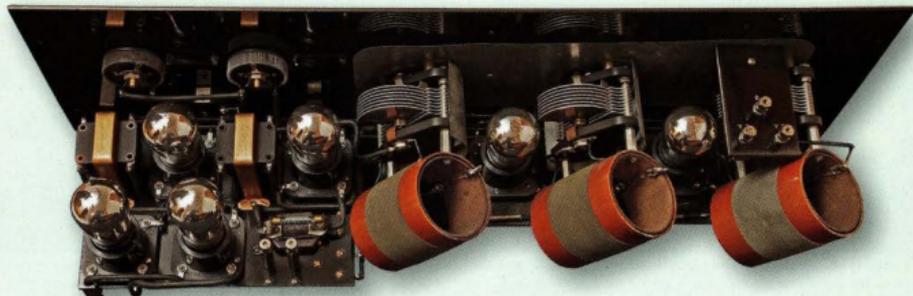
Rear view showing the large coils and the two wirewound rheostats. The entire detector/audioboard on the left was missing from the salvaged unit and had to be rebuilt from scratch, using photos obtained via the internet as a guide.

The missing audio section was made by following photographs of complete NR-7 radios. Two brass brackets need-

ed manufacturing, so brass stock with the same profile as the brackets in the RF area was obtained from a company in Clayton, Victoria that specialises in brass profiles. This brass stock was then cut and bent to shape.

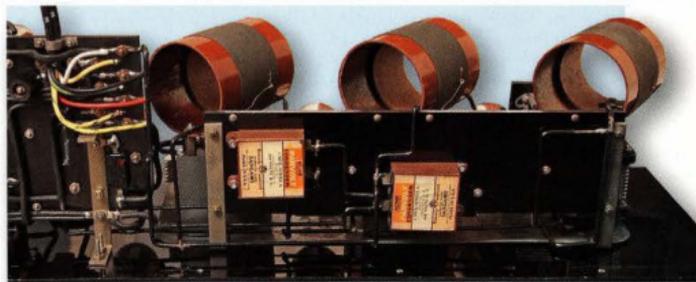
The two 1µF capacitors mounted under the RF stage were still operational, while the new multi-way battery cable was obtained from stock especially made for the HRSA valve bank.

A new cloth-covered, multi-core DC power cable, obtained from the HRSA Valve Bank, was also installed.

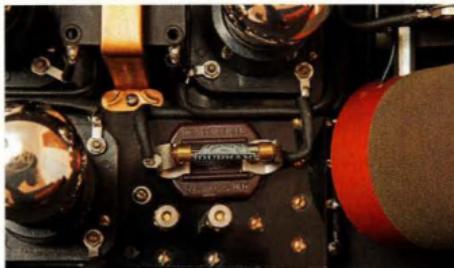
The only fixed resistor in the circuit is the 2M Ω grid leak resistor for the detector valve. It's mounted between two clips above a 0.00025 μ F (250pF) mica capacitor.

The only fixed resistor in the entire circuit is the 2M Ω grid resistor for the detector valve. This clips into two brackets mounted at either end of a 0.00025 μ F (250pF) mica capacitor (see photo). These parts also had to be replaced.

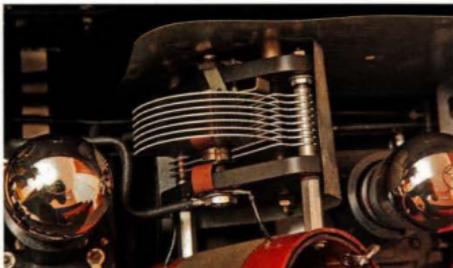
This close-up view shows one of the variable capacitors after it had been ultrasonically cleaned, scrubbed with a toothbrush and re-assembled. It now looks like new.

After initially cleaning the RF parts, all three variable tuning capacitors were disassembled and placed in an ultrasonic cleaner. Their aluminium vanes and frames were then finished off by scrubbing them with a toothbrush, after which the bearings were oiled and the parts reassembled. They came up looking like new.
