Vintage Radio

The AWA B30: a transistor radio just like grandma's

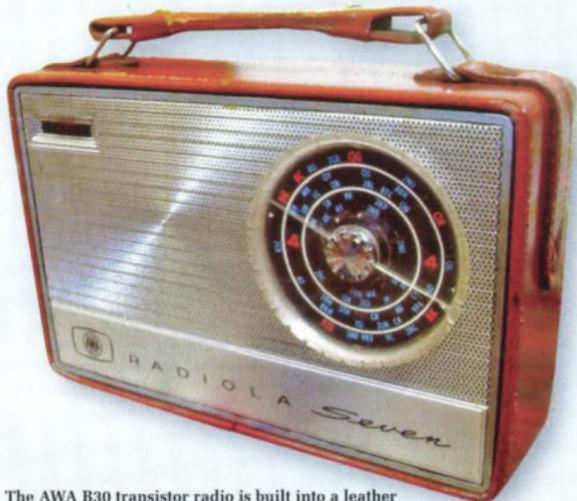
The AWA B30 transistor radio is built into a leather case and has just two controls: a large handspan dial and roller volume/power switch at top left.

It was then just a matter of reinstalling the PCB assembly in its case and giving the leather a good clean. The accompanying photo shows the result.

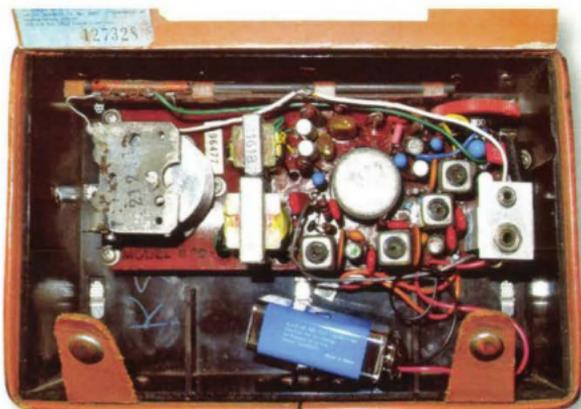
Most of the parts inside AWA B30 transistor radio are mounted on a densely-packed PCB. The original long 9V battery pack used in these radios is no longer available but a type 216 9V battery (wrapped in foam to stop it rattling) can be used instead.

The PCB assembly in this radio is very compact, with the parts jam-packed together and the resistors standing on their ends. This can make component replacement a difficult operation. The components are also relatively large by today's standards, which further adds to the impression of a crowded circuit board.

The original battery was a long 9V pack which was mounted under the PCB. These batteries are no longer available but can be replaced by a 9V type 216, as typically used in smoke alarms. I usually replace the battery

plug with a snap connector to suit the type 216 and always fit an alkaline battery, as these are now available quite cheaply and have quite a long life in this application.

A piece of plastic foam can be cut to fill the large space left when installing this battery type, to hold it in place and stop it from rattling around inside the case.

Typically, the copper tracks on PCBs used at that time were sensitive to overheating when parts were installed or, more particularly, when they were being removed. The tracks peel away from the board laminate quite readily if too much heat is applied, so it is necessary to always use a temperature-controlled soldering tool, set as low as possible.

It's also important to work quickly, to avoid overheating the pads and tracks. I always have a good supply of solder-wick handy to speed up component removal, especially for early Australian-made equipment. After all, preventing the track from lifting in the first place is better than trying to patch a damaged track.
