Vintage Radio

The upmarket 1950 HMV R53A radiogram

HMV R53A radiogram

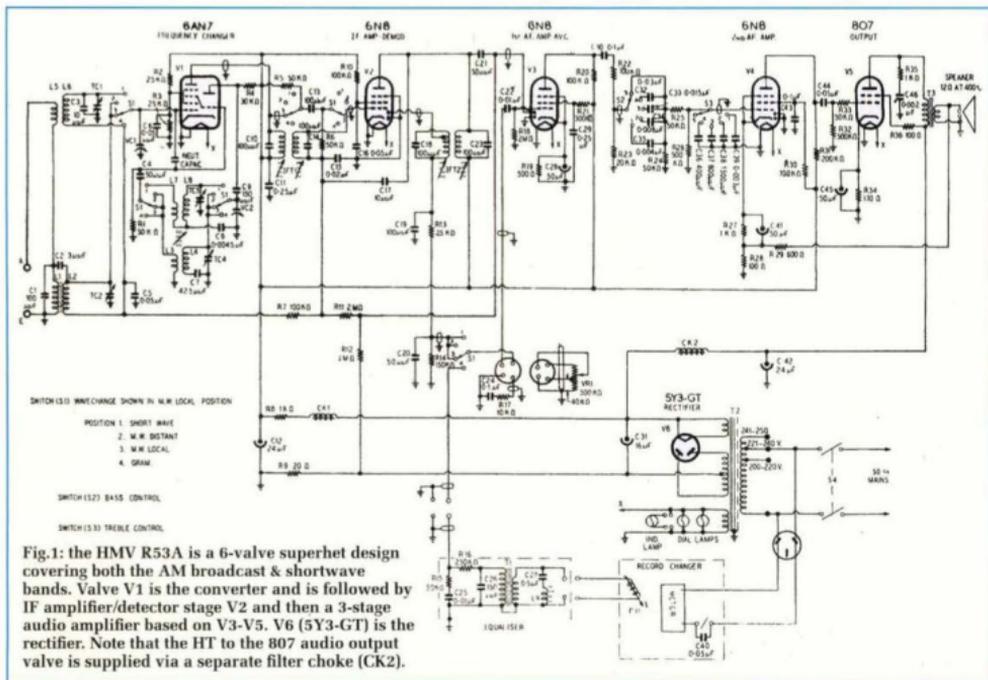
Basically, the owner wanted to be sure that the chassis could be repaired before he undertook the cabinet restoration. As shown in the photos, the R53A is quite a large unit, with the radio chassis and the record changer

mounted side-by-side in separate compartments. These compartments are accessed by opening separate doors which hinge down.

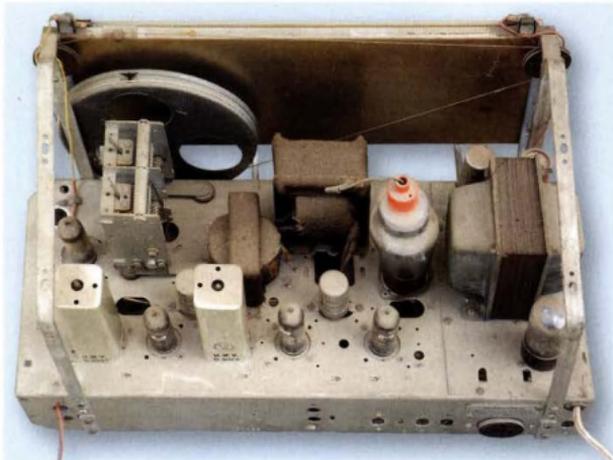
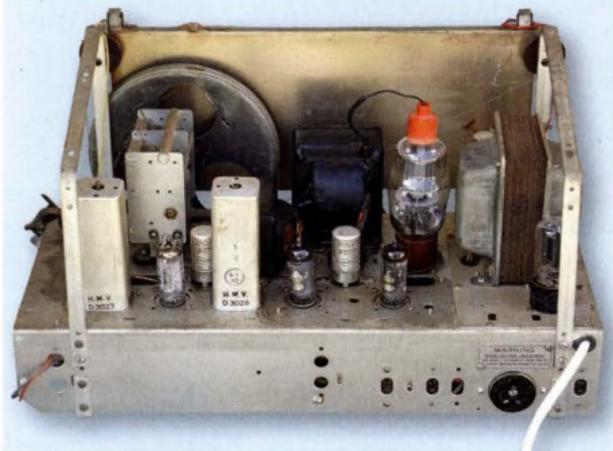
These two views show the chassis before and after restoration. Note the insulated cap (red) on the top of the 807 output valve. This is the plate connection and must not be touched due to the shock hazard.

Once it was out of the cabinet, the chassis was carefully dusted using a paintbrush and cleaned with a kerosene-soaked rag. This also worked wonders on the black sealing material used on the transformers. The cabinet was then brushed down and a damp sponge used to remove any ingrained dust from the woodwork.

There was no corrosion to any extent and the chassis looked quite presentable. This old HMV R53A has obviously been stored in a dry environment to still be in such condition.

As is my usual practice, my next step was to remove all the valves and wash them in warm soapy water. The miniature valves were simply dunked in the water and the glass envelopes rubbed clean. However, you have to be careful not to remove the type markings, as these can easily be rubbed off. These valves were then rinsed under clean water and allowed to dry.

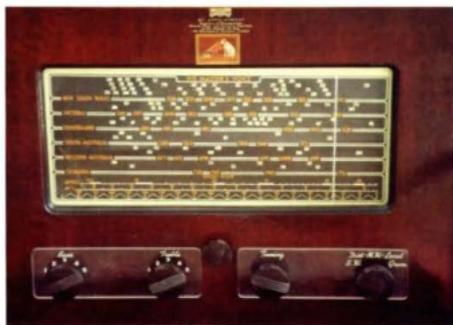
The two tone controls, the tuning control and the band-switch are mounted just below the dial, while the volume control is mounted on a side-panel of the cabinet.

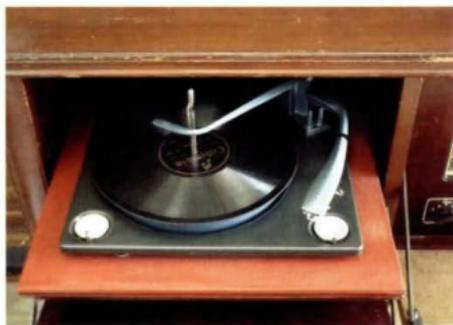
The original record changer had obviously given trouble because it had been swapped out for this more-modern BSR unit. It sits on a shelf that slides out of the cabinet.

The biggest problem with this changer turned out to be the pick-up cartridge – it simply had no output. Unfortunately, a direct replacement is now almost impossible to obtain and after looking through many catalogs, the only generic pick-up that was suitable was listed by WES Components of Ashfield in Sydney.

It wasn't a drop-in replacement, however, and the tone-arm mounting had to be carefully modified so that it could be installed properly. It wasn't a difficult job but it did take more time than expected.

Having set the stylus pressure, I then cleaned any old congealed grease off various surfaces and applied fresh, light grease in its place. The motor bearing and various pulley bearings were then oiled. This was relatively straightforward although I did have to dismantle the motor to gain access to its bearings. In fact, this should be done every few years as these motors can seize up if they are not lubricated and this particular unit was very close to that point.

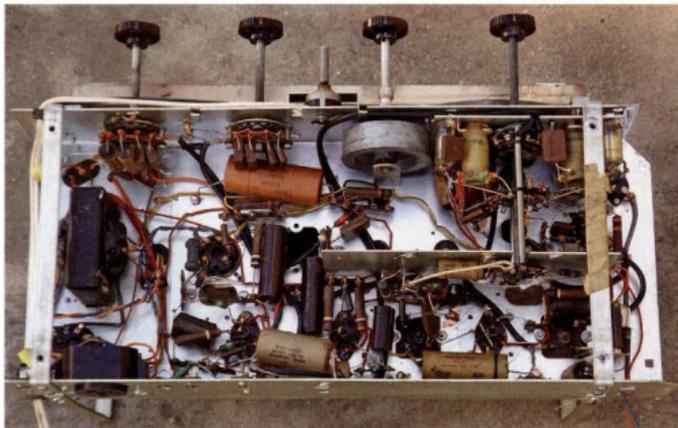
All the parts under the chassis of the HMV R53A are readily accessible. This view shows the chassis prior to restoration – some parts were replaced to get the set going, while the 2-core mains cable was later replaced with a 3-core cable so that the chassis could be earthed.

The next job was to replace all the electrolytic capacitors and any paper capacitors that were excessively leaky. The paper capacitors were tested for leakage using a high-voltage insulation tester. This tester was then set to its 1000V range and used to check the insulation of the power transformer. In this case, the resistance from the mains winding to earth was found to be in excess of 100M Ω , which is quite satisfactory.

In order to maintain the original appearance, the faulty electrolytic capacitors on the top of the chassis were left in place but were disconnected from the circuit. New capacitors were then fitted in place under the chassis. The most critical capacitor is the one connected to the 5Y3GT as this rectifier doesn't 'like' high surge currents flowing through it. In this case, C31 was initially replaced with a 10 μ F 525V capacitor (see below).

The two components (one resistor and one capacitor) that had been replaced earlier in the set's life had failed again and so new parts were substituted for these. A couple of other resistors were also found to be well out of tolerance and were also replaced.

all the movable controls were lubricated using either light machine oil or Innox[®] lubricant. These controls then all worked smoothly and were free of mechanical noise. The original 2-core power lead was also replaced with a securely anchored 3-core lead so that the chassis could be safely earthed.

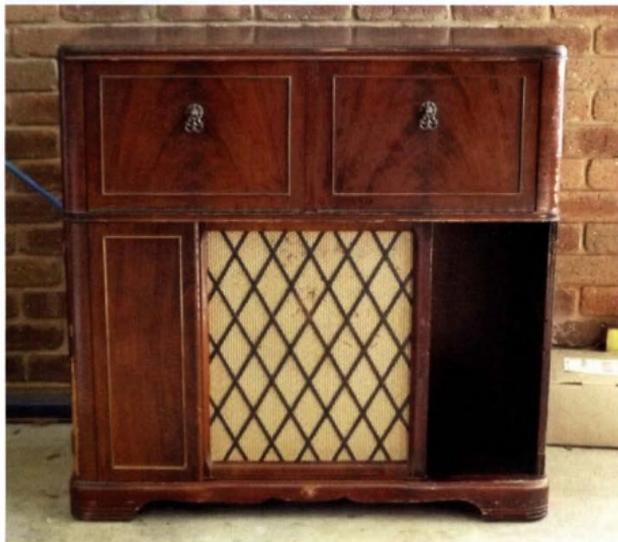
Now that the radio and record changer have been repaired, the next job is the cabinet restoration. One of the bottom doors is missing and will have to be made.

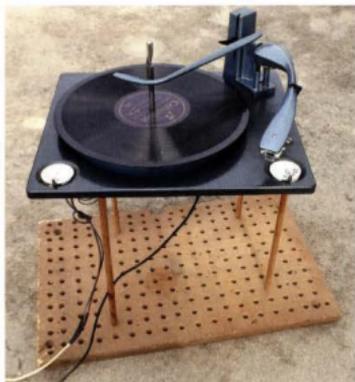
The record changer was serviced by sitting it on top of this homemade jig.

Observing the operation of a record changer mechanism isn't normally an easy job. However, back in the October 2000 issue of SILICON CHIP, I described a home-made servicing aid which allowed a changer to sit up on 300mm-high dowels, so that the mechanism could be observed during operation.

As shown in one of the photos, I also used this device when I overhauled the R53A's changer. As mentioned, the original changer had obviously given trouble because it had been replaced with a more-modern BSR unit.
