Vintage Radio

The AWA Radiola 523-M: the last vibrator-powered radio

Battery/vibrator-powered domestic radios started life in the 1930s and continued to be manufactured in Australia until the late 1950s. They were still used in some areas of rural Australia well into the 1970s. Here we take a look at AWA's battery/vibrator-powered Radiola 523-M, a 4-valve superhet design with some interesting features.

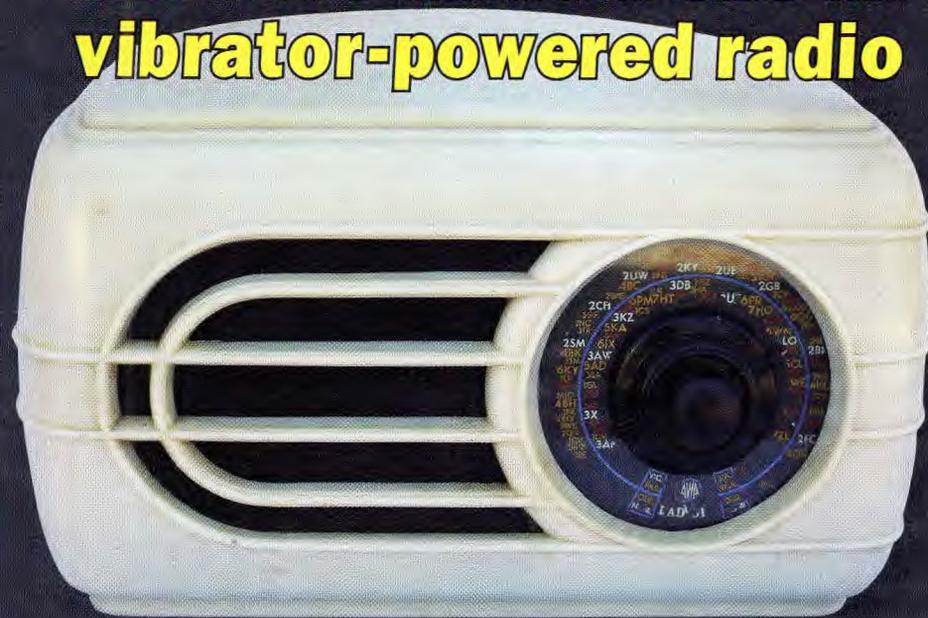
This photo shows the dilapidated state of the cabinet, dial scale and speaker cloth before restoration, while the photo on the facing page shows the set after restoration. The exterior of the set now looks almost like new again.

Once the chassis had been removed, the very grubby cabinet was scrubbed clean using a nail brush dipped in soapy water. This was done carefully though, to avoid wetting the paper label pasted inside the cabinet (this label shows the chassis layout). The cabinet was then carefully rinsed with clean water and rubbed down with car cut and polish. It now looks almost like new again.

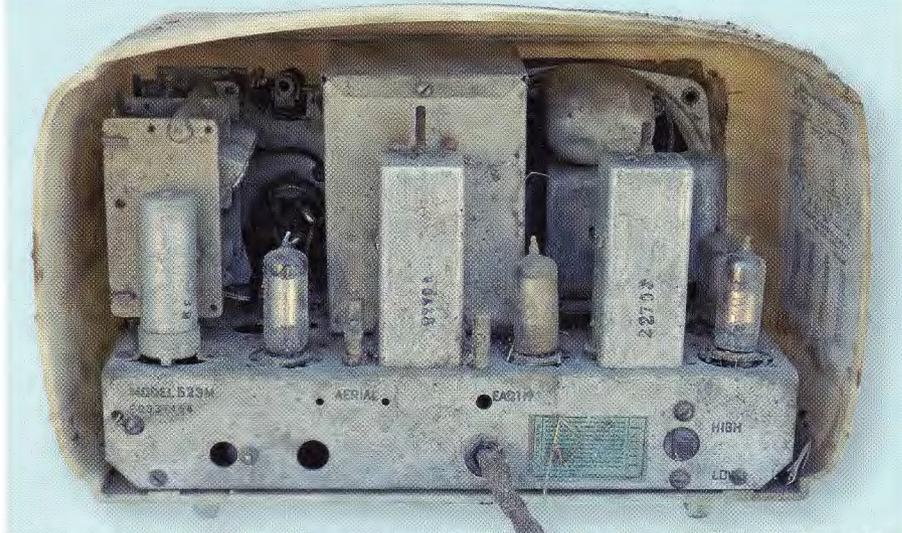
This is the view inside the rear of the cabinet prior to restoration. Unfortunately, mice had made a home in the set and the acid in their urine had etched through the plating on the chassis in quite a few places.

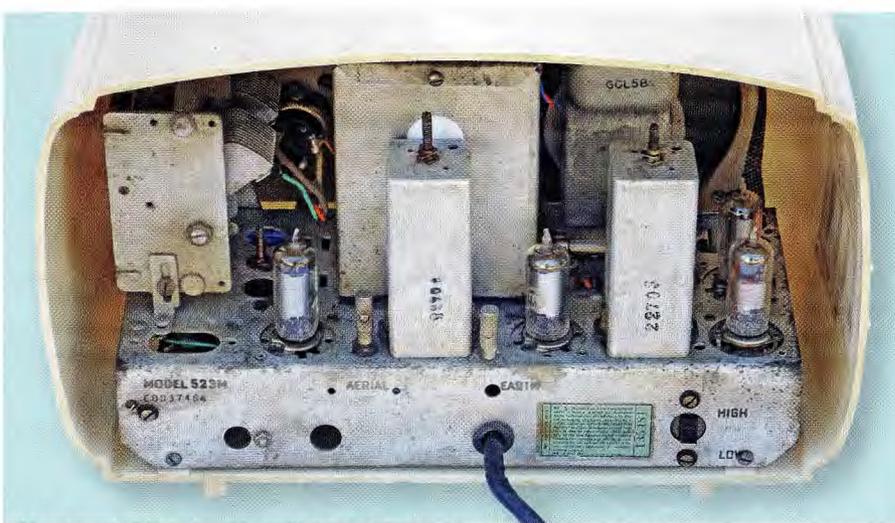
The view inside the rear of the cabinet after restoration. Great care was taken during cleaning to avoid damaging the label stuck to the inside of the cabinet and the ARTS&P label on the back of the chassis.

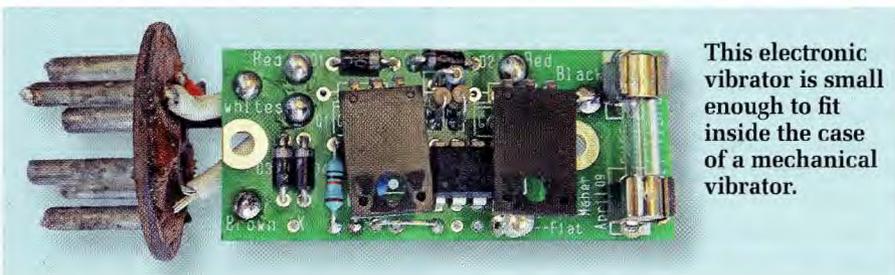
This electronic vibrator is small enough to fit inside the case of a mechanical vibrator.

To overcome these problems, Tony Maher of the Historical Radio Society of Australia (HRS) developed a solid-state MOSFET-based replacement module several years ago. It's designed to take the place of a variety of vibrators and what's more, it fits easily into old vibrator housings.

When I substituted one of Tony's V1 (second version) modules, the results were excellent. The output voltage was now around 107V with a 17mA load, while the current drawn from the 4V supply was about the same as it was for the electromechanical vibrator (which produced just 75V). So the electronic version is definitely much more efficient.

In fact, my measurements showed that the supply has an efficiency of 75% when using the Mosfet solid-state module. This drops to just 40% when using the rather tired mechanical vibrator. A new mechanical vibrator should result in better than 50% efficiency.
