# Vintage Radio

## The 1948 Healing L502E 5-valve radio

**Boasting excellent performance, the Healing L502E was released in 1948 and is a fairly conventional 5-valve superhet receiver. A number of different models share the same cabinet design, with some unusual mechanical linkages used for the on/off switch and tone controls.**

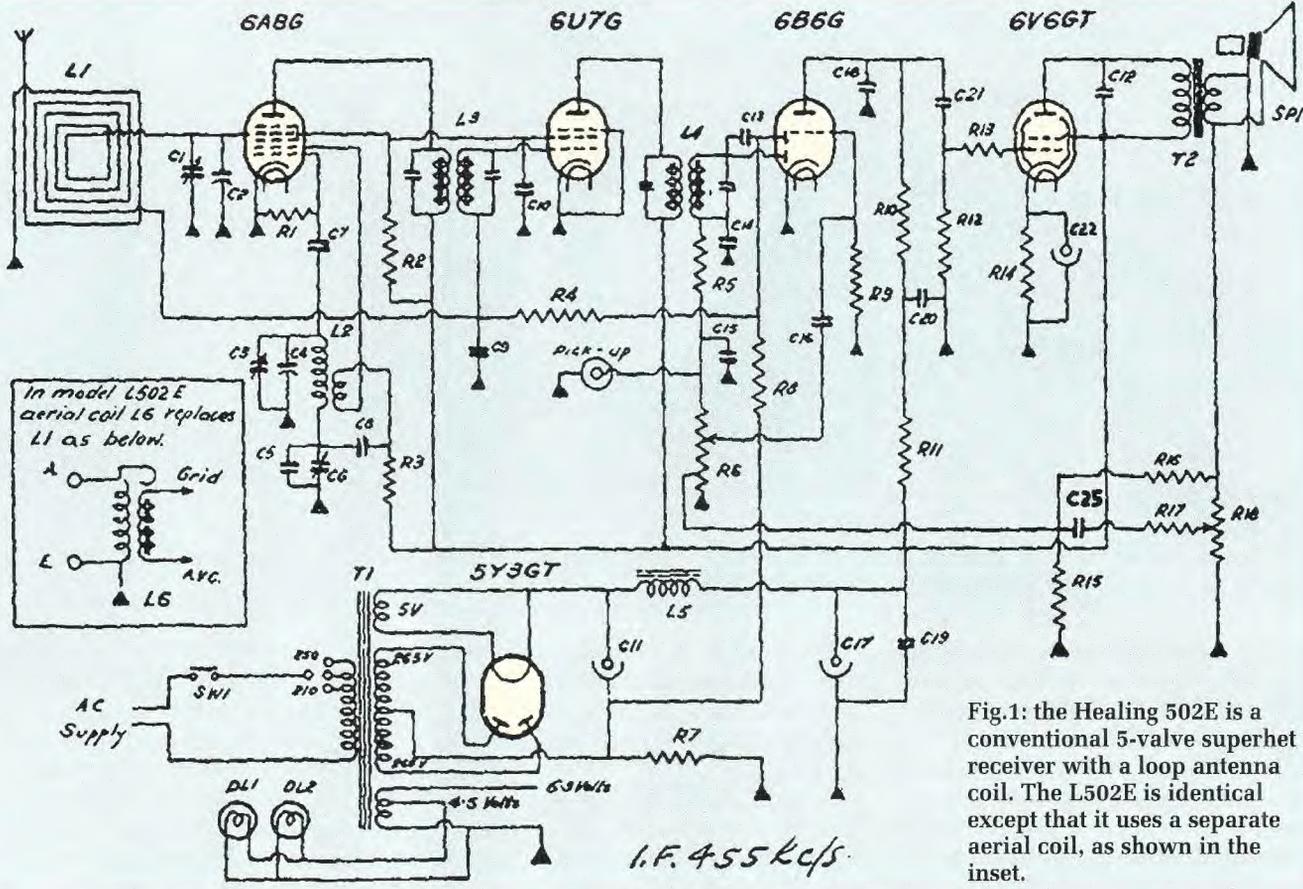
Fig.1: the Healing 502E is a conventional 5-valve superhet receiver with a loop antenna coil. The L502E is identical except that it uses a separate aerial coil, as shown in the inset.

Fig.1 shows the circuit details of the Healing Model 502E. There are no radical surprises here and no corners were cut for the sake of economy. However, it’s worth noting that, at the time, Healing also made a smaller 4-valve economy model designated the 401E. This “kitchen radio” did omit as many parts as possible to drive the cost down.

As shown in Fig.1, the Healing 502E is a fairly conventional 5-valve super-

het design employing a 6A8 mixer oscillator, a 6U7 IF amplifier, a 6B6 detector/AGC/audio preamplifier, 6V6 pentode output and a 5Y3 rectifier. The tone control circuit is somewhat more complicated than usual, with feedback from the output transformer via bass control pot R18 to a tap on the volume control to provide bass boost.

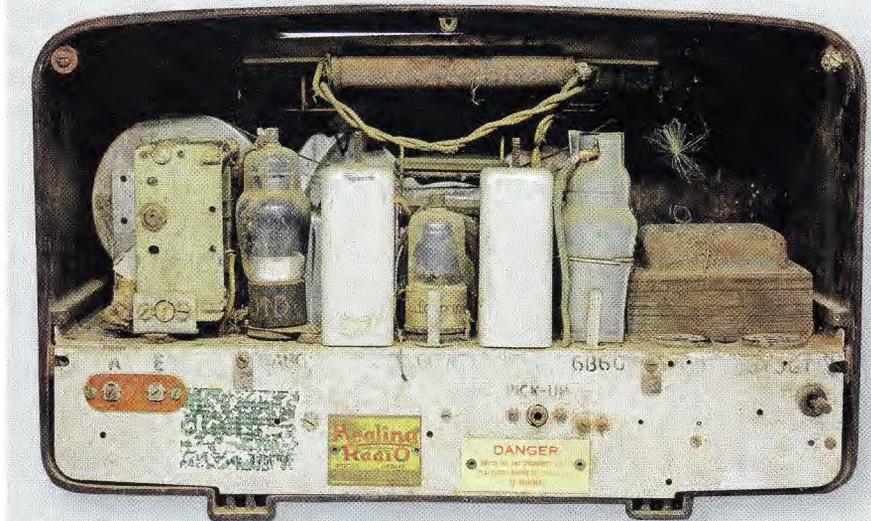
The author’s L502E receiver prior to restoration. It was covered in dust, had missing knobs and valves, and came with spider webs and a wasp nest.

When I acquired it, the L502E was missing all its knobs but came complete with spider webs and a rock-like mud-wasp nest between the tuning gang and the chassis. This wasp's nest had penetrated between the vanes of the tuning gang but I was able to remove it using a stiff wire brush.

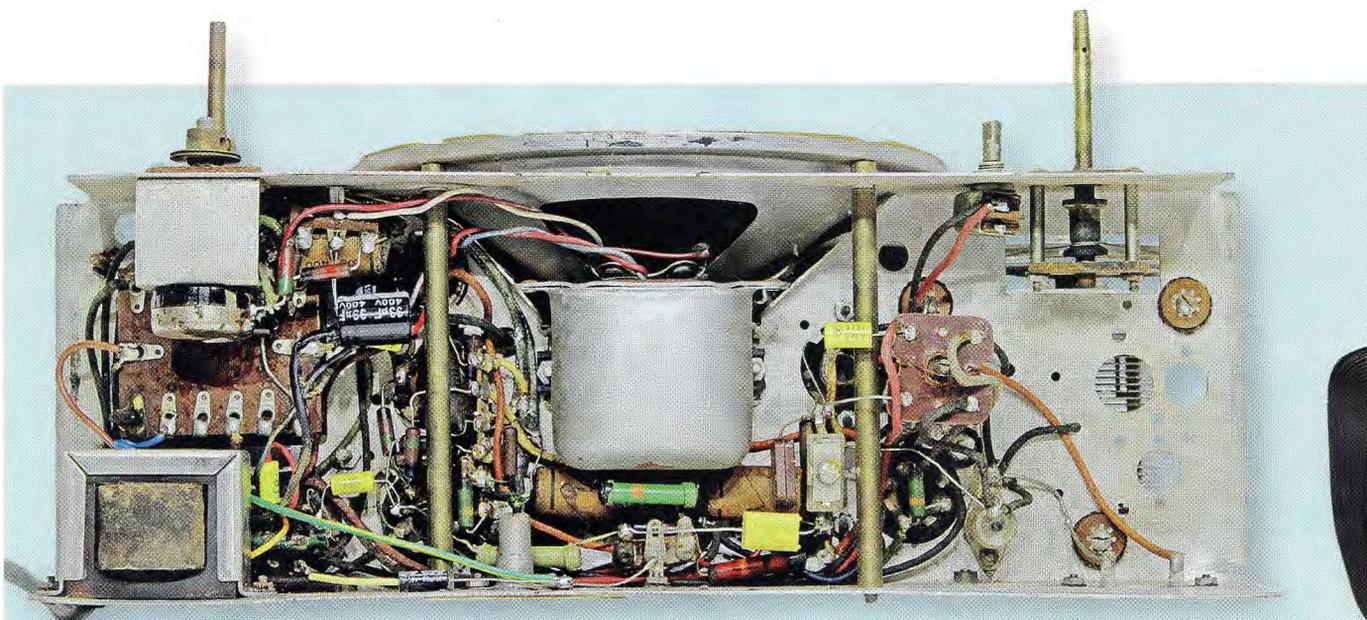
This view shows the 502E after the under-chassis restoration work had been completed. Some parts are difficult to access as they are buried under other components.

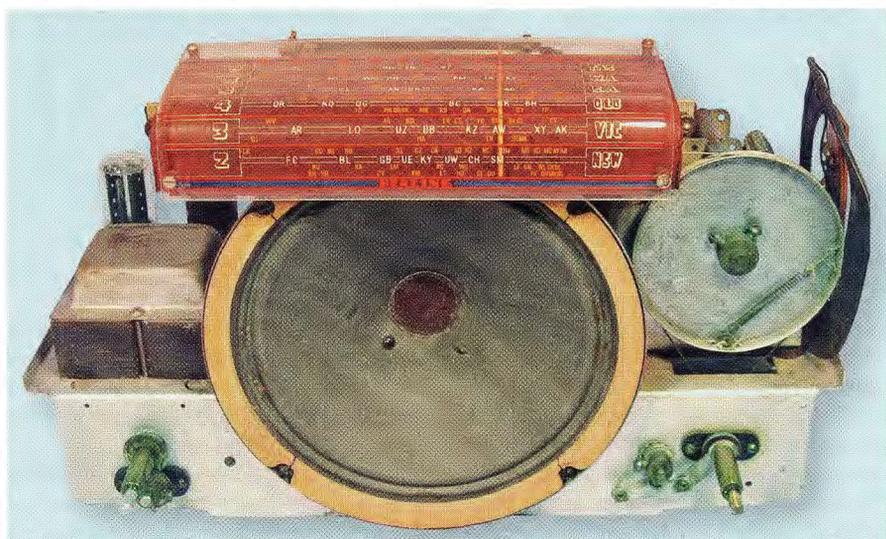
This front view of a 502E chassis shows the unusual curved dial-face and the mechanical linkages used for the on/off switch (right) and the tone control (left).

The right-hand central shaft is used for tuning. A mechanical linkage is also present on the lefthand side, with the outer control shaft fitted with a friction wheel. This in turn drives a wheel on the shaft of the separate tone control pot. The lefthand central shaft controls the volume pot. Basically, the engineering techniques used for these controls were driven by the aesthetics of the case design.

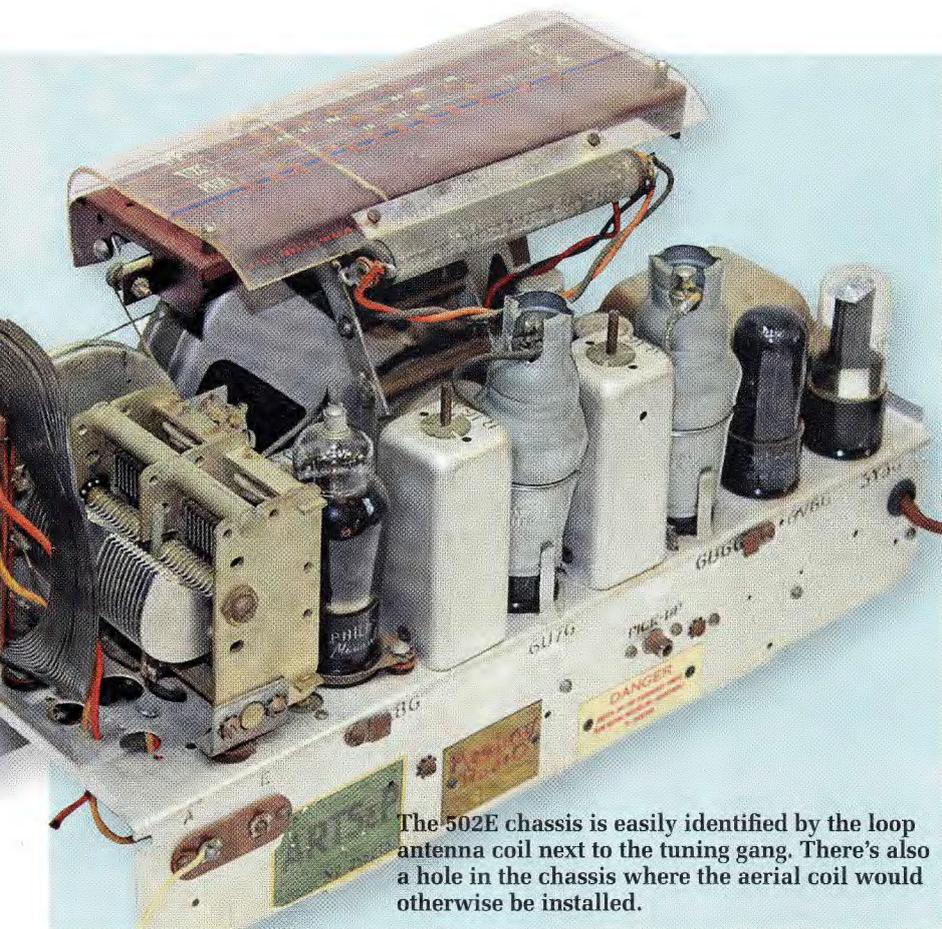
The 502E chassis is easily identified by the loop antenna coil next to the tuning gang. There's also a hole in the chassis where the aerial coil would otherwise be installed.

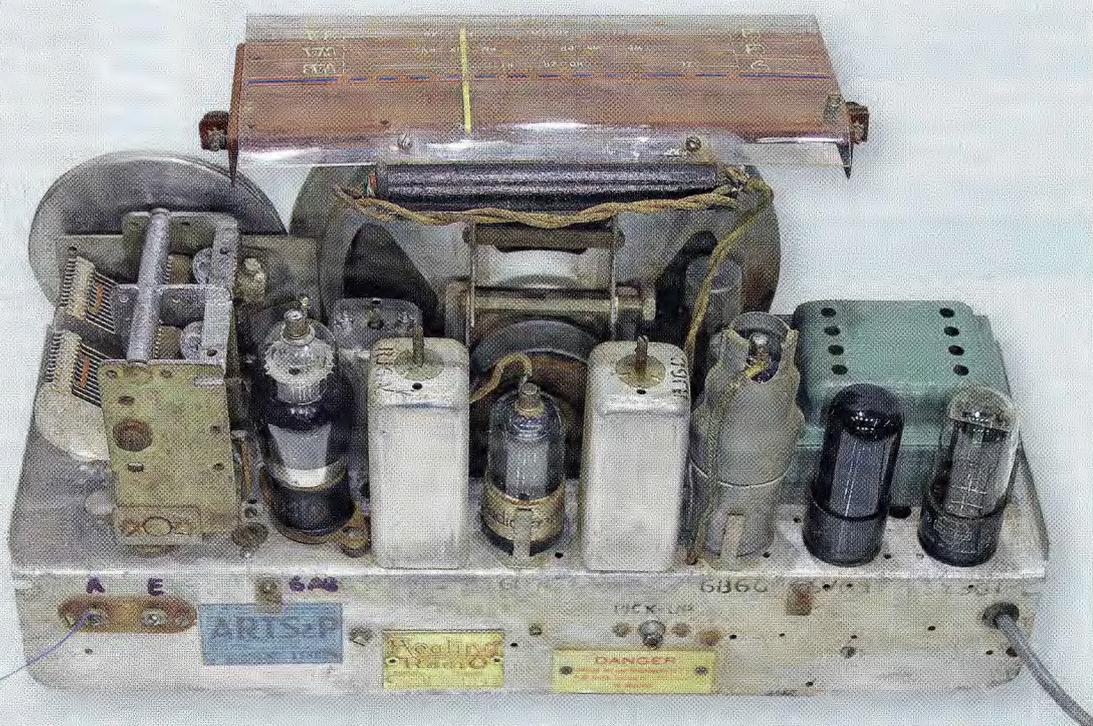
The model L502E uses a conventional aerial coil instead of the loop antenna coil used in the 502E. It's shown here nestled between the first IF coil and the loudspeaker (ie, immediately behind the tuning condenser and the 6A8 mixer-oscillator valve).

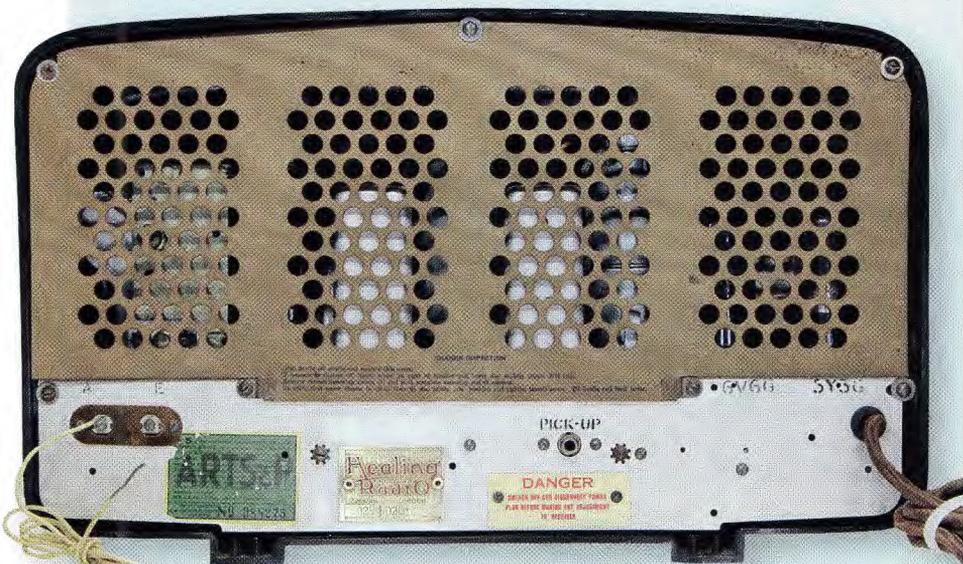
The Healing 502E & L502E sets carried a "Pick-Up" socket on the rear of the chassis so that a turntable could be plugged in. There was no provision to mute the radio section when this was done though.

As with many similar sets, the 502E has a gramophone "pick-up", with the signal fed in via an RCA-type socket in the middle-rear of the chassis to the top of the volume control pot. There is no provision to mute the radio section when it is used with a gramophone pick-up though, so presumably it was just a matter of the user tuning off-station, to a quiet part of the dial.
