HMV Service Manual – Models 209/660

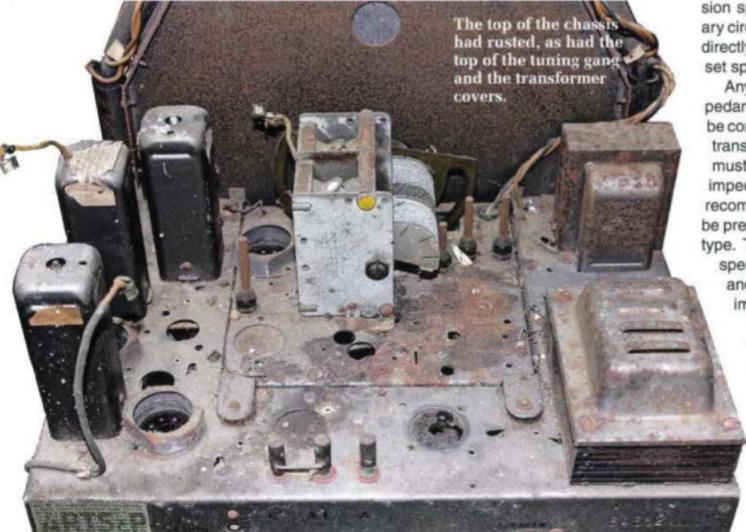
The top of the chassis had rusted, as had the top of the tuning gang and the transformer covers.

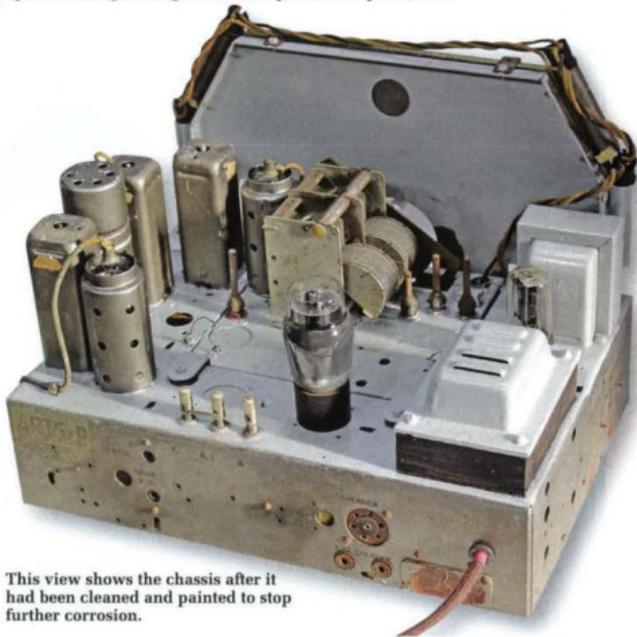
This view shows the chassis after it had been cleaned and painted to stop further corrosion.

Everything appeared to be in good condition under the chassis. However, the original figure-8 mains flex was still in place, so this was replaced with 3-core mains cable so that the chassis

could be securely earthed.

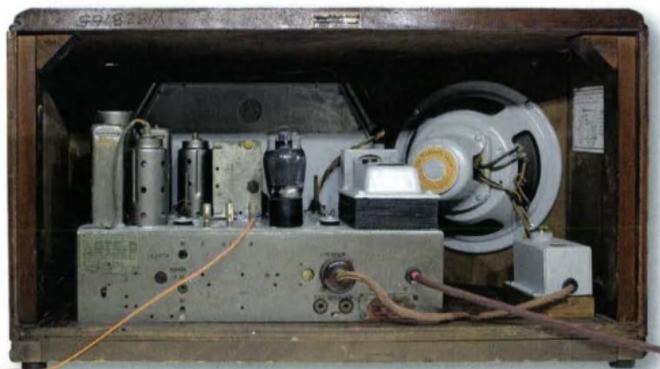
The two HT electrolytic filter capacitors are located in a box that's spliced into the speaker cable. These capacitors had previously been replaced, as had electrolytic capacitors C11 & C29.

The two HT filter electrolytics (C34 & C35) are located in a box spliced into the speaker cable and had previously been replaced, as had electrolytic capacitors C11 & C29. No other component replacements were evident and the under-chassis parts all checked OK.

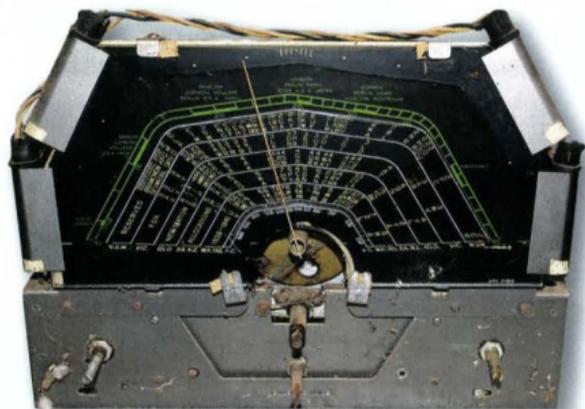
This view shows the front of the chassis and the dial prior to restoration. Despite its unusual shape, the large dial scale is easy to read.

Another problem was that the original celluloid dial cover had yellowed. This was replaced with a clear dial cover fabricated from thermo-moldable PETG plastic.
