Vintage Radio

The AWA 461 MA clock radio & the Heathkit RF signal generator

Restoring a vintage radio can be time-consuming, particularly if you also have to fix the gear that's meant to help fix the radio. In this case, I started out restoring an AWA 461 MA clock radio and ended up also repairing a Heathkit RF signal generator and a Racal frequency counter.

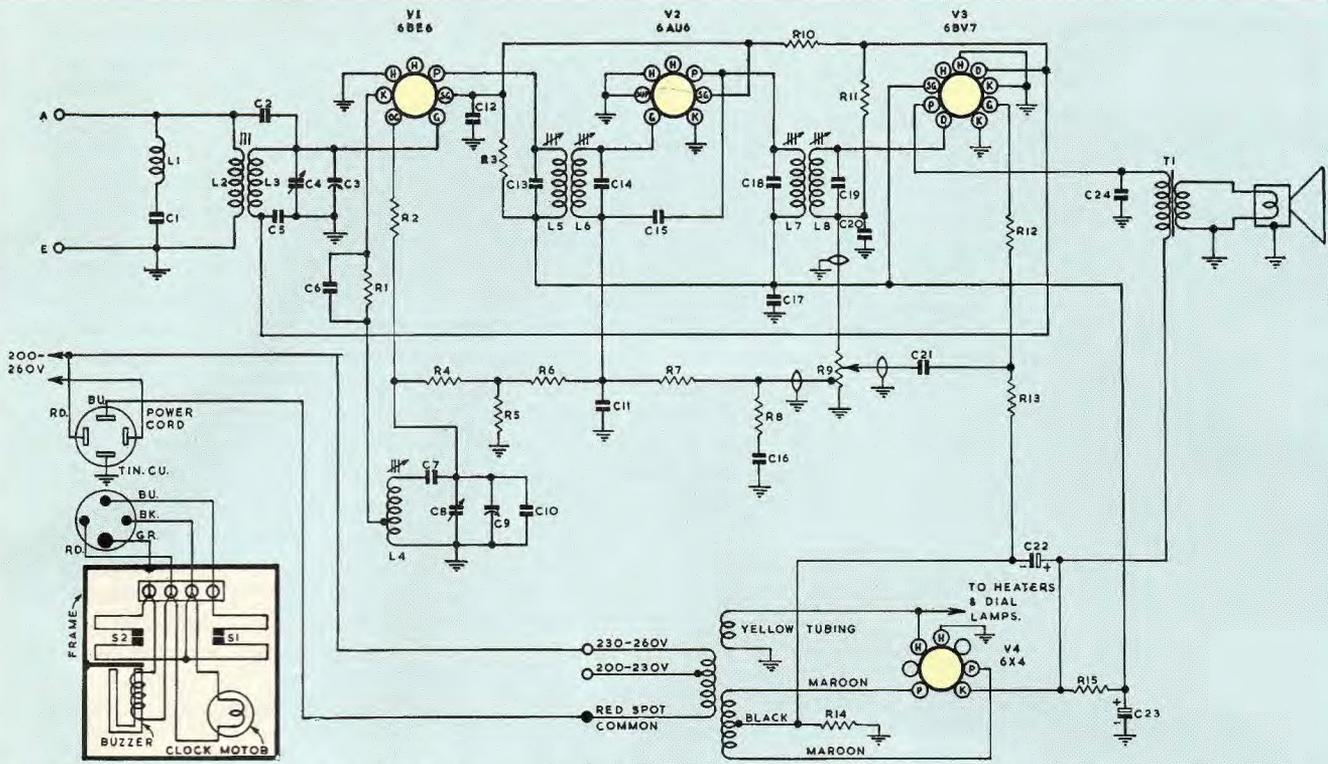
Fig.1: the circuit of the AWA 461 MA clock radio. It's a fairly conventional 4-valve superhet set with a 6BE6 converter, a 6AU6 IF amplifier, a 6BV7 detector/AGC/audio output stage and a 6X4 rectifier. It also incorporates an electric clock with an alarm to switch on the radio at the set time. (Circuit courtesy www.kevinchant.com).

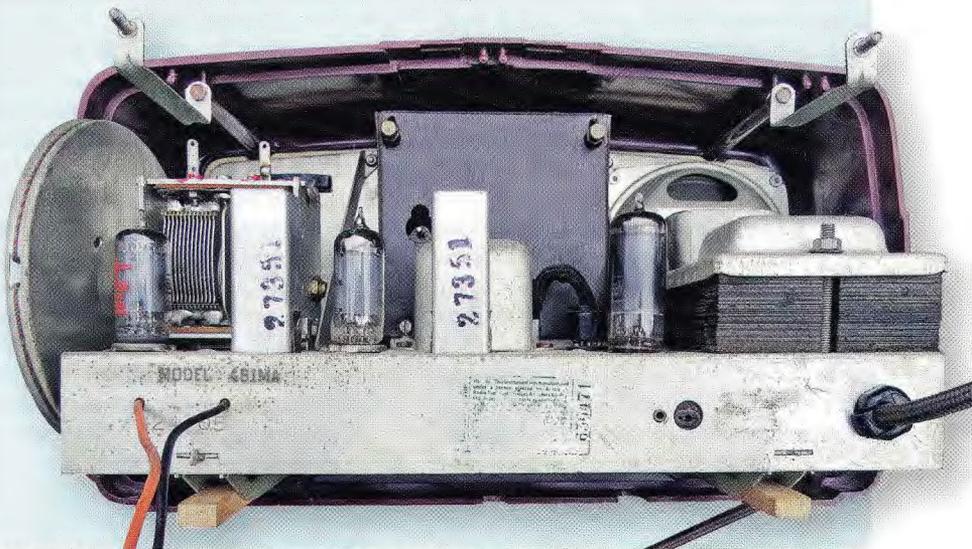
The 461 MA's chassis layout is clean and uncluttered, with all parts readily accessible. The clock mechanism is in the centre, next to the loudspeaker, and is fitted with a dust cover.

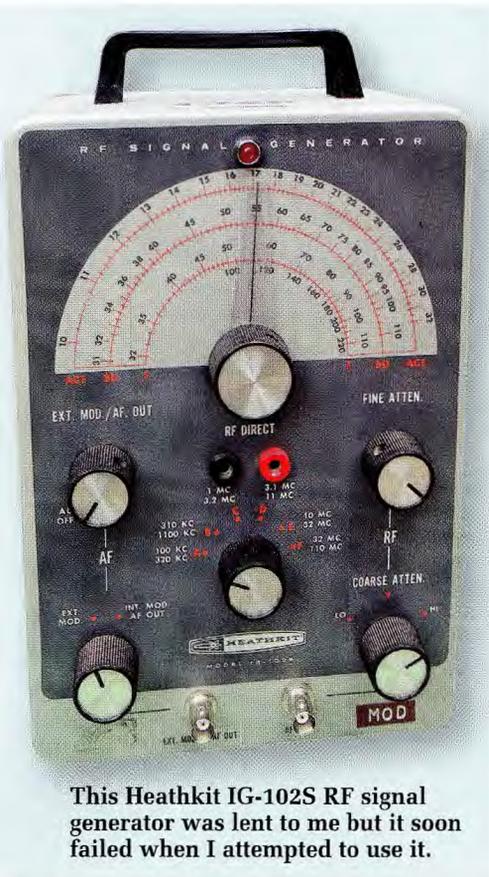
This Heathkit IG-102S RF signal generator was lent to me but it soon failed when I attempted to use it.

Ron’s RF generator came with a frozen band-switch and a power lead with a missing plug. It also had old microphone output connectors on the front that are all but useless these days and so, with Ron’s permission, I changed these connectors to the more common BNC type. I then fitted a new mains plug, lubricated the band-switch so that it rotated and powered the beast on.

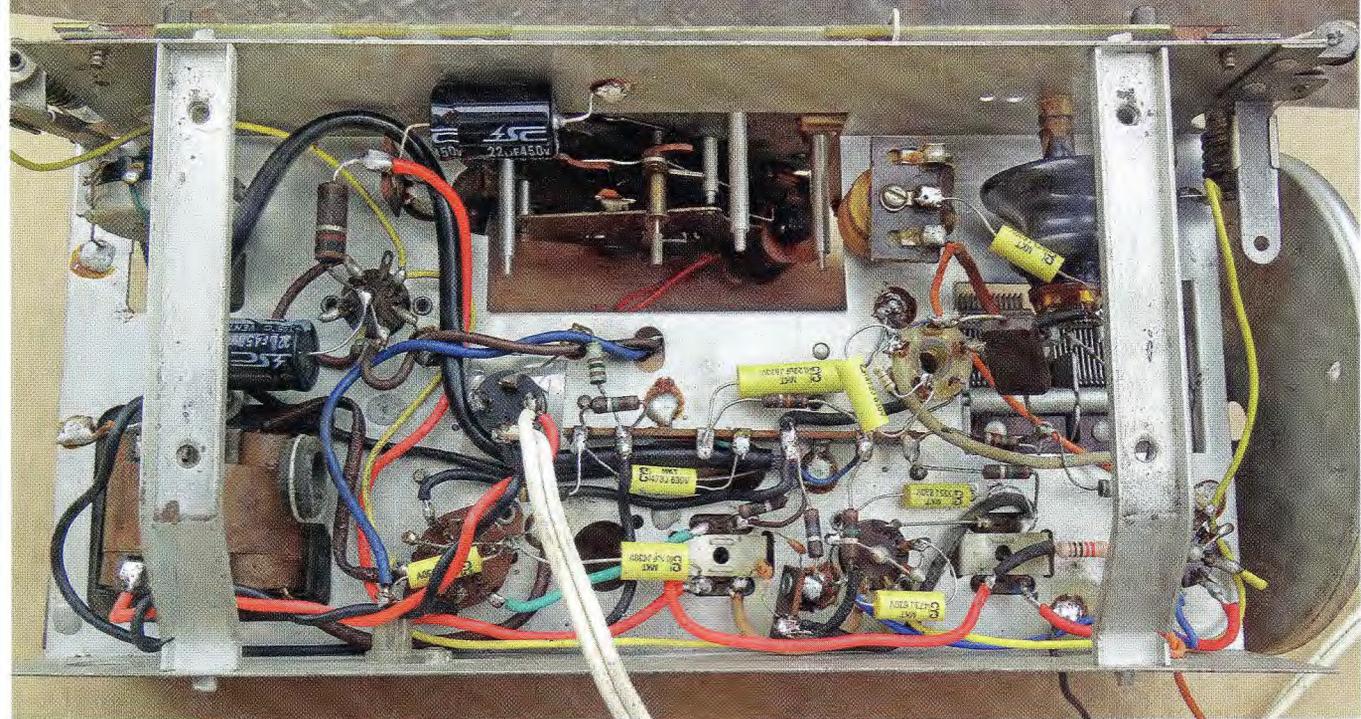
The black non-polarised capacitors in the AWA 461 MA's chassis were eventually all replaced with modern high-voltage equivalents, as were all the electrolytics. In addition, the twin-core mains flex shown here was later replaced with a 3-core flex so that the chassis could be earthed.

I swapped out the electrolytic capacitors in both radios, as well as some of the black non-polarised capacitors that had visibly cracked open. Some of the remaining capacitors looked OK to me and seemed to react appropriately when connected to my multimeter. However, I couldn't be sure if their values had drifted, so I logged on to eBay and purchased a capacitor tester. It wasn't very expensive but I was confident that it would prove useful. The buying spree had begun.

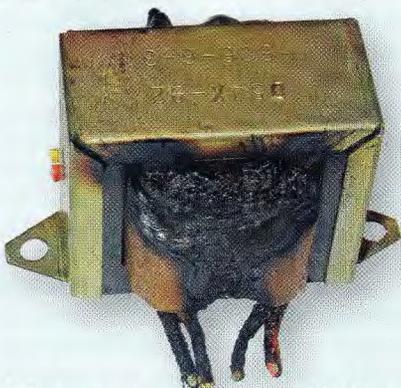
Once the new smoke alarm had been installed, I opened up the Heathkit generator to find the mains transformer a charred mess. It was well and truly cooked and a look at the schematic diagram indicated that this American-designed kit had a 110VAC transformer! However, this unit had obviously found its way to Australia and even though it wasn't fitted with an Australian mains plug, it did have a good-quality 3-core mains cord.

A closer look at what was left of the transformer showed that it had two primary windings wired in series, so I was confident that this unit was indeed designed to handle 230VAC. But why had it failed so dramatically?

The power transformer inside the Heathkit RF generator ended up a charred mess because someone had modified the power supply.

Imagine my surprise then when I looked at the actual power supply components inside the generator and found that someone had, like me, decided that the power supply wasn’t all that great and had built their own. However, in place of the original single diode design, he’d used a voltage doubler! What the . . .!

I connected my multimeter to the output of this redesigned power supply and instead of the specified 130V, it read 300V! As the valves warmed up and drew some current, this voltage fell to 220V or so but that was still way over what it was supposed to be!

The cause was easy to find. The modulation select switch had a 500nF capacitor off one leg that was rated at 200V but it was now acting as a straight piece of wire. In other words, it was a dead short which went some way towards explaining why the transformer had burnt out. Replacing it with a new 600V-rated component solved that particular problem.

The Heathkit’s mains transformer obviously needed replacing so I contacted Southern Electronic Services in Dandenong South and gave them the specifications: one secondary at 120VAC 20mA and another at 6.3VAC 1.2A (for the valve filaments and power indicator lamp). They did a great job at a reasonable price and a few days later I had my replacement transformer. It was slightly larger than the original but a new mounting hole was drilled and it fitted in the case just fine.

After some thought, I decided that the easiest thing to do would be to rewire the power supply so that it was close to its original design. The electrolytic capacitors used in the doubler were marked 24 μ F but measured 29 μ F on my capacitance meter. That seemed OK, so I used two of them with a new 2.2k Ω 1W resistor between them as the original schematic specified.

I did make one change though. I couldn’t help myself and replaced the single diode with a bridge rectifier. While this would give a slightly higher voltage than a half-wave rectifier, it would also have far less ripple, which in an instrument such as this seemed desirable.

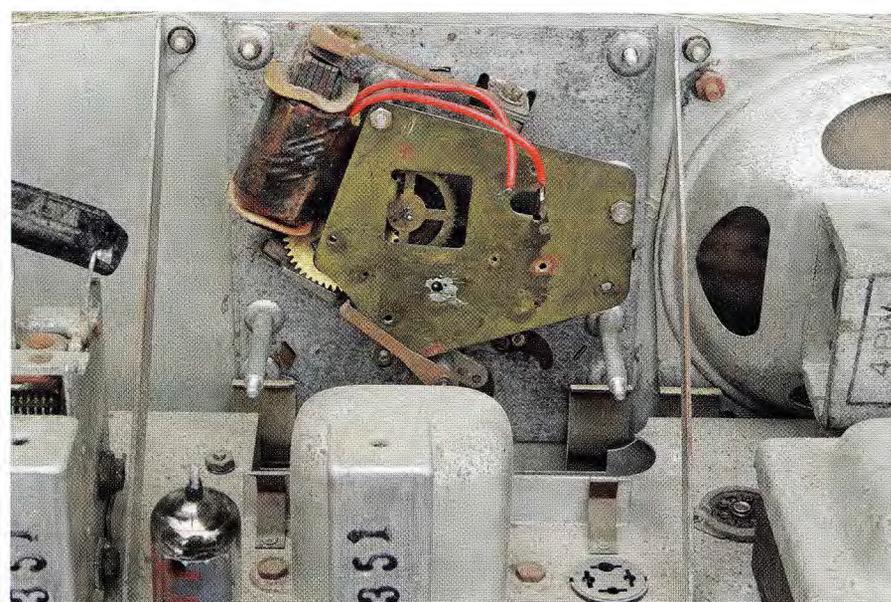
This close-up view shows the clock mechanism before restoration. Parts had to be scrounged from three different chassis in order to repair it.

Back home, I pulled all three radios apart and started with the clock mechanisms. Sadly, out of the three radios, none of the clocks worked reliably, so I had to swap assorted shafts and gears around in order to get a single working unit. This clock mechanism, by the way, incorporates the power switch, an alarm function and a devilishly-designed “snooze” function that is entirely mechanical.

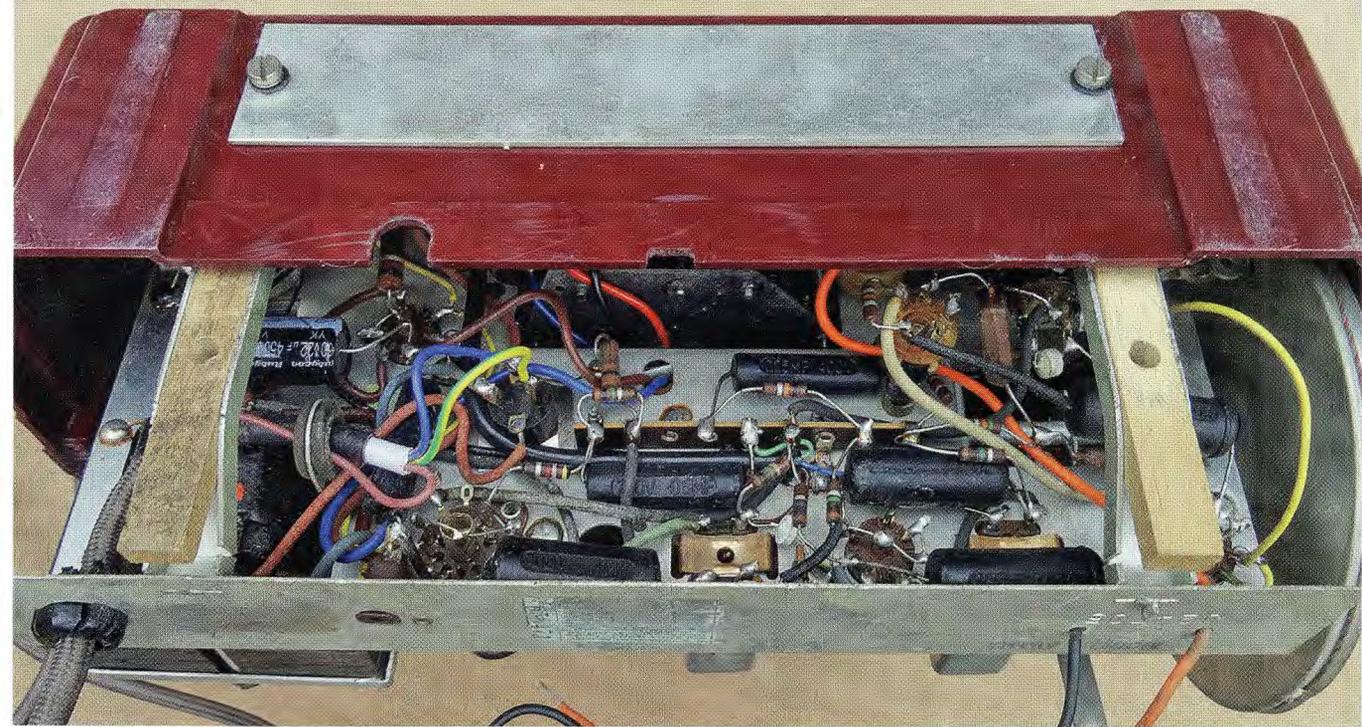
This chassis had been fitted with a new mains cord but had yet to have its black non-polarised capacitors replaced when this photo was taken. All three radios worked after restoration but only one had a working clock.
