# Vintage Radio

## Restoring a pile of hydrated ferric oxide

**This was once HMV's C13C 5-valve mantel radio**

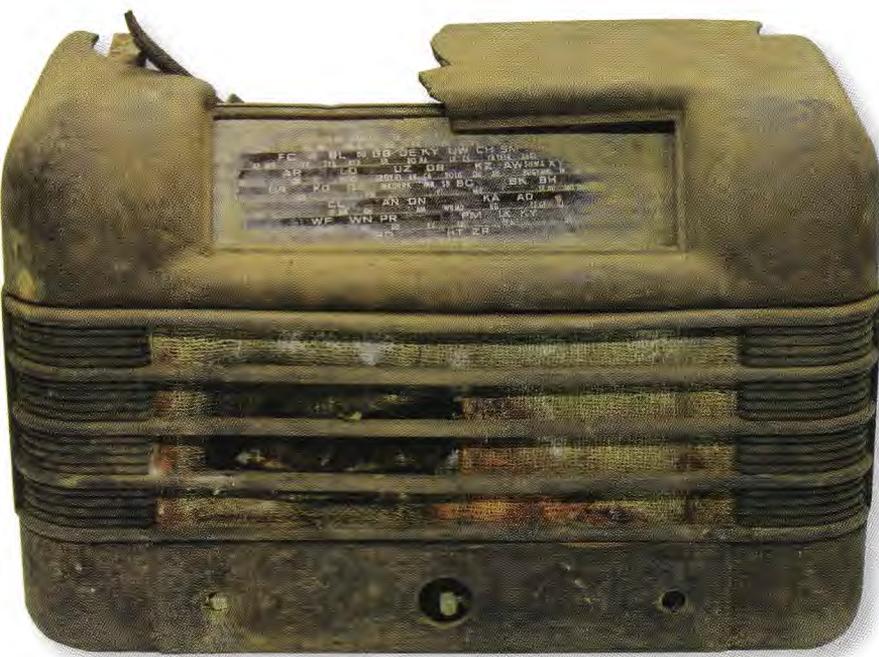
You can see above that this shattered Bakelite cabinet looks almost beyond repair, but it hides a chassis that has decayed to the point that it can never be restored.

It looked like a pile of rubbish and it was. The cabinet was badly fractured and that was only the start. And while I had paid the princely sum of \$2 for ten minutes of banter with Mike Osborne, I was really just saving him the trouble of carting it home and putting it in the bin. I was certainly not motivated to restore it.

As a start, the bare case was thoroughly washed and the lettering "HIS MASTER'S VOICE" emerged from underneath the encrustation of mud. The case had some serious fracturing but fortunately, a large fragment of the missing top section was present as a separate piece. So it was not beyond redemption.

The next step was to cut an aluminium sheet to span the gap, large enough to overlap so that it could be clamped and glued in place with Araldite from below.

This corrected the distortion of the case and provided a base for gluing the large fragment. Then 2-part car body filler was applied to achieve a good surface for sanding back.

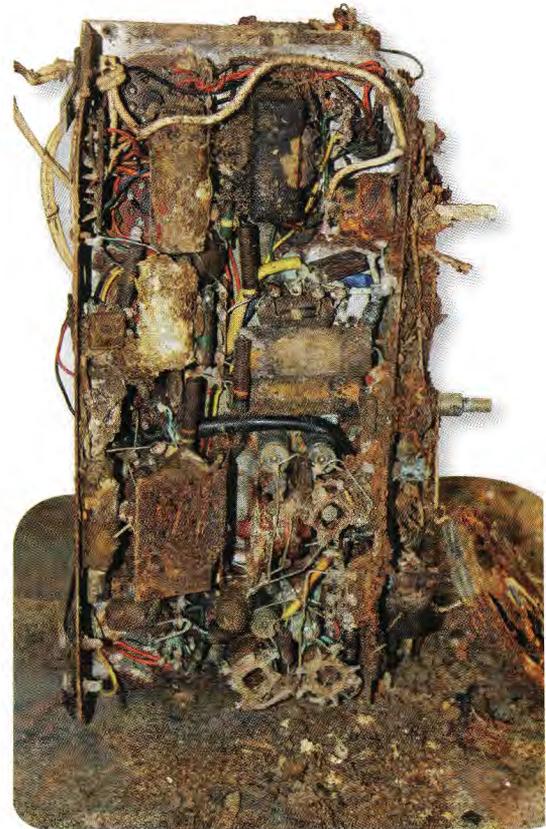
While shown at right is the underside view of the chassis, with various components having been shed over time.

And the reason the ferric oxide was hydrated was that the radio had evidently been partly submerged in water for some years. The water had destroyed every component under the chassis except for some coils and resistors; hardly a good starting point for an electrical restoration.

the chassis lay on my bench dropping rust and other miscellaneous detritus. There was virtually nothing that was recognisable on the underside.

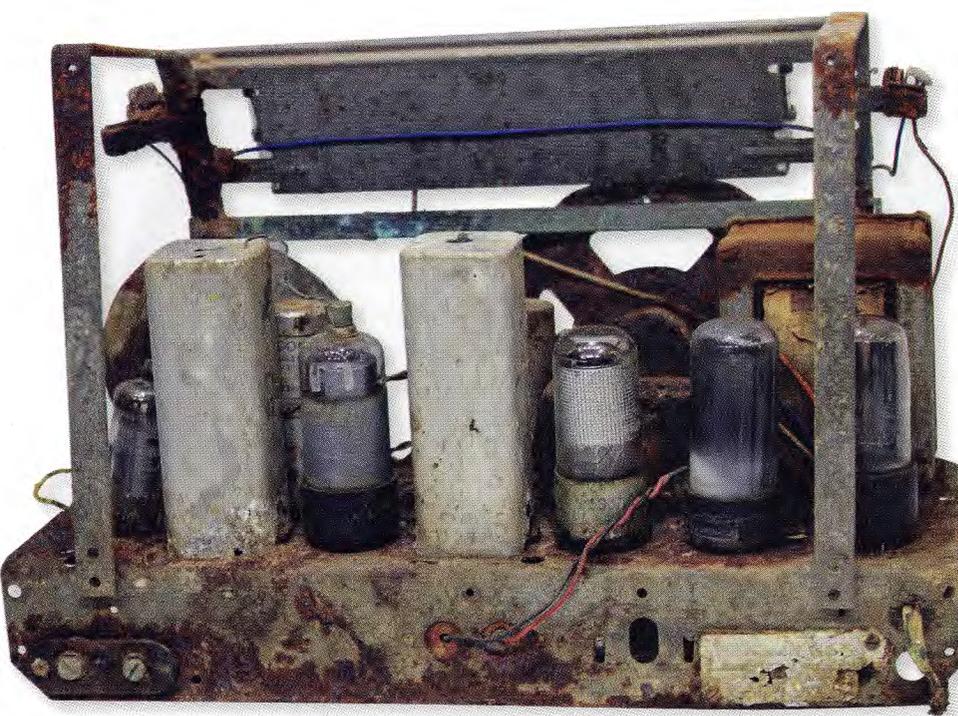
**This is the chassis after it had been washed. Note the remains of the loudspeaker and the exposed windings of the transformer.**

The top of the chassis was similarly discouraging. The tuning capacitor had evidently completely dissolved and just a rusty rim was left of the 5-inch Rola speaker.

A glance at the photos of the chassis before and after this will reveal the full extent of this superficial restoration to a "static model". Notice the exposed windings of the primary transformer after it had been hosed off.

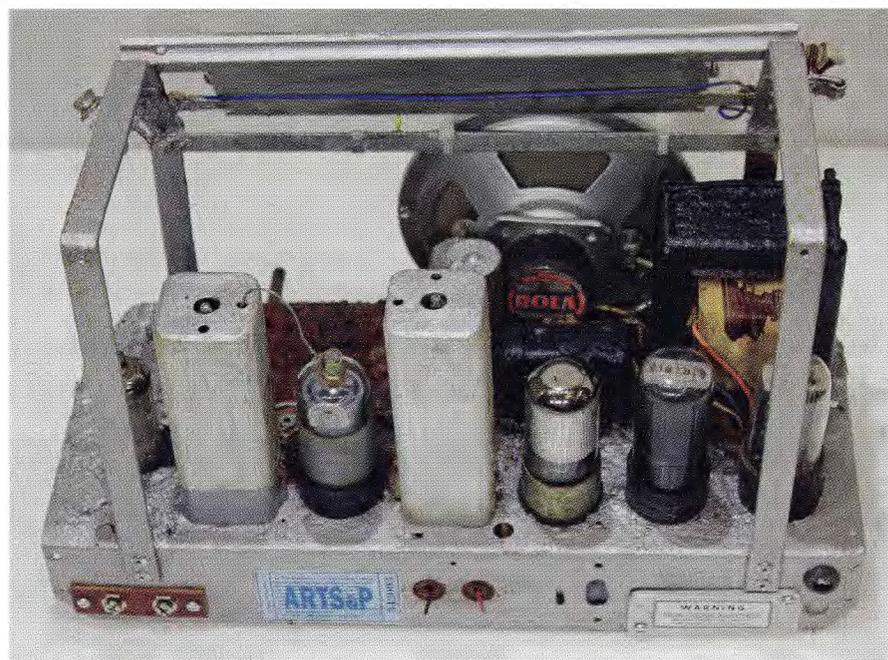
**This shows the chassis after it has been painted, labels added and the loudspeaker replaced. Note the gaffer tape around the base of the first IF transformer, hiding a large hole. It's still a pile of garbage.**

The rust-encrusted steel chassis was cleaned up as well as possible but not too vigorously because it was tissue thin in many places. A coating of silver paint (water-based acrylic enamel) restored the appearance of the chassis. A little paint hides a lot of defects; well, more or less.

And even though the radio would never be operational, a replacement 5-inch Rola speaker was essential to keeping up appearances.

The original phenolic panel for the aerial and earth connections simply crumbled away due to the adverse effects of water immersion, so I fitted a new set of terminals.

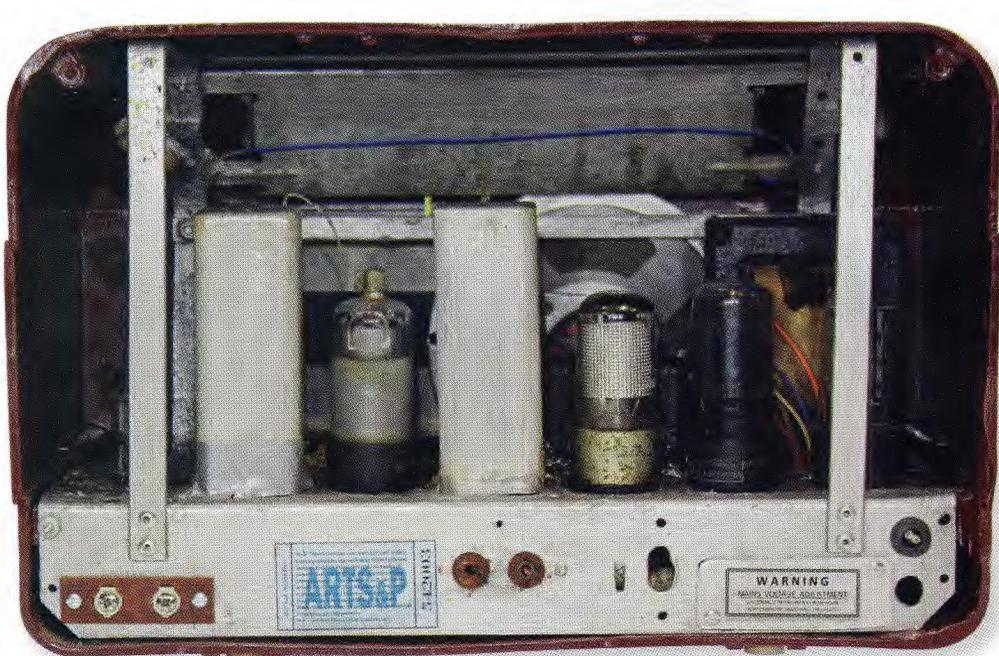
This shows the tarted-up chassis back in the newly painted cabinet. The tuning capacitor for this radio was not replaced as the area where it would sit is still heavily corroded. The 6V6 tetrode output valve (far right) was coloured black using a marker pen to hide the fact that it was gassy.

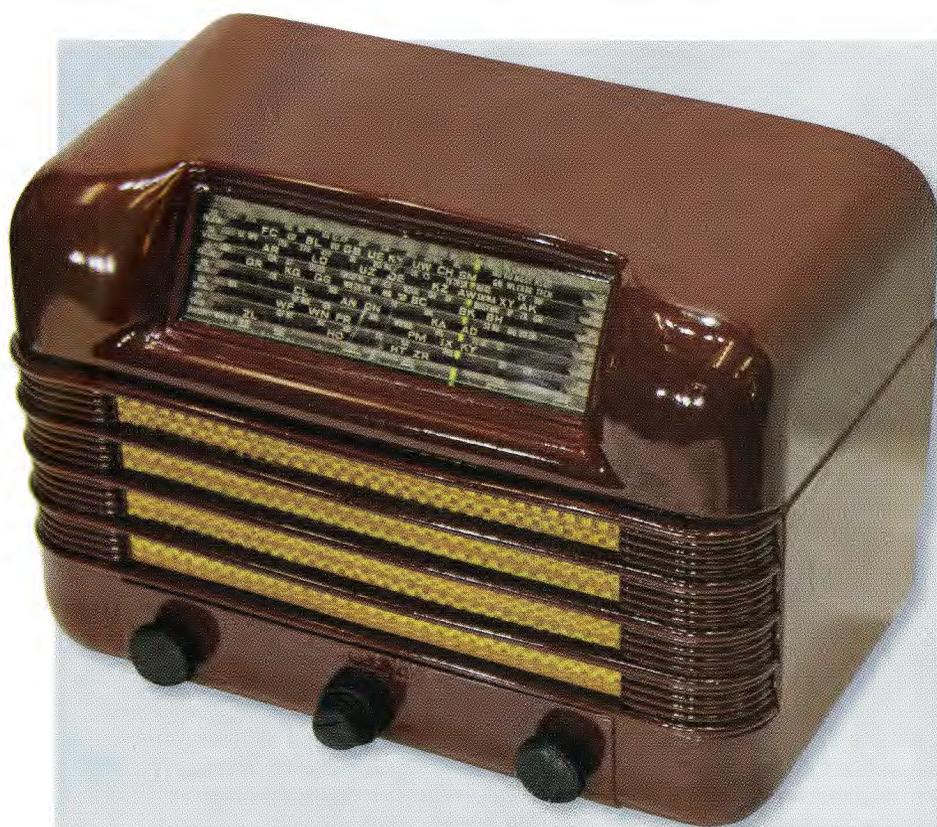
Shown above is the freshly painted cabinet and finished restoration for the HMV C13C mantel radio. From left-to-right, the first knob is the band switch, next is tone control and the last is for volume/power.

This was followed with an undercoat, then a spray with Motortech-brand "Indian Red" paint. The result was similar to the appearance of the original Bakelite case and certainly a miraculous improvement over the initial condition. Some yellow speaker grille cloth and knobs completed the external restoration.

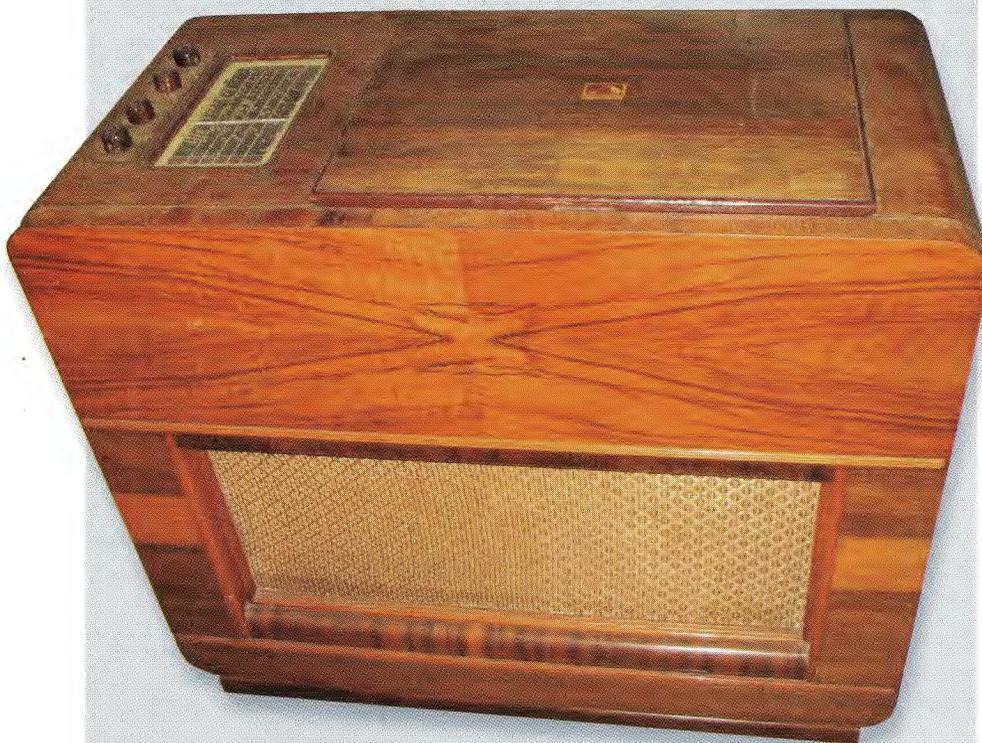
While not the star of this article, this HMV E43E radiogram used a nearly identical circuit as the HMV C13C mantel radio but was still regarded as hifi. The only difference was that it had a 12-inch Rola loudspeaker.

Using the same circuit and chassis as in the C13C, the HMV E43E radiogram was "hifi" in 1951. The only difference was the provision of a well-baffled 12-inch Rola speaker to provide good volume and frequency response.

The HMV radiogram pictured here from the author's collection shows that it was also an elegant item of furniture.
