Vintage Radio

By Dr Hugo Holden

The **ZENITH** Royal 500 “Owl Eye” AM Radio

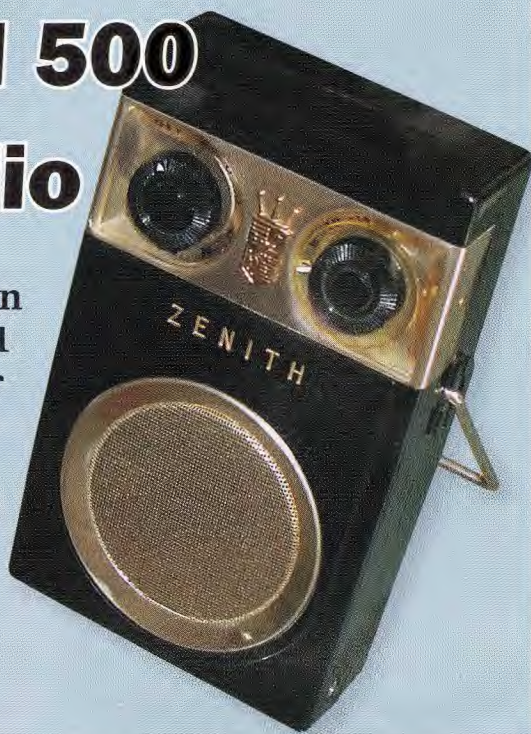
The Zenith Royal 500 radio appeared in 1955, one year after the Regency TR-1 which was the first commercial transistor radio in 1954. Unlike the Regency TR-1 though, by the time that the Zenith Royal 500 was released, the technology had rapidly progressed into the conventional circuitry we know today as the typical “7 transistor AM radio”.

The styling of the Royal 500 could be said to be distinctive, with the metallic surrounds for the black tuning and volume controls and the metallic speaker grille, so much so that in later years it became known as the “Owl Eye” radio.

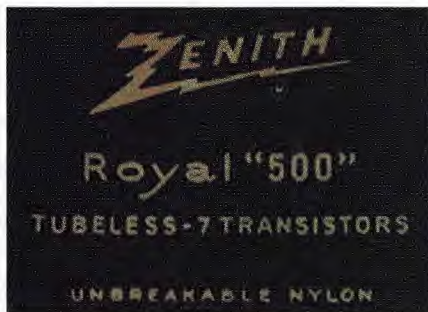
Also on the back and shown in the photo below, the radio is described as “TUBELESS - 7 TRANSISTORS”.

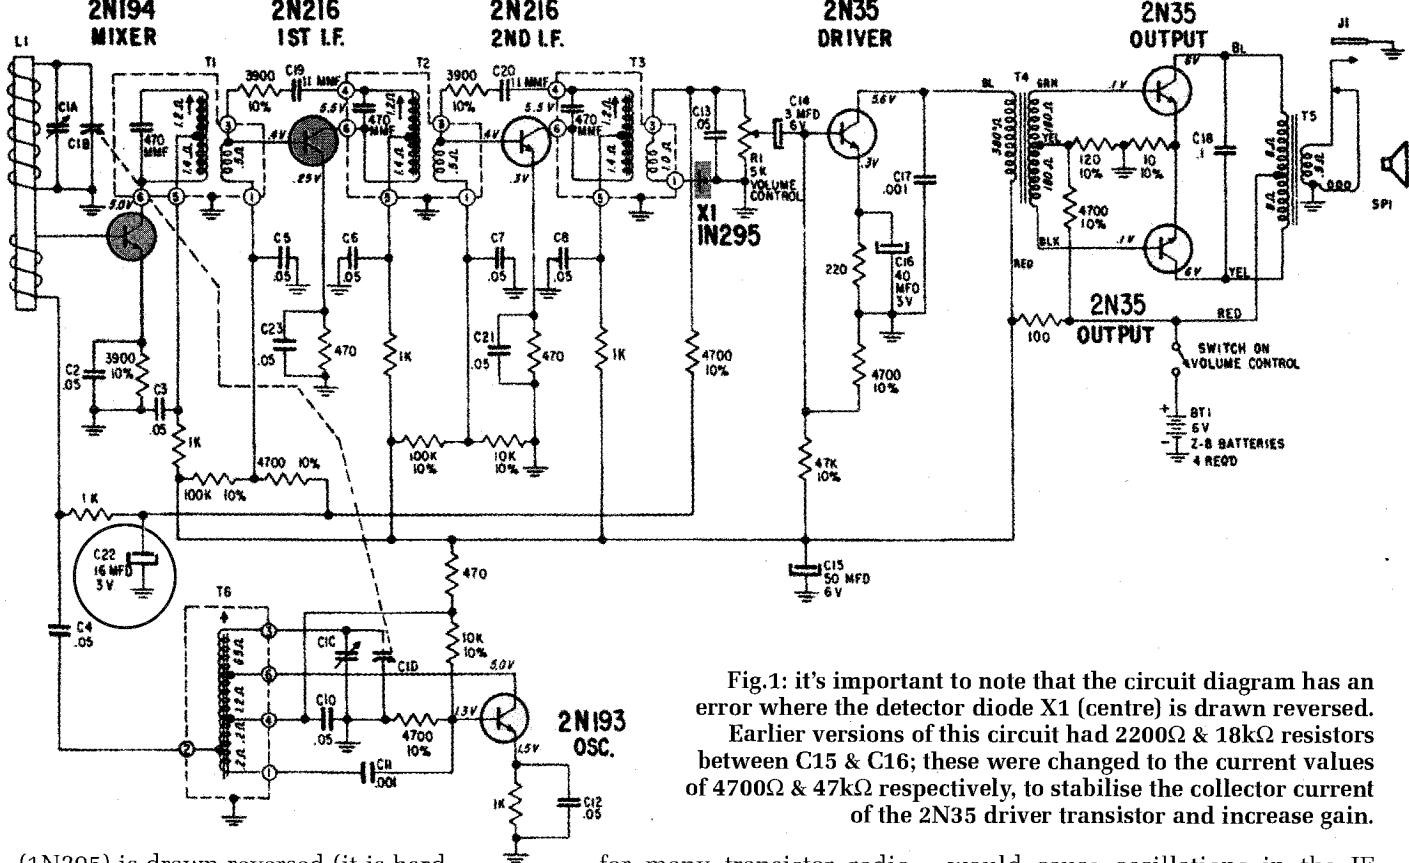
Fig.1: it's important to note that the circuit diagram has an error where the detector diode X1 (centre) is drawn reversed. Earlier versions of this circuit had 2200Ω & 18kΩ resistors between C15 & C16; these were changed to the current values of 4700Ω & 47kΩ respectively, to stabilise the collector current of the 2N35 driver transistor and increase gain.

(1N295) is drawn reversed (it is hard to see and is at the secondary output of the third IF transformer, T3). It is not wired this way in the real radio though, where the diode cathode is returned to ground (negative).

The negative-going AGC voltage is developed across C22, a 16μF 3V electrolytic capacitor.

With low signal levels this electrolytic capacitor is subject to a small voltage of the correct polarity from the bias network of the 2N216 and first IF amplifier (the 100kΩ and 4700Ω resistors connected to C22's positive electrode). This also forward-biases the detector diode X1 a little, which helps with detecting low level signals.

However, with most reasonable signal levels from local stations, the AGC voltage on the positive terminal of C22 goes negative with respect to the radio's ground and then C22 is subject to reversed polarity; not good for an electrolytic capacitor.

for many transistor radio designs. The practical remedy today is to fit a bipolar electrolytic AGC filter capacitor instead.

Perhaps not surprisingly, this AGC filter capacitor often does go open-circuit in early transistor radios and C22 was open-circuit in my Zenith radio. The unbypassed feedback causes oscillation of the IF stages.

Investigation revealed that the mixer transistor had partially failed and the first IF transistor was noisy. The faulty components are indicated in red on the circuit.

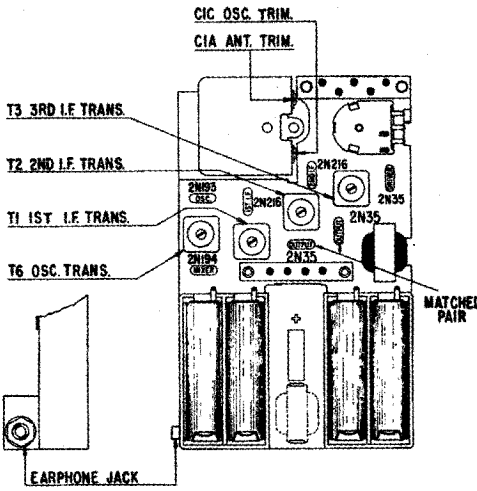
TRANSISTOR & TRIMMER LAYOUT FOR 7XT40 CIRCUIT #2

While obscured in the photos, the Royal 500 does have a separate mono earphone jack (J1 on Fig.1). Source: www.transistor-repairs.com/schematics.html

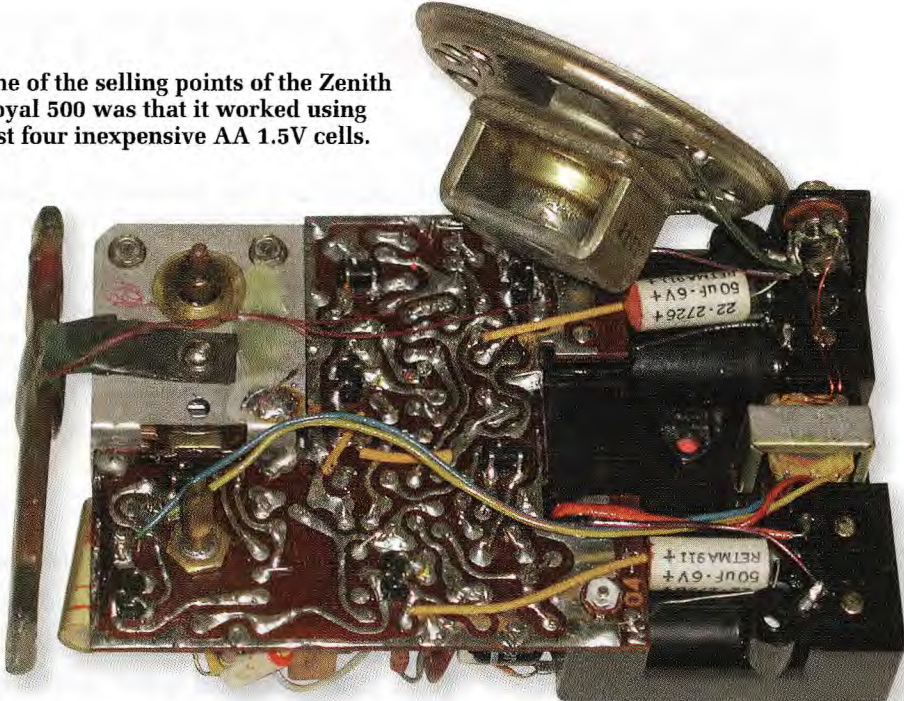
The Royal 500 shown in this article is a model B. It was released in 1956 and used the PCB shown above, instead of being hand-wired. The transistors are all mounted in plug-in sockets, which makes it easy to remove and replace them. While this version of the Royal 500 used NPN transistors, later models made the switch to PNP transistors as they became more common.
