VINTAGE RADIO

Ekco Gondola 5-valve mantel radio

Ekco's Gondola set is keenly sought after by collectors because of its distinctively styled cabinet. But its circuit is very simple, resulting in a very spartan under-chassis layout. That makes it easy to work on – but this particular set was a wreck and needed a lot of restoration.

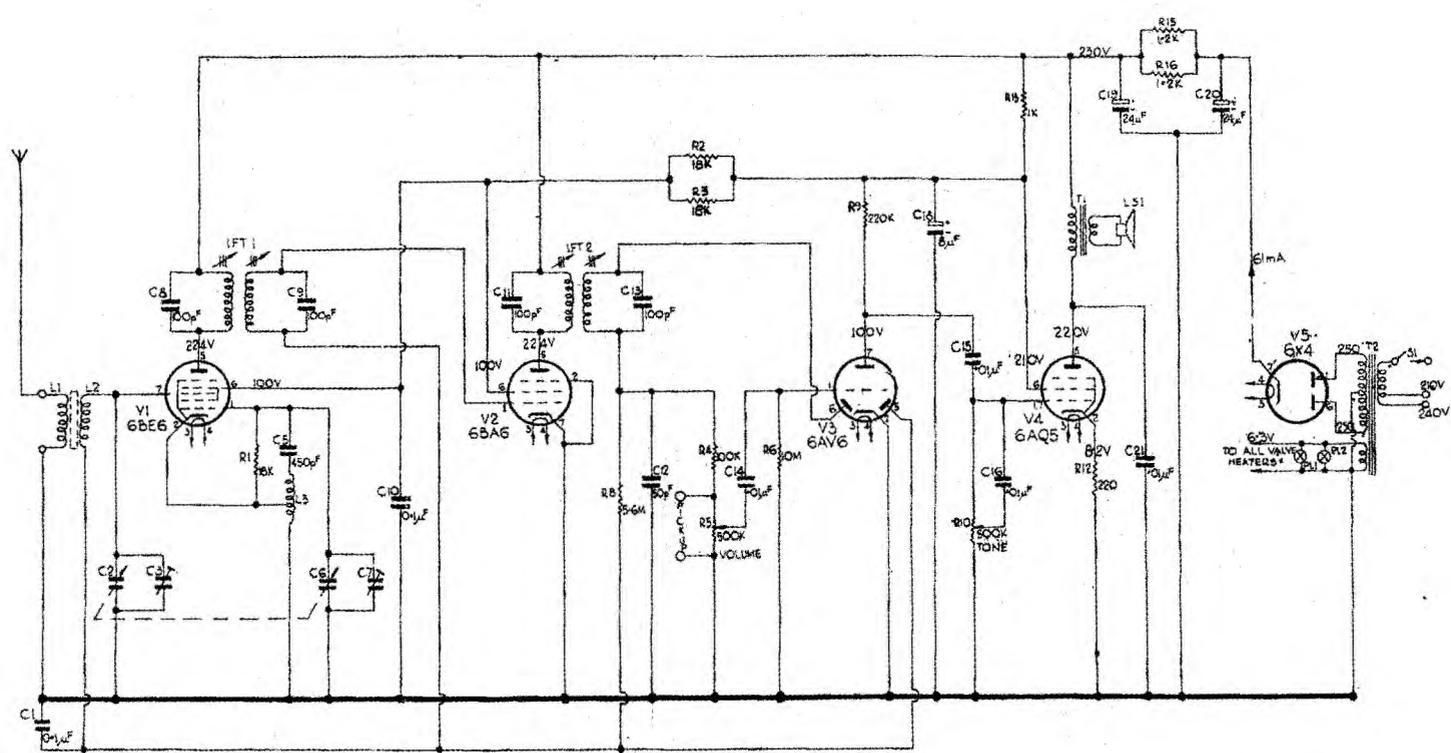
Fig.1 shows the details of the 5-valve circuit which is a conventional superhet. The local oscillator circuit feeding into the 6BE6 is a Hartley configuration using a tapped coil tuned by one gang of the tuning capacitor. The output load at the plate of the 6BE6 is the first IF transformer, IFT1, tuned to 455kHz.

Its secondary feeds the grid of the 6BA6 IF amplifier which drives the second IF transformer, IFT2. The top of its secondary is connected to pin 6 of the 6AV6 detector and audio amplifier. The bottom of the secondary is connected to pin 5 via a 5.6MΩ resistor. These two pins are the anodes of the two diodes in this valve.

The diode at pin 6 is the demodulator and the audio output appears at the bottom of the secondary of IFT2. It is filtered by capacitor C12 and fed to the volume control R5 via resistor R4. From there, the audio signal is tapped off by the wiper of R5 and fed via ca-

Fig.1: the circuit of the Ekco Gondola is a basic superhet with a very low component count. Note that pin 5 of the 6AV6 is a tiepoint for the 5.6MΩ resistor R8. The associated diode with pin 5 performs no signal detection.

capacitor C15 to the grid of the 6AQ5 output pentode. Capacitor C16 and potentiometer R10 provide a simple treble cut tone control.

The demodulated output of pin 6 of the 6AV6, appearing at the top of secondary of IFT2 is also used to derive the AGC voltage.

It is filtered by the above-mentioned 5.6MΩ resistor and the 0.1μF capacitor C1. The AGC acts on the grid of the 6BE6 via the secondary of the aerial coil and on the grid of the 6BA6 via the secondary of IFT1.

In fact, it does nothing. The pin 6 diode both demodulates the audio and generates the AGC voltage. It connects the “top” end of the IFT2 secondary to ground when that end is positive, which means that the “bottom” end of the secondary assumes a negative DC level – the demodulated audio and the AGC voltage.

The pin 5 diode is merely used as a connection point for the 5.6MΩ resistor. Typically other sets using the 6AV6 use one diode to do demodulation and produce the AGC and connect the second diode to chassis.

Looking at the circuit diagram of Fig.1 showed only two other logical possibilities; the tuning gang or its trimmer (C3). At a first glance the tuning gang's trimmer had been pushed down, although it was seemingly intact.

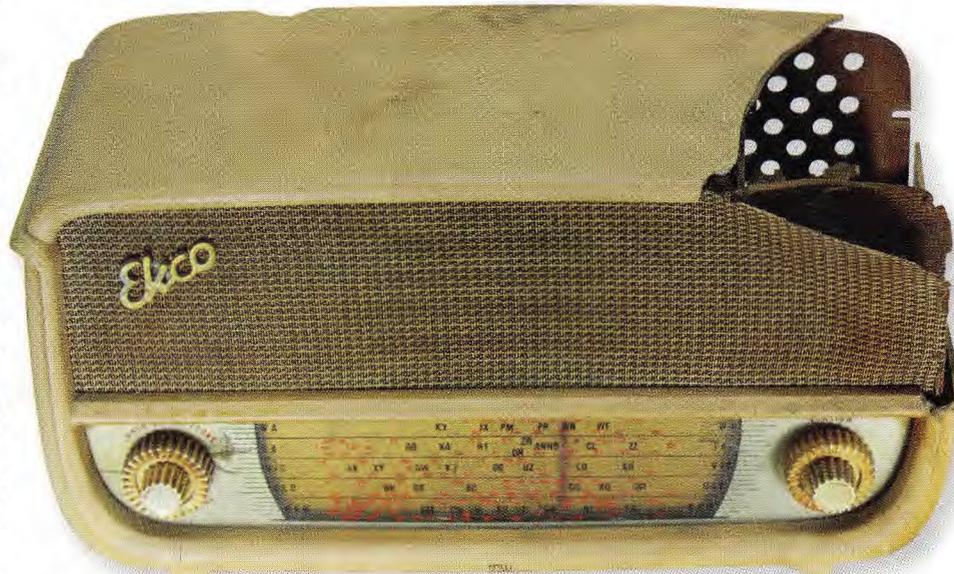
The plastic case had seen better days, and the dial had minor fractures.

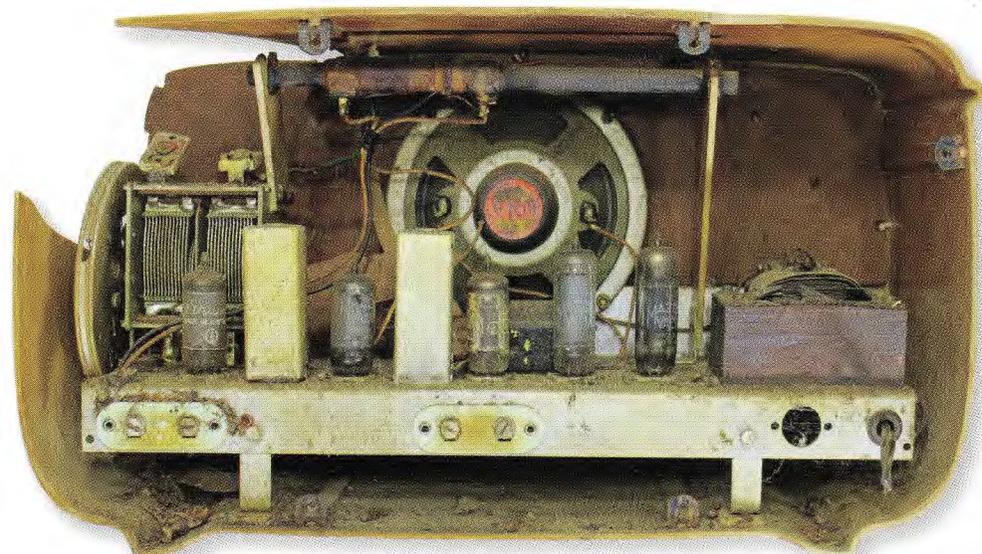
The interior of the case was littered with leaves, dirt and who knows what else that had managed to find its way inside.

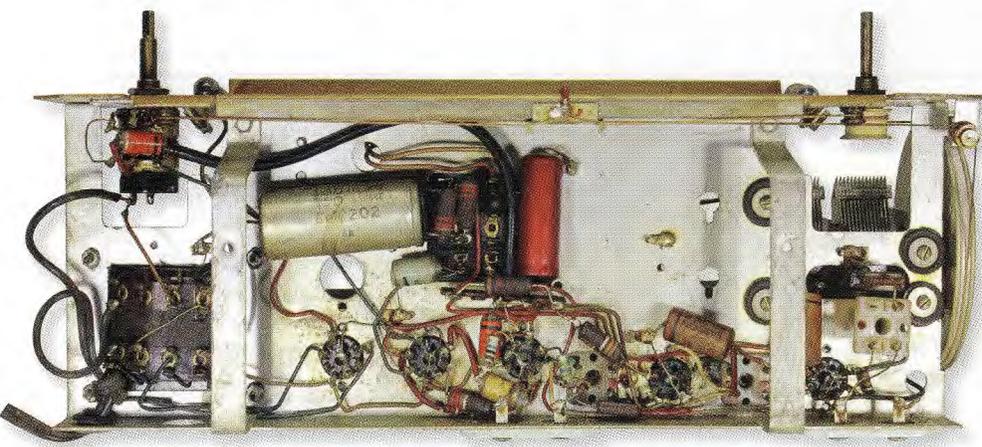
▲ At lower left, the 2-core mains wire is anchored by a knot in the chassis. This was replaced with a properly anchored 3-core cable.

The original 2-core mains flex was anchored by a knot inside the chassis; that's the crude way it was done in those days.

This was replaced by a 3-core cable which has the benefit of providing an earthed chassis. The new cable was properly secured to the chassis when it was installed, as this is good practice.

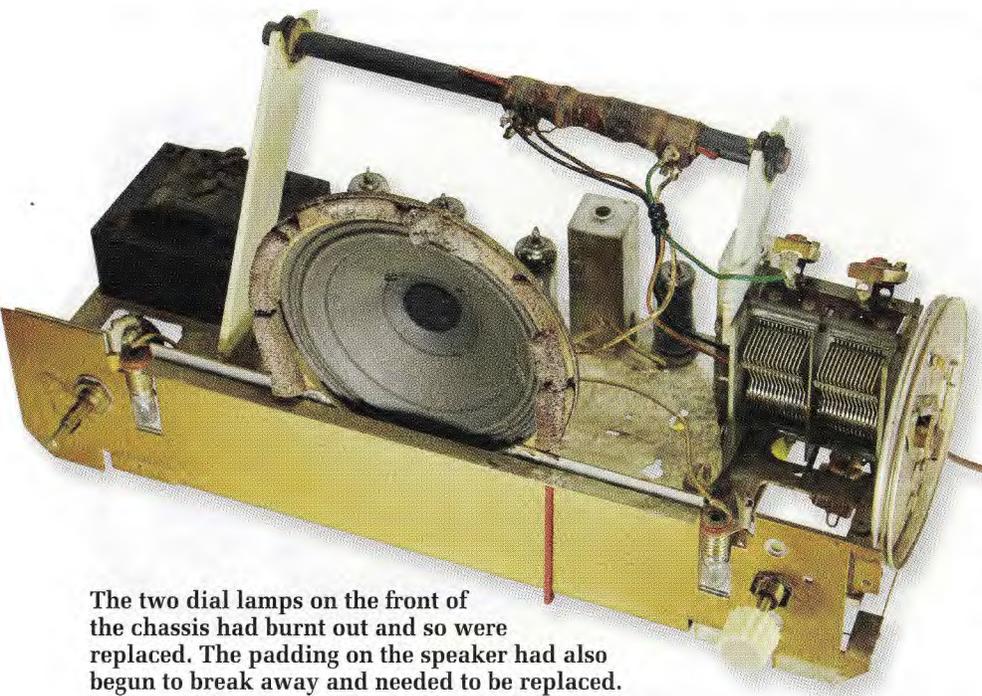
The two dial lamps on the front of the chassis had burnt out and so were replaced. The padding on the speaker had also begun to break away and needed to be replaced.

The two blackened dial lamps were replaced and then it was to time switch on without the valves being installed. All was well so the valves were fitted. The next power-up showed stable power consumption of around 43W, as expected from the service manual

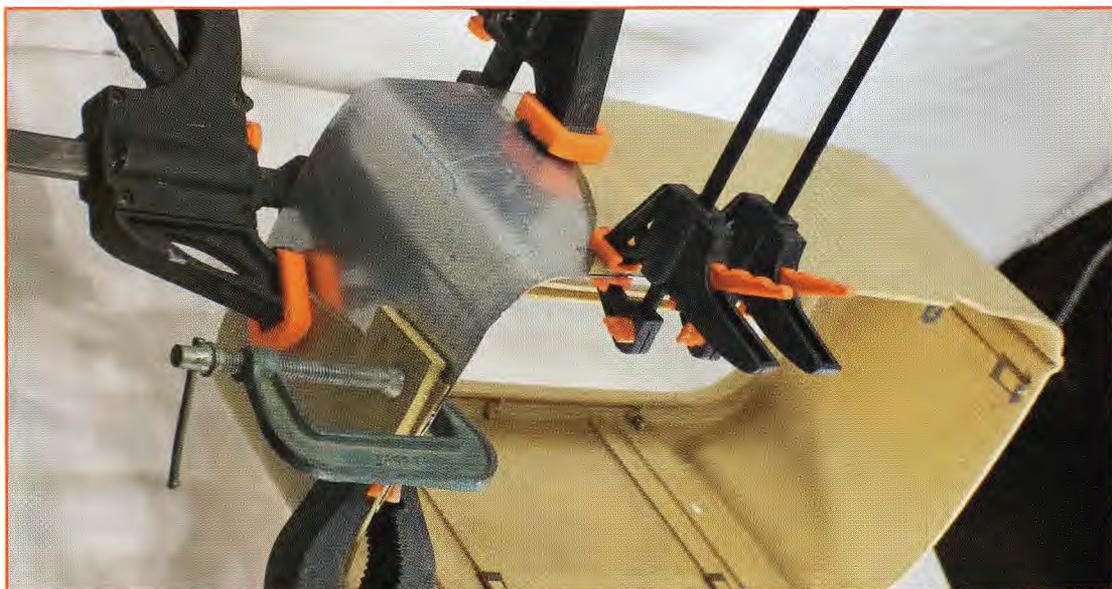
An aluminium sheet mould was clamped to the case, forming the template for the 2-part epoxy filler. Multiple applications of the epoxy filler were needed due to the curvature and thickness of the case.

The strategy was to cut and shape an aluminium sheet to overlap the edges of the breaks and provide the basic contour of the case. Then Araldite was used to glue the contoured plate in place inside the cabinet.

2-part epoxy car body filler was then applied in three major applications. Multiple applications were needed because of gravity. Much like preparing for pouring cement on a building site, form work was created for each of the front, top and side sections.

When mixed, the filler flows under gravity for about ten minutes before becoming viscous enough to hold shape. All sections were set proud of the final profile.

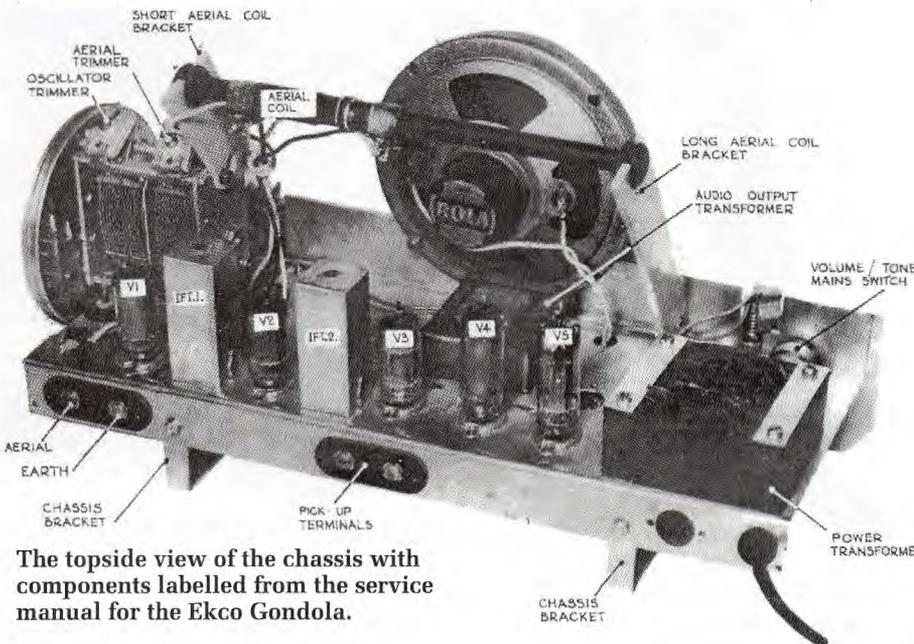
The topside view of the chassis with components labelled from the service manual for the Ekco Gondola.

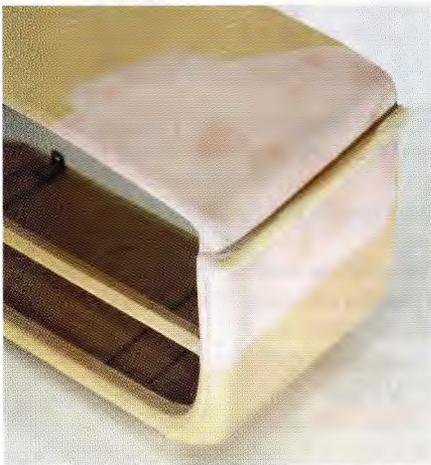
The photograph showing the near-final case repair also shows some darker pink blotches. These blotches were created by the application of filler to the Swiss-cheese-like air holes that inevitably appear in the epoxy filler.

The side-bar was made from a small piece of MDF. The blotches in the hardened epoxy were due to air holes.

These holes are not gas released during the epoxide reaction with the amine setting agent. The chemistry of the setting is an addition reaction without by-products. The gas holes are air that mixes with the filler when the two parts are blended.

A piece of MDF board (chosen because it has no wood grain) was profiled to create the side-bar then held in place with Araldite. Epoxy filler was added to blend the MDF with the cabinet. A Dremel shaping tool added the finishing touches to the contours.

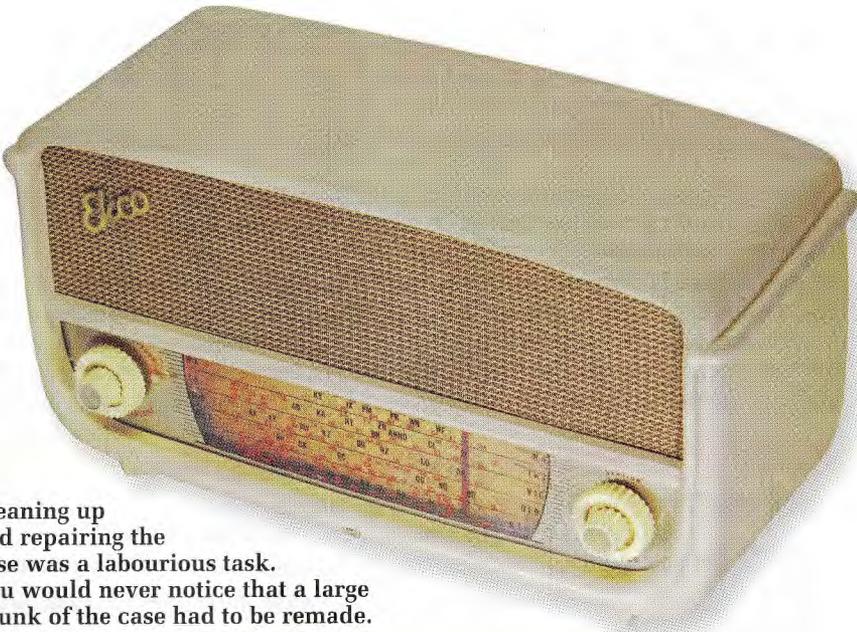
The whole repaired case was undercoated then sprayed with Dulux semi-gloss Paperbark enamel paint. The result is a fair match to the original. I shared the outcome of this repair with some radio mates and was well repaid for the restoration effort by the complimentary feedback. The most succinct response was "OMG!".
