# VINTAGE RADIO

## AWA 1948 compact portable model 450P

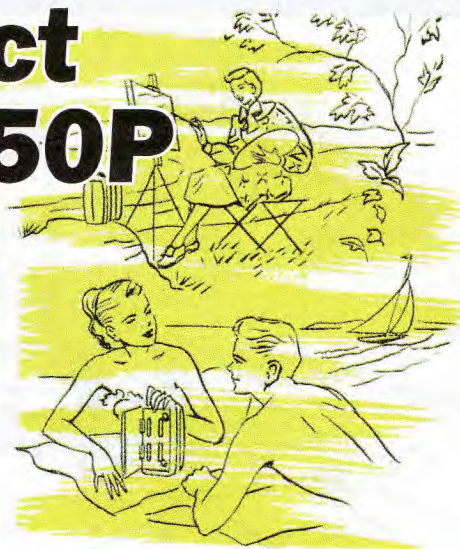
From the 1920s onwards, there was a market for portable radios that had a role roughly analogous to contemporary mobile phones, as a form of portable entertainment. You can see its intended uses in the illustrations on the cover of the product booklet reproduced above.

The unit I restored has a replacement carry strap. The original handle, which is shorter, can be seen on the cover of the product booklet.

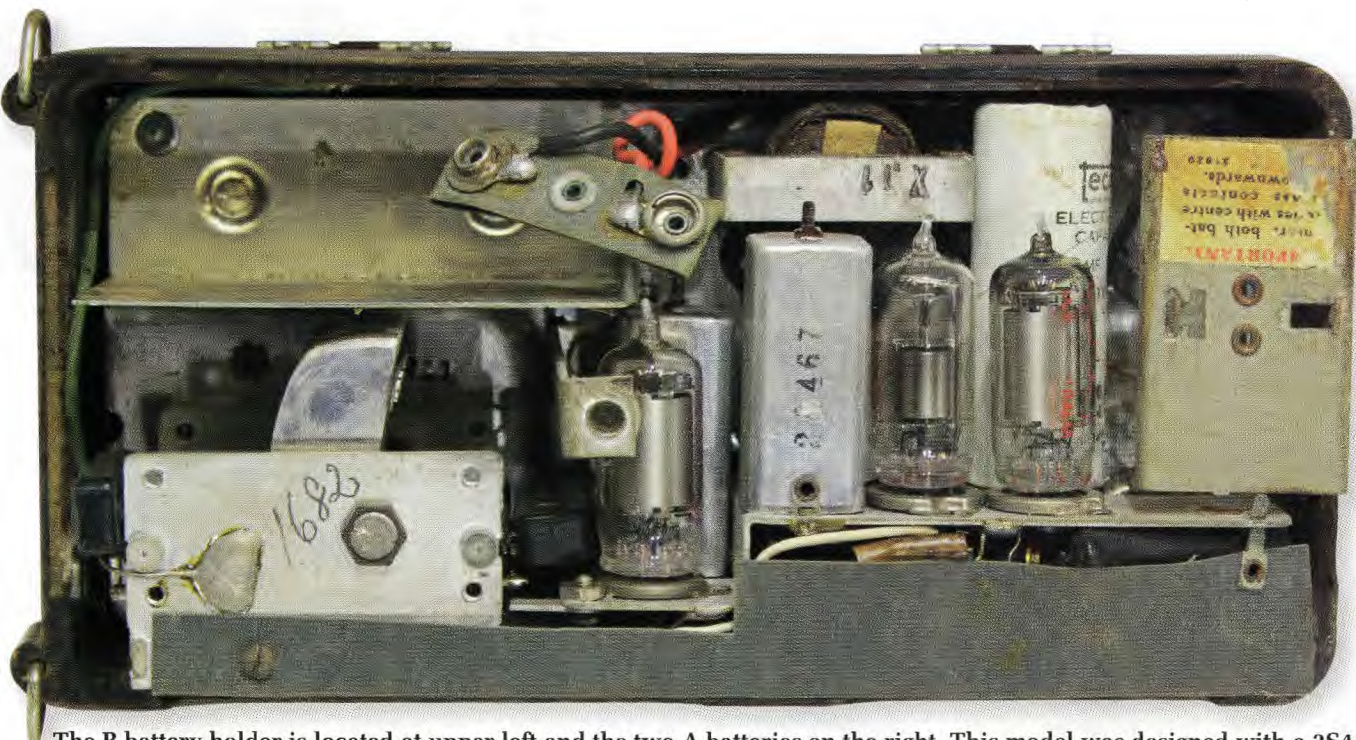
The B battery holder is located at upper left and the two A batteries on the right. This model was designed with a 3S4 pentode valve for the audio output stage, but due to its scarcity at the time, many models used a 1S4 instead.

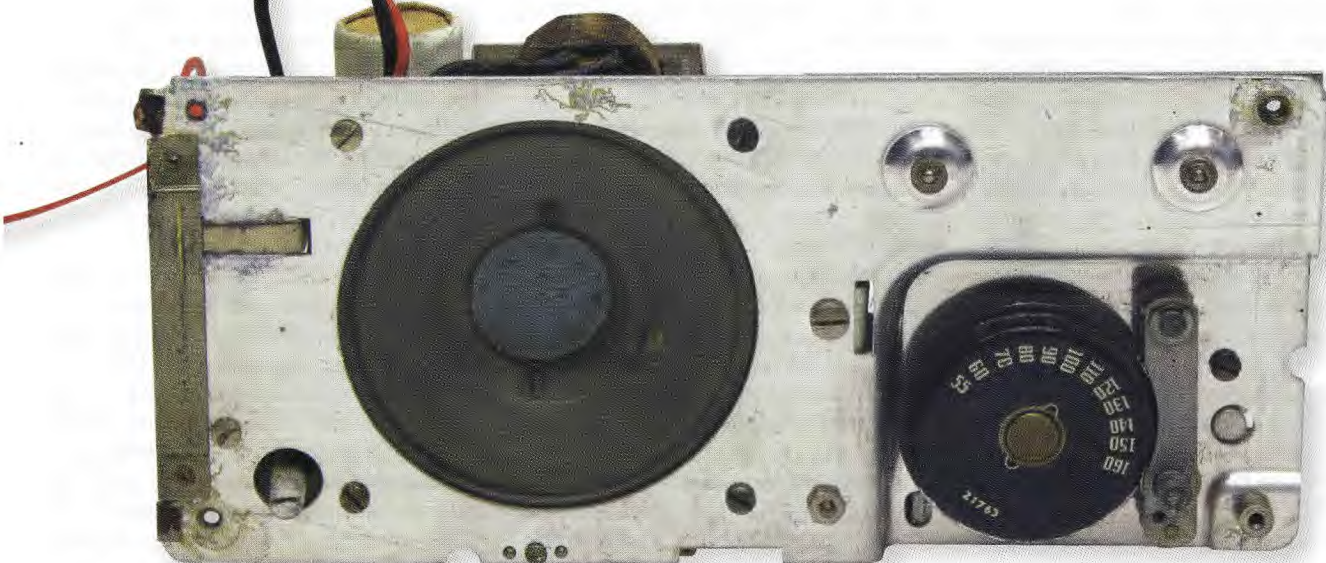
The front of the chassis is adorned by just the 3.5-inch speaker and tuning knob, with a tuning range of 540kHz-1600kHz. The volume control protrudes at lower left of the chassis.

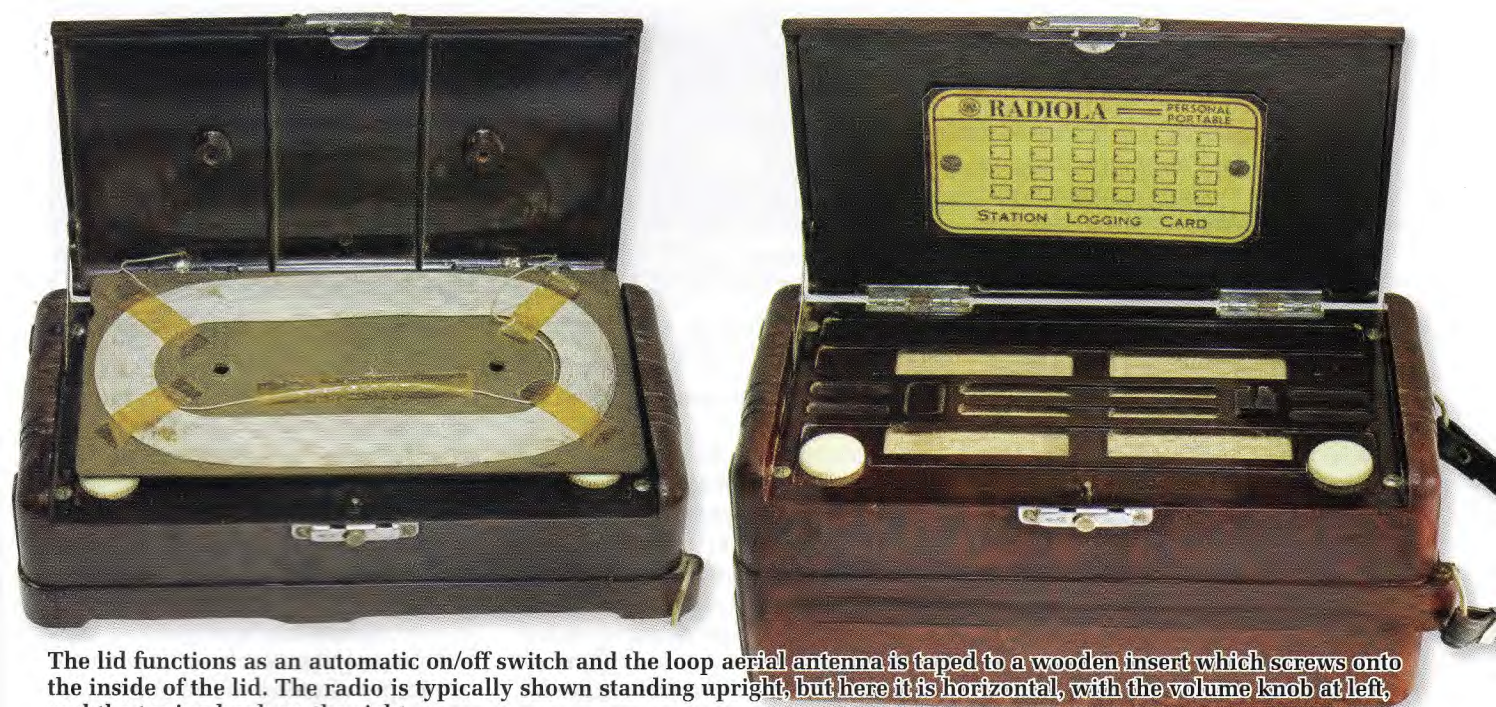
The lid functions as an automatic on/off switch and the loop aerial antenna is taped to a wooden insert which screws onto the inside of the lid. The radio is typically shown standing upright, but here it is horizontal, with the volume knob at left, and the tuning knob on the right.

The large loop aerial is mounted inside the set's lid, behind the panel holding the station logging card. Interestingly, the electrical connections to the loop are made via the lid hinges. One wonders how reliable that would have been. Tuning is via a full-size dual-gang tuning capacitor (which only just fits in the case) that ranges from 12pF to 450pF.
