VINTAGE RADIO

1958 Stromberg-Carlson Baby Grand 48A11

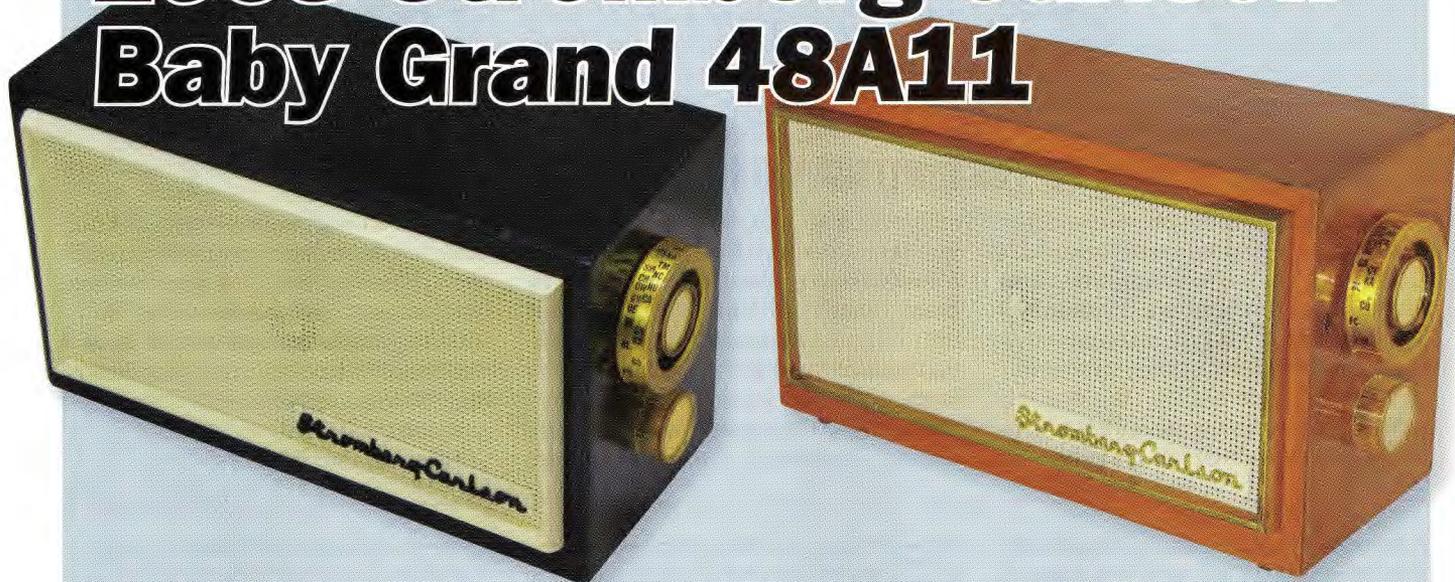
The Baby Grand epitomises simplicity; it is a minimalistic radio, stripped back to the bare essentials, yet still quite handsome. It is a conventional 4-valve, mains-powered MW superhet.

As the photos show, the enclosure is a simple timber box with rebated cleats into which the chassis slides.

The tuning knob has stations marked on the side. The same scheme was used on the Stromberg-Carlson model 79TII transistor radio from 1959. On the Baby Grand, the knobs are on the side while the transistor radio has the calibrated knobs on the top. In both cases, the station markings are visible from the front of the radio.

There were four different sets of station markings used on the radio, each accommodating two Australian states. Cleverly, the knob is moulded with two flats in the spindle hole so it can slide onto the tuning shaft in either of two orientations, rotated by 180°. This allows the stations to be visible for one state or the other.

For example, with the radios shown here, the station marker stud (set into the case) indicates either Victorian stations or, in the alternative mounting position, NSW stations.

When I bought it, the black-case radio had damage on the edges of its case, exposing bare timber. The fascia is held in by plastic lugs penetrating through the woodwork of the front of the case. The black case was separated from the fascia and resprayed with satin black to provide the much-improved appearance seen in the photos.

The timber veneer case was likewise abraded at the edges and so I refinished it with satin polyurethane.

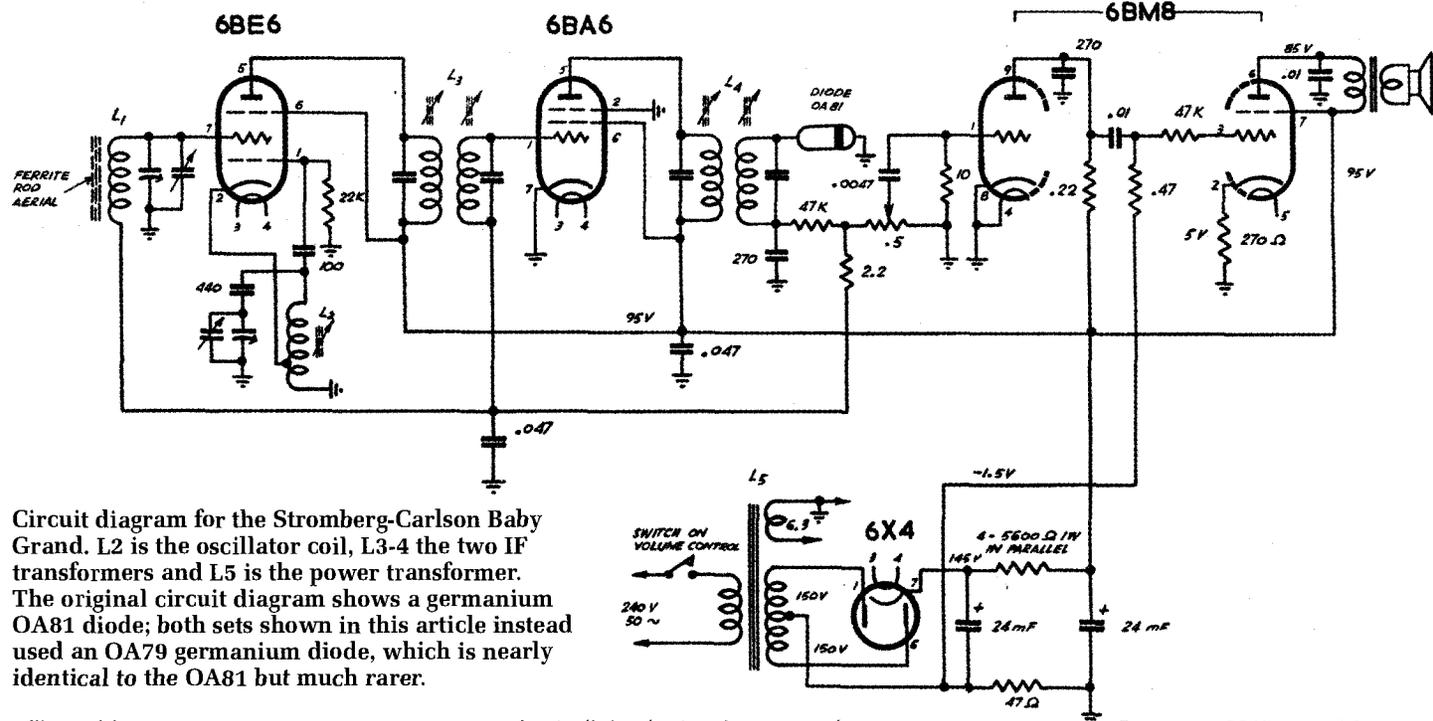
The circuit is shown in Fig.1. Reception starts with a large ferrite rod antenna. There is also a coupled external aerial winding, allowing signal strength to be increased if necessary. This is not shown on the circuit diagram but can be seen in pictures of the radio. The external aerial wire simply dangles from one of the ventilation holes in the back panel.

The other 6BE6 connections are all standard, with the broadcast signal applied to the control grid and the anode feeding the 455kHz heterodyne signal to the first IF transformer. The negative control voltage for AGC is supplied to the 6BE6 grid, derived from the anode of the OA79 diode (the cathode of the diode connects to Earth).

The circuit diagram shows the pentode plate at 85V. At first glance, it might seem that the triode plate is at 270V, but that is actually the value of the plate decoupling mica capacitor of 270pF.

Circuit diagram for the Stromberg-Carlson Baby Grand. L2 is the oscillator coil, L3-4 the two IF transformers and L5 is the power transformer. The original circuit diagram shows a germanium OA81 diode; both sets shown in this article instead used an OA79 germanium diode, which is nearly identical to the OA81 but much rarer.

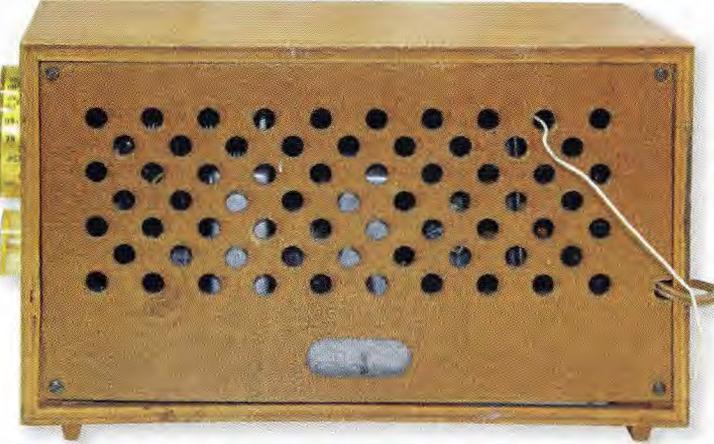
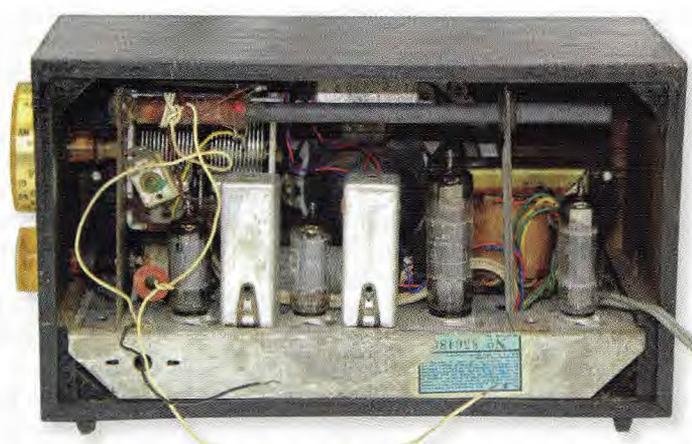
The back of the set with the external aerial wire and mains power cable hanging out. Apart from the colour of the cabinet, logo and power cable, there isn't any other difference between these two sets.

The photos show the original two-core figure-8 mains leads. I replaced these with 3-core cable, Earthed to the chassis.

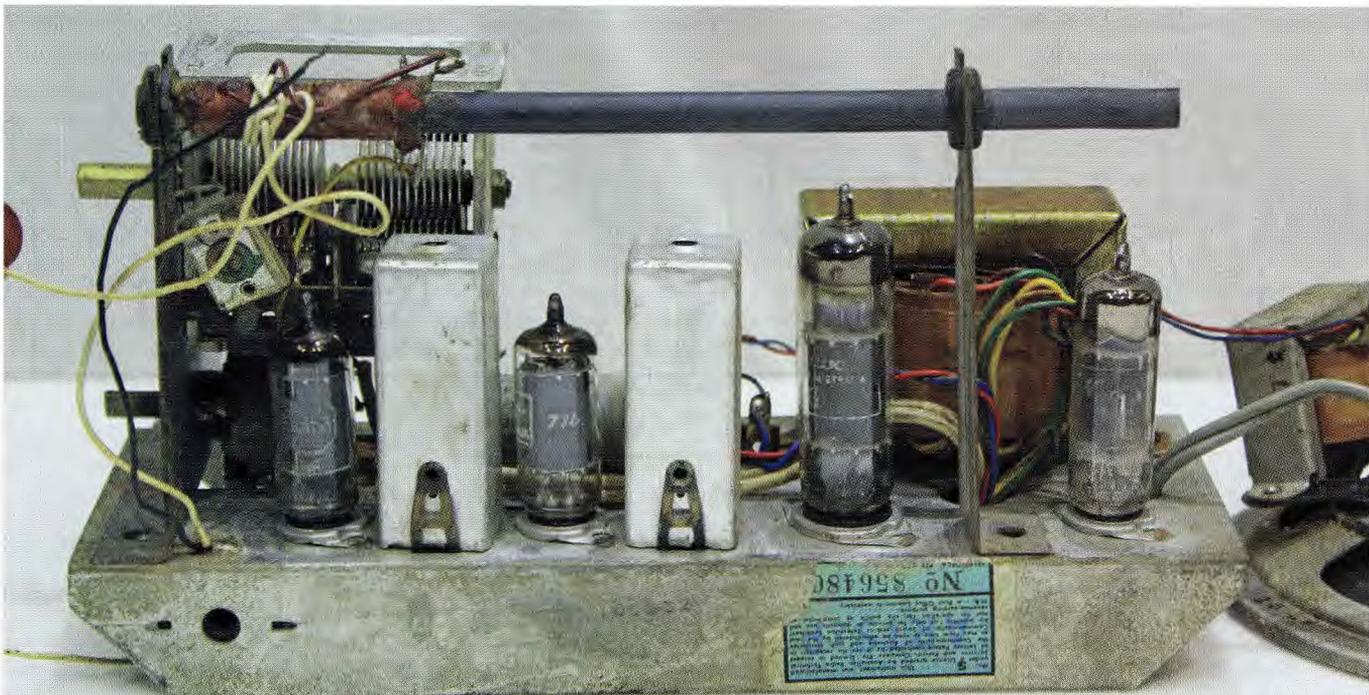
A closer view of the chassis from the rear, out of its case. From left to right, the valves are: 6BE6, 6BA6, 6BM8, 6X4.

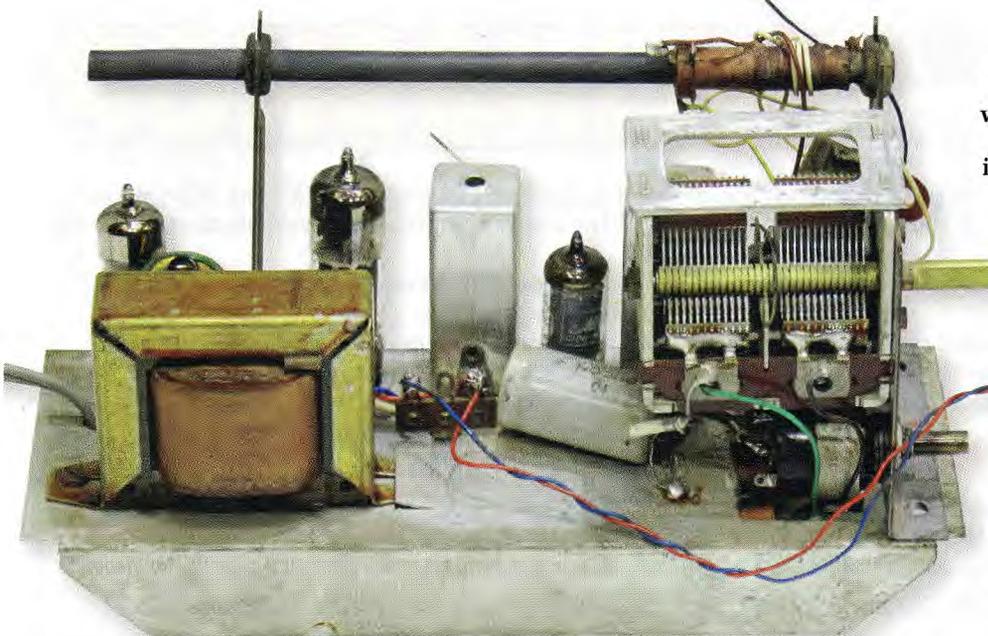
The front of the Baby Grand chassis with a Rola 5-inch 3.5Ω loudspeaker. Like other radios, the power switch is integrated with the volume control pot, visible near the bottom of the chassis.

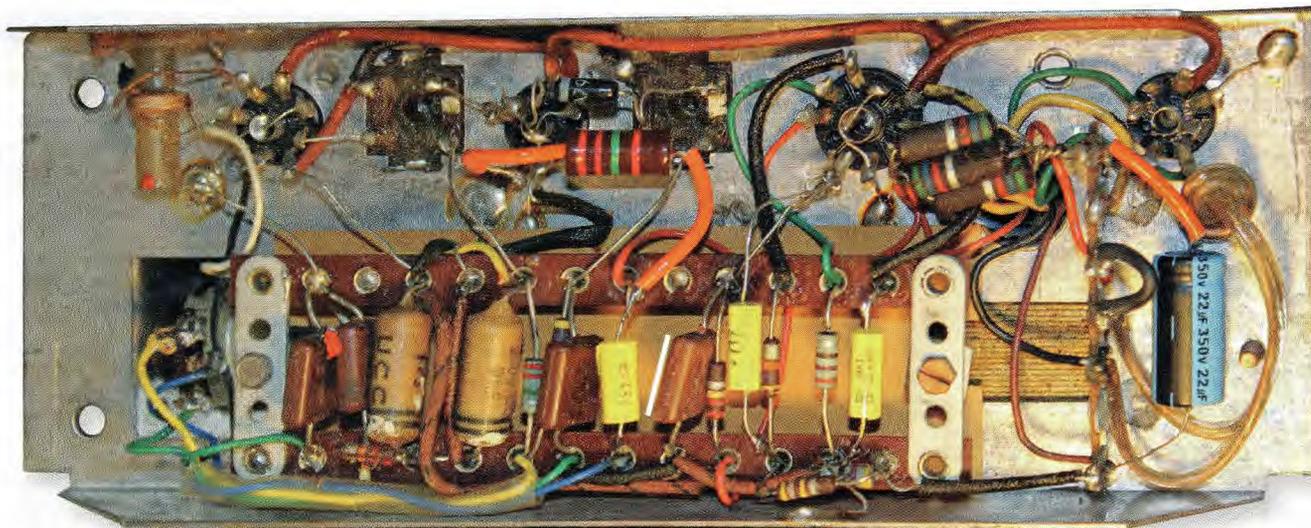
The black-case radio worked well from power up. But the timber veneer radio crackled. Even with the volume control set at zero, it still made the irritating noise, so the crackle was clearly being produced after the volume control pot. I progressively replaced the most likely components that could generate crackle.

at the triode plate. The only component that I had not replaced that connected to the triode plate (pin 9) was the 270pF mica capacitor that was designed to shunt any high-frequency signal to Earth.

The underside of the restored chassis. The source of the crackle was due to a single mica capacitor, located between two of the replacement MKT capacitors (marked by the white line).

Sherlock Holmes asserted that when every other explanation has been eliminated, then the only one remaining must be the truth. Indeed, Holmes proved correct. Replacing the mica capacitor to the 6BM8 triode plate killed the crackle.

In sharing this experience with others, I discovered what is now becoming ever more common in vintage radios, mica capacitors look rugged and indestructible, but they are now reaching an age where their failure leads to crackle. If you encounter a case of crackle, start by replacing the mica capacitors.
