AWA Radiola Model 137 *the "Fisk" recreated*

Rob took an old radio chassis he inherited from his grandfather, fixed it and built a cabinet for it. The style is 1930s Art Deco, but with a less ornate and much smaller cabinet than the original. He had to repair or replace quite a few of the original components, and figure out how to get it working with few circuit details to go on. The result is a new-looking radio with the style and the sound of the 30s.

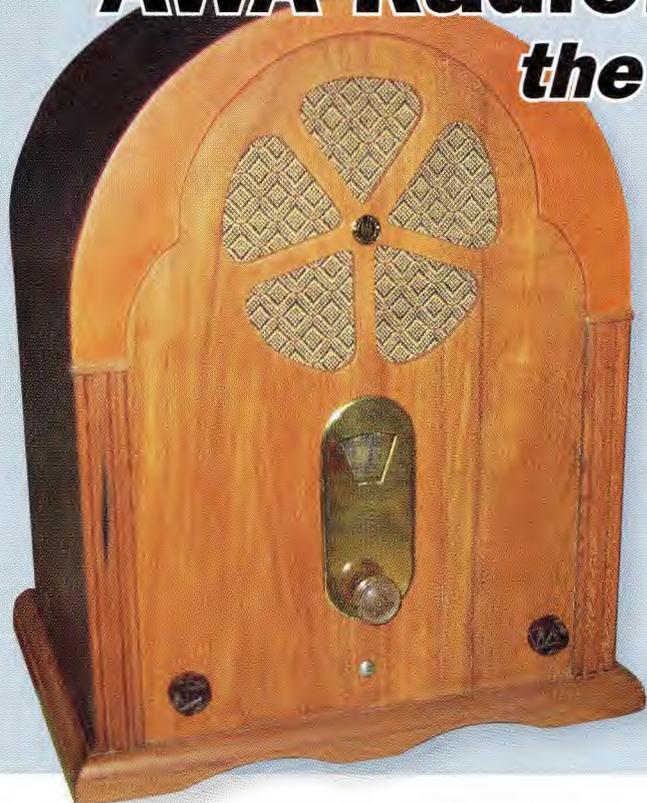
◀ The new case is custom-built in an Art Deco style, and is much smaller than the original console cabinet (shown at right). The rear of the new case was affixed with an old AWA employee badge and a replica logo was made for the front.

The base is made from recycled Australian cedar, as are the vertical pieces on either side, while the main part of the face is veneered in teak. The top arch is stained plywood. The badge in the middle of the speaker is a replica AWA Fisk Radiola.

I cut and shaped brass into a rounded rectangular shape for the dial feature. I had "Model 137" engraved under the dial opening. On the rear, I fastened an AWA employee badge that I found in a box of old badges.

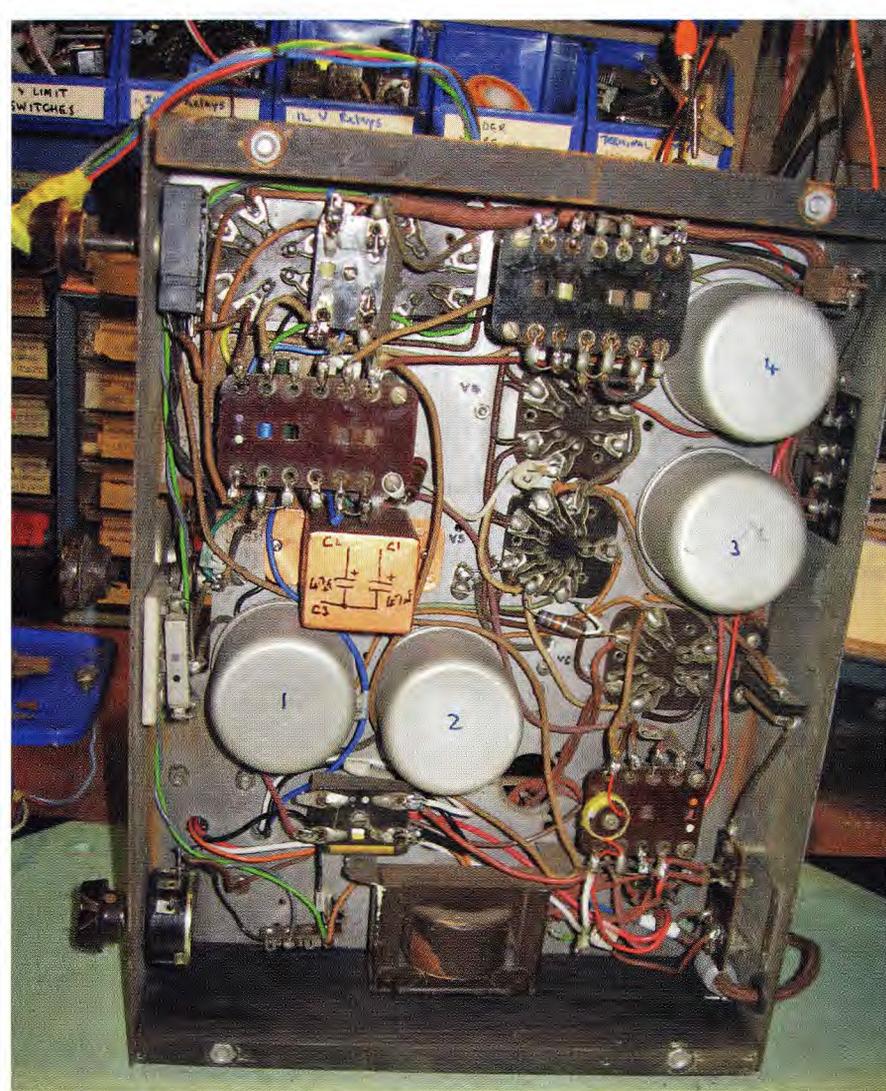
The underside of the chassis is quite neat. The silver cans marked 1-4 contain the coupling transformers, while the two copper boxes on the underside and top (left of the dial) of the chassis contain electrolytic capacitors.

The set also has a phono input socket and switch. The phono input is marked "P" and the switch marked "R" and "P", below and to the left of the 2B7 detector/audio preamplifier. In the "R" position, the signal from the demodulator is fed to the control grid of the 2B7 pentode, while in the "P" position, the demodulator is disconnected and the phono signal is fed in instead.

The demodulator has a 100k Ω load resistor to the 2B7's cathode and 82pF filter capacitor to remove the IF modulation. The 2B7's cathode resistor is bypassed with a 50 μ F capacitor to maximise gain. The audio signal from the R/P switch is further filtered by a 100k Ω /10pF RC low-pass filter, presumably to remove any remaining RF.

The radio also has a tone control pot. One end of its track connects to plate of one of the 2A5s (ie, one end of the speaker transformer primary) while its wiper is connected, via a 50nF coupling capacitor, to the anode of the other 2A5 and thus the opposite end of the speaker transformer.

There is also a connector for an external loudspeaker, marked "L", shown just to the right of the 2A5s. It connects directly to the anodes of both 2A5s. One would hope that this terminal is well-insulated, given the high voltage which could appear across those two terminals.

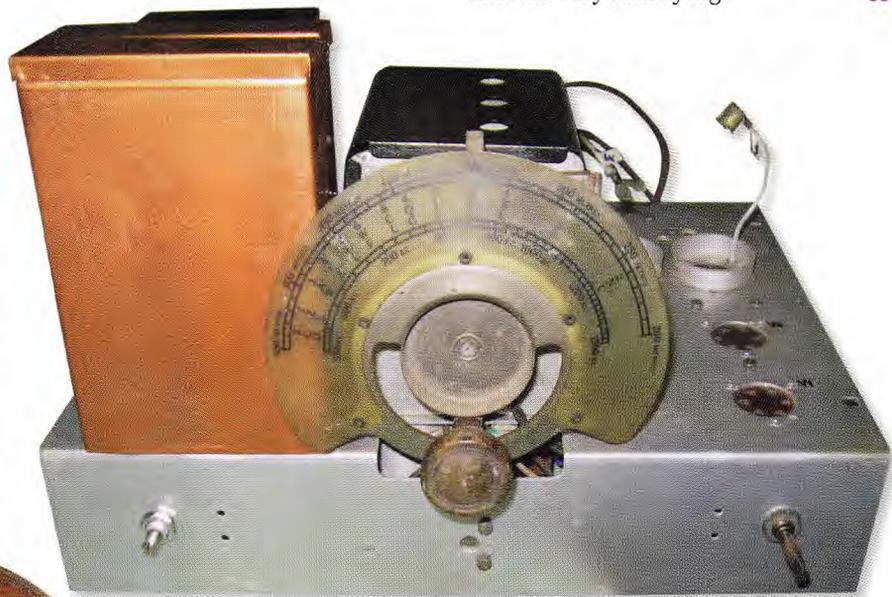
▲ The stations listed on the dial are, from left to right: 2CO, 7ZL, 3AR, 5CK, 4FC, 6WF, 5CL, 4QG, 3LO, 2BL, 4RK and 2NC. The only callsign still in use is 2BL.

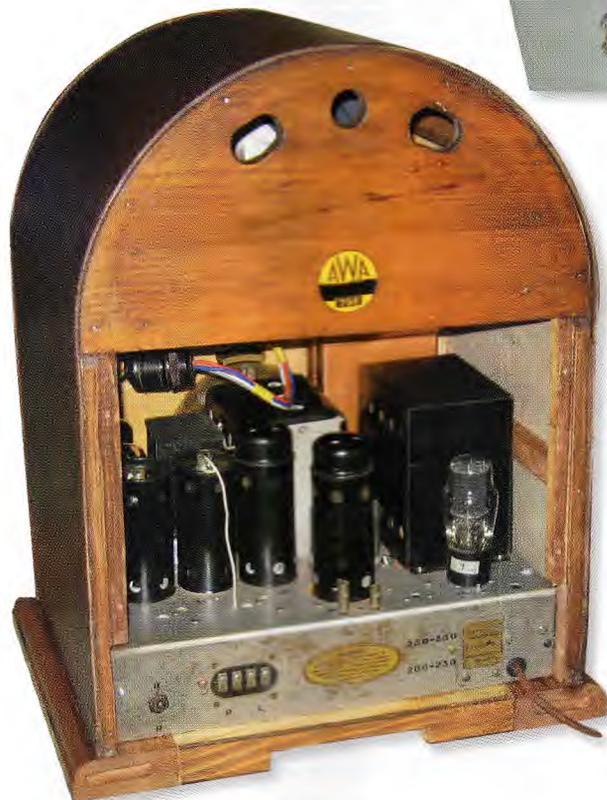
carded long ago. I had a picture of the original AWA cabinet (shown here); a huge piece of furniture. I was not keen to recreate that. So I browsed the internet, looking at pictures of vintage radios and eventually decided that I would build a tombstone style cabinet for it, with a rounded top.
