VINTAGE RADIO

Tecnico 1950 Model 1050

Tecnico 1951 “Baby Fortress” Model 1140

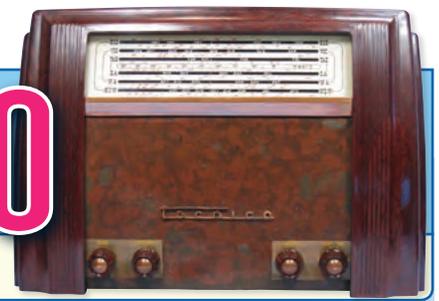
At 9.6kg, this is a heavy-weight table radio and it has suitably imposing styling. One could even accuse it of belonging to the early Brutalist period. Fortunately, the splendid walnut-character Bakelite case with decorative slots rescues it from being overly austere.

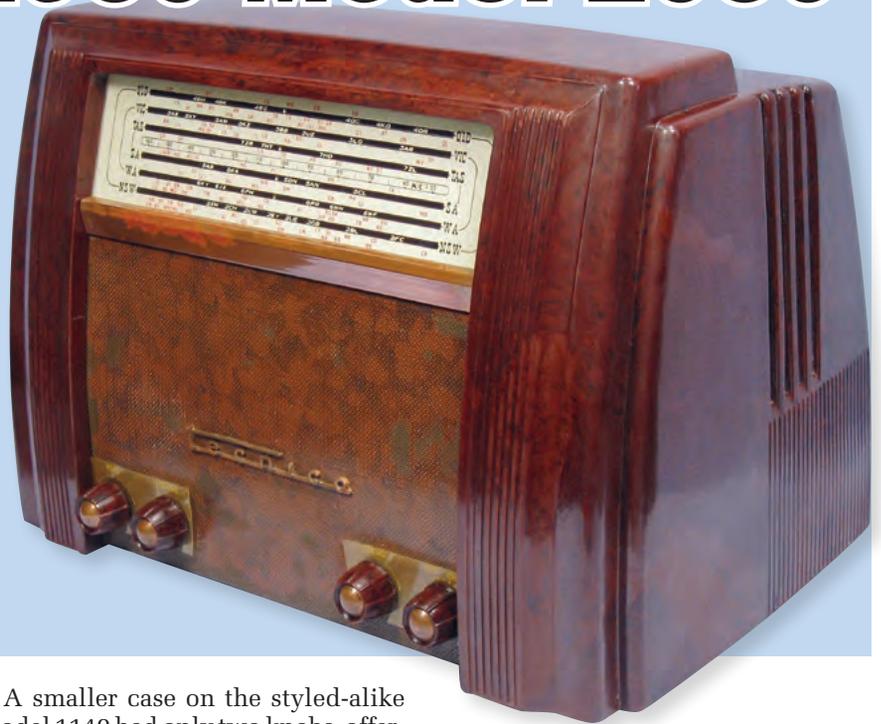
The perforated metal speaker grille copies Bendix radios and is painted in dappled shades, like military camouflage. Continuing with this theme, the case has the look of a World War Two concrete 'pillbox'. (Military structures of the WW2 were a major inspiration on Brutalism).

In keeping with the new demand for colourful radios at the time, the case was also available in shades of cream, green and blue with various degrees of mottling. The model shown here has four front panel knobs for power on/off (full DPDT switching), volume, tone and tuning.

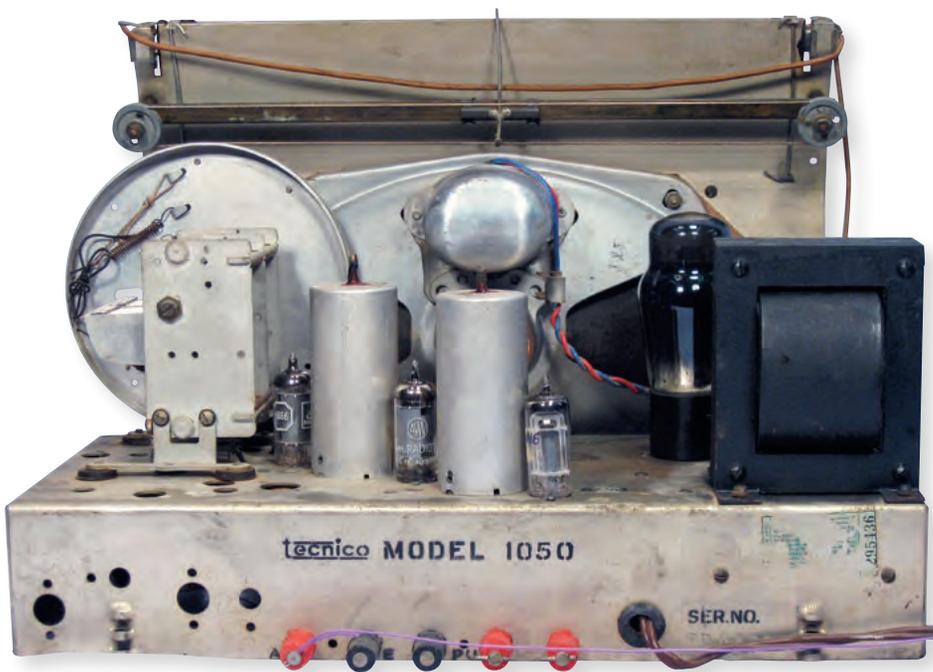
The rear of the Tecnico 1050 chassis showcases the miniature valves, power transformer, tuning gang, 9-inch speaker etc.

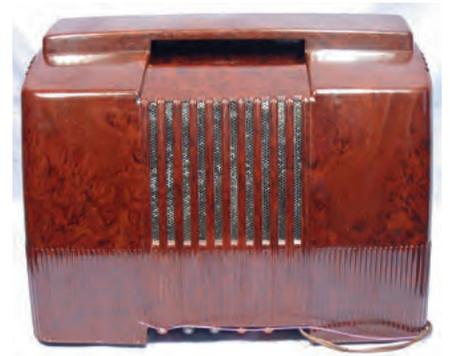
The mesh behind the rear grille bars restricts heat transfer, so the gap below the handle at the top is the major ventilation port.

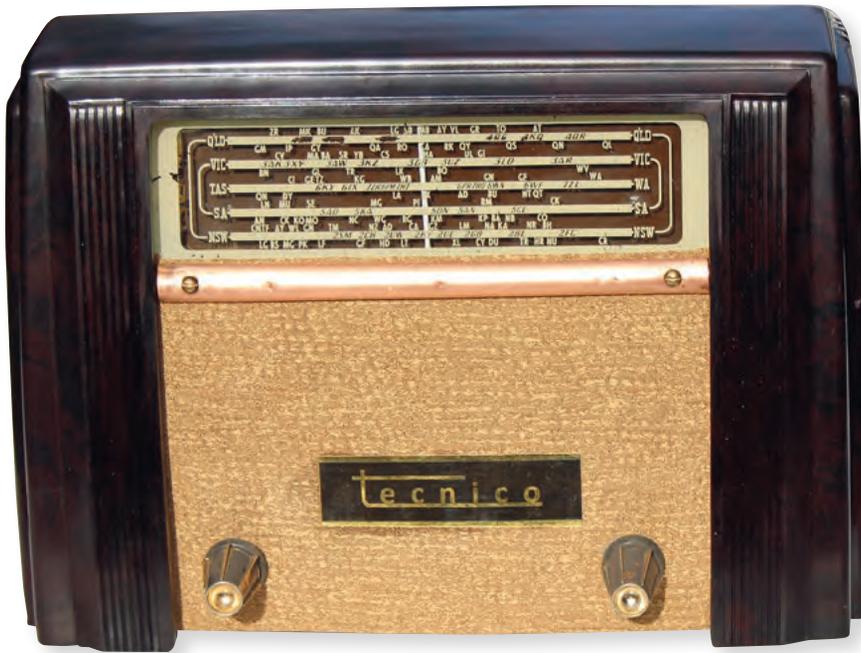
Here is a short bonus article on a Tecnico Model 1140. The only similarity between this radio and the Model 1050 is in the case design. The restored radio does not have a truly “authentic” look as the case should be white, and the knobs and grille are not originals.

The example shown here was acquired lacking the front grille and knobs, so it needed some restoration work. In this case the replacement knobs were taken from an HMV stereogram. The genuine grille and knobs are the same as for the model 1050.
