# VINTAGE RADIO

## Philips 1948 table model 114K

By Associate Professor Graham Parslow

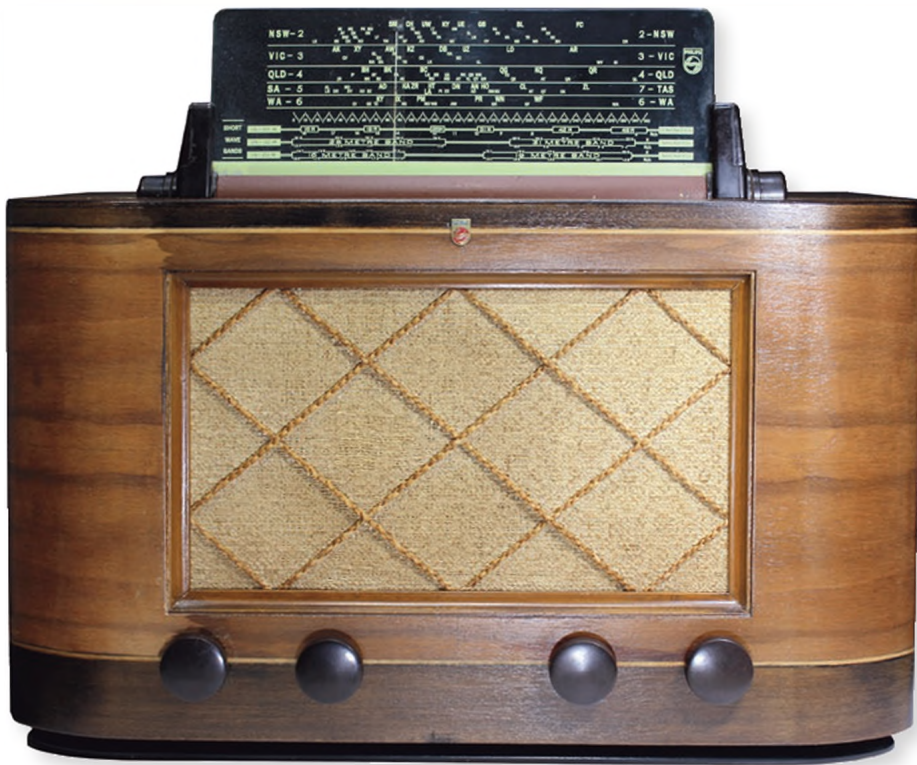
The 114K radio is one set in a series of similar radios made by Philips, and was among the last all-octal radio designs, due to decreasing stock in the post WW2 era. The radio is otherwise a fairly standard six valve superhet, but weighs in at a hefty 12kg.

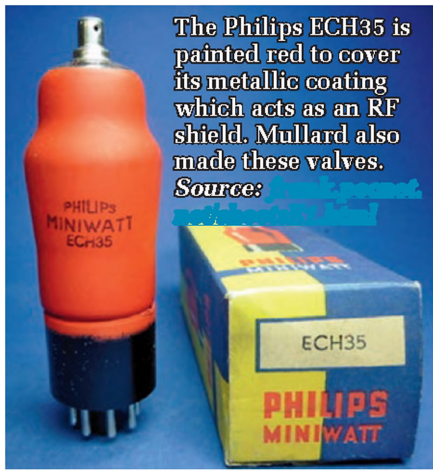
The Philips ECH35 is painted red to cover its metallic coating which acts as an RF shield. Mullard also made these valves.

The mixer valve in this radio is an ECH35, released in Europe in 1939. The red-painted opaque envelope on an ECH35 covers a metallic coating that acts as an RF shield while the primary grid is connected via a top-cap.
