VINTAGE TELEVISION

Sanyo's 8-P2 TV (1962) and horizontal linearity

By Dr Hugo Holden

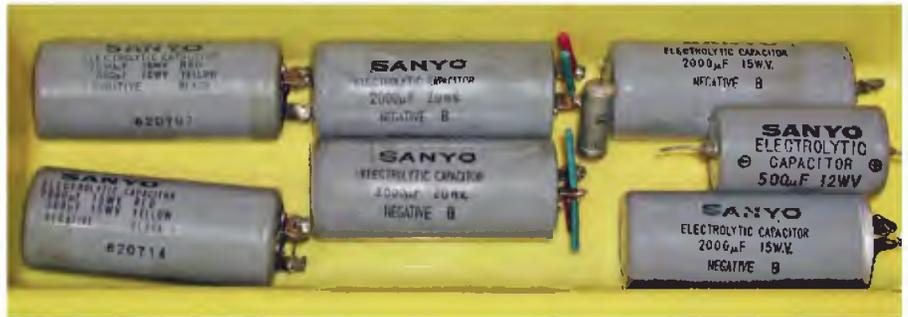
The original Sanyo capacitors (shown approximately half size) used for power supply filtering etc, had failed when the set was powered on. The 500 μ F capacitor at right is the coupling capacitor for the vertical yoke's coils. The rest of the 2000 μ F capacitors were replaced with 4700 μ F Nichicon types shown below (actual size), as they were the closest in terms of appearance and size.

The original Sanyo capacitors are shown at upper right; they were fairly generous with the number they used. The set requires good power supply filtering as there is no electronic regulator for the 12V rail; merely a transformer and bridge rectifier when running from mains power. The larger 500 μ F axial electrolytic in the photo is the vertical yoke's coils coupling capacitor.

These capacitors are huge for their ratings compared to modern equivalents, which have about 20% the volume or less.

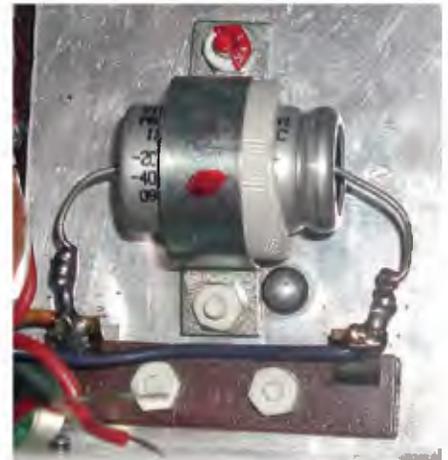
The yoke coupling capacitor was replaced with this Rifa 1000 μ F automotive capacitor.

I had to remove the CRT from the set to replace the 500 μ F 12V-rated vertical yoke coupling cap. I replaced this one with a 125 $^{\circ}$ C, 40V-rated 1000 μ F Rifa automotive-grade capacitor that will never likely need replacing. I replaced the 2000 μ F 15V units with 4700 μ F 80V Nichicon types. This was the closest I could find with a large enough diameter canister size to approximate the original appearance.

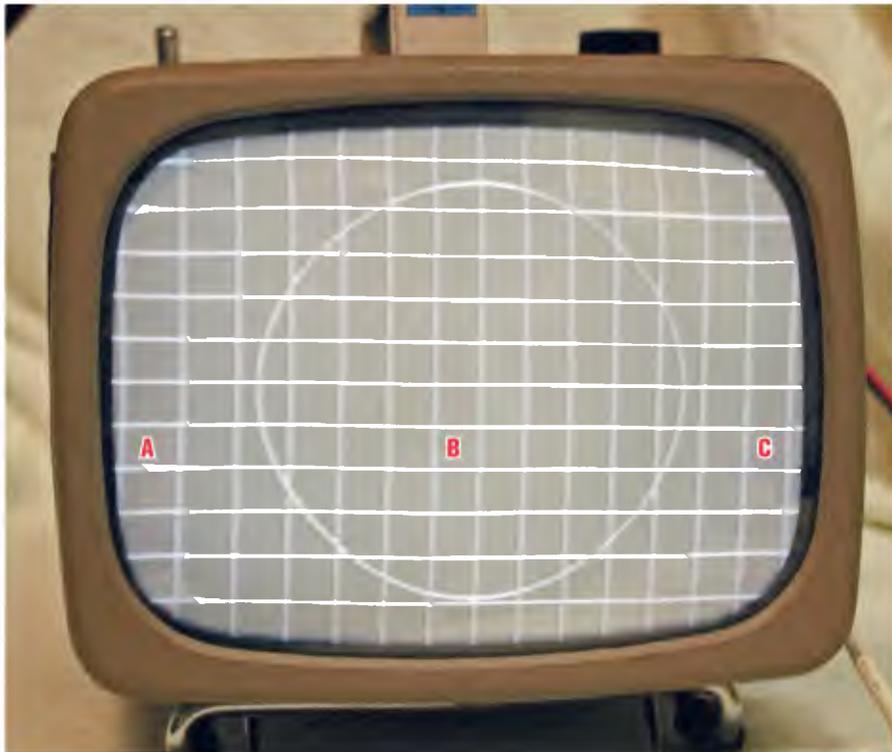
The horizontal linearity of the Sanyo 8-P2 is not as good as the adjacent Sony TV (for example region "A") despite it having an S-correction capacitor.

The linearity of the image on the Sanyo 8-P2 is shown below, which has an S-correction capacitor. Unlike the Sony Micro TV, the horizontal linearity of the central area of the screen (B) is very similar to that near the righthand

side (C), thanks to S-correction.

But it is still expanded in the region A on the lefthand side, due to the magnetic field reversal and the current waveform shape.

In the case of the Sanyo 8-P2, the horizontal scanning linearity defect on the left side could be eliminated with the addition of a magnetic linearity coil; however, I decided to leave it as it was designed.
