VINTAGE RADIO

Stromberg-Carlson 1936 model 496 mantel radio

By Associate Professor Graham Parslow

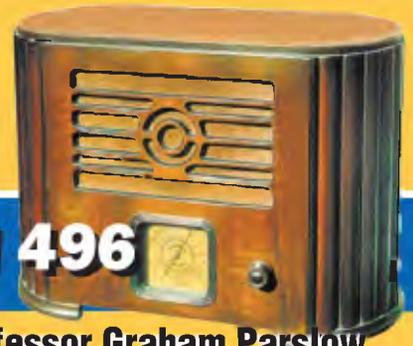
After many years at the masthead of Vintage Radio, finally, here is an article on the feature radio! It's an early superhet with Art Deco styling. You can see the dramatic change between its pre- and post-restoration appearance.

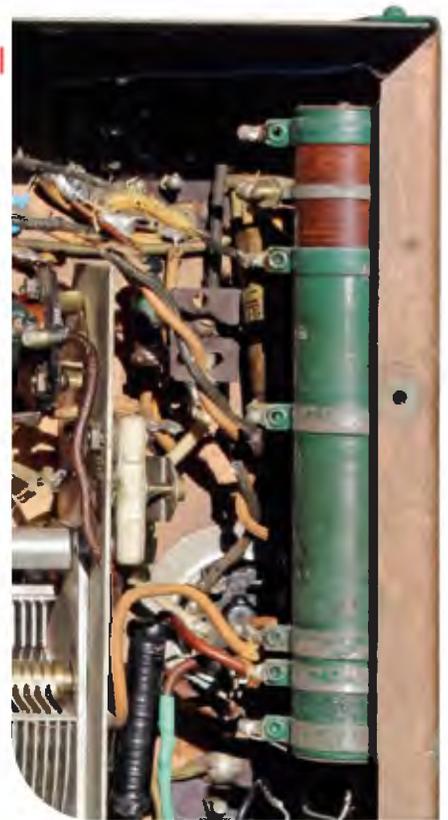
Shown at left is the underside of the chassis after restoration. A subsection is shown above of the green multi-section wire-wound resistor which was replaced with a tag board.

Checking the large green multi-section wire-wound resistor showed that the only functional section was the 140Ω grid bias resistor. The other clamps were not making contact with the wire beneath them. This explained why there was no screen voltage, because this is derived from a 15kΩ segment that was open-circuit.

To restore the function of the resistor series, I decided to populate a tag-board with discrete resistors. The tag-board I selected was unused and dated from about the time of this radio, so installing it was not an outrageous affront to its character.

A previous modification had been to add a 150Ω resistor in series with the 140Ω resistor in the output valve grid bias circuit, so that the AL3 could be replaced with a 6V6. The result was that bias at the 6V6 was -15V. I instead used a 100Ω + 150Ω pair, resulting in a -14V bias.

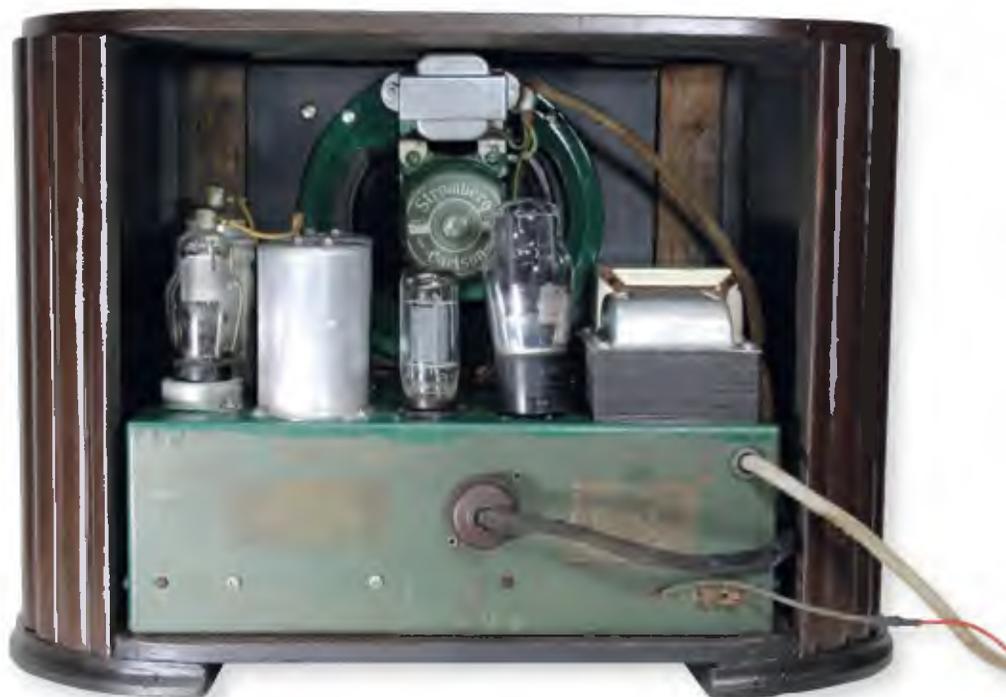
On the rear of the chassis you can see the cloth-bound mains lead which was a replacement for a figure-8 flex as a way to Earth the chassis.

The two dial-lamp holders looked forlorn, but they cleaned up well and remained serviceable. Unfortunately, the set had a short length of modern figure-8 flex coming out from the rear. I replaced that with a cloth-bound three-core mains lead, allowing the chassis to be Earthed.

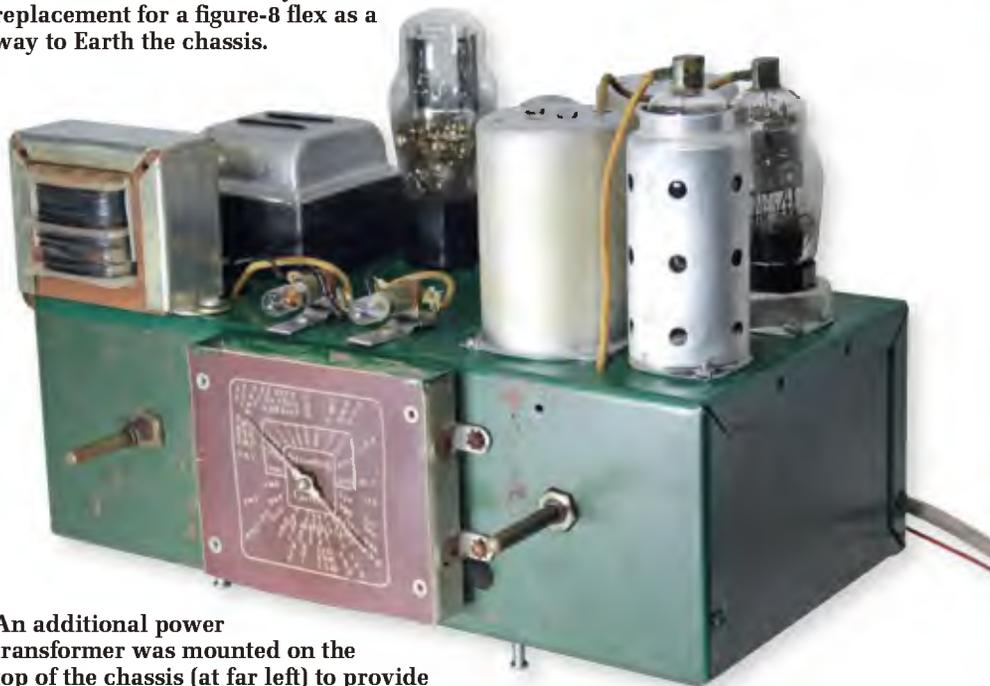
An additional power transformer was mounted on the top of the chassis (at far left) to provide higher filament voltage. This was mounted where two old electrolytic capacitors used to be.

The AC filament voltage measured as only 4.9V, an apparent reason for the poor performance. Valves usually specify a maximum of $\pm 10\%$ filament voltage tolerance. Cathodes subjected to chronic low filament voltage change their chemistry to poison the oxide layer, resulting in lower emission.

To provide the required higher filament voltage, I mounted an additional transformer on top of the chassis over the two holes formerly occupied by electrolytic capacitors.

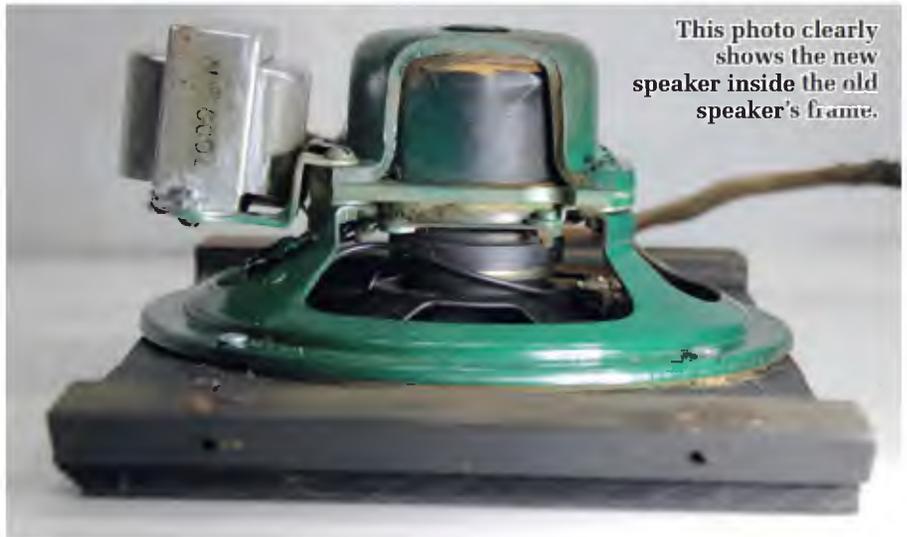
This photo clearly shows the new speaker inside the old speaker's frame.

It was not difficult to hook this speaker into the secondary of the speaker transformer. However, because the new speaker was a few millimetres proud of the old speaker rim, a reworking of the original baffle with an additional three-ply spacer was required. It was an excellent mental and physical exercise to finalise this solution.

The pictures show the result. I abraded the rust on the speaker transformer and speaker frame away and repainted them to optimise the appearance from the rear (the sides of the speaker cannot be seen in the
