# VINTAGE TELEVISION

## Restoring a Sony 5-303E Micro-TV

By Dr Hugo Holden

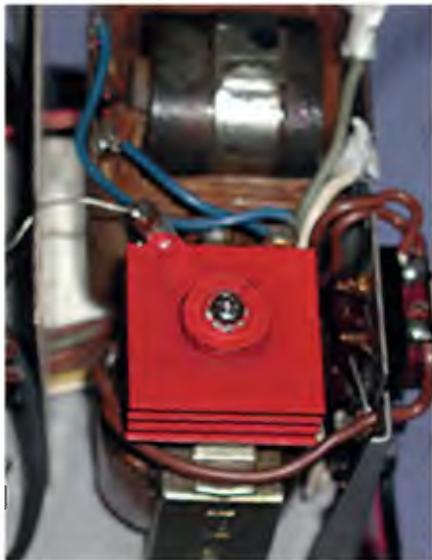
Other interesting features of this set include a somewhat retro unregulated 12V DC power supply based on a selenium bridge rectifier (see Fig.2).

◀ Fig.2: selenium rectifier stacks are famous for producing lots of toxic fumes when they fail. That's why many people prefer to replace them with modern rectifiers. Still, you have to be careful because modern rectifiers can lead to much higher surge currents and have lower forward voltages.

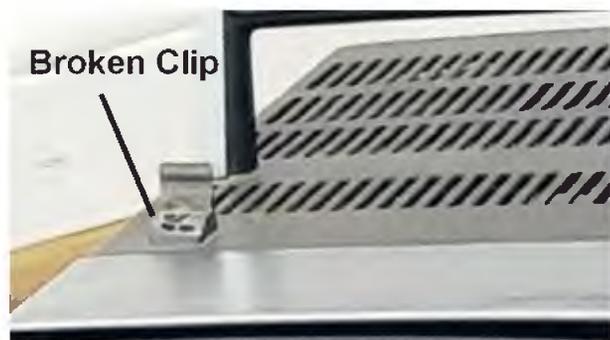
The plastic hardens and cracks with time, as shown in Fig.11. Mine was a victim of this, so I simply hand-crafted a new one from a block of Nylon (Fig.12).

**Fig.11 (above):** pretty much all Sony 5-303E sets will suffer from a broken plastic antenna clip by now, as the plastic becomes brittle over time.

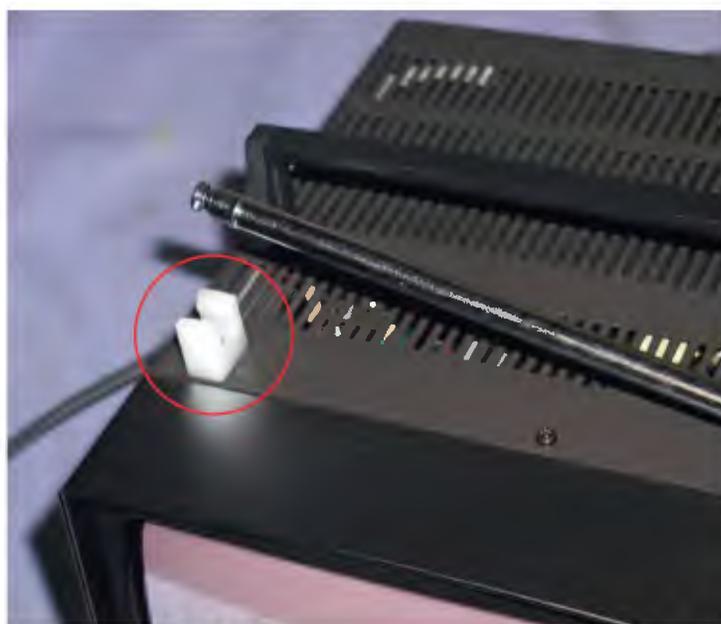
**Fig.12 (right):** I hand-crafted this replacement antenna clip (circled in red) from a small block of Nylon. It isn't pretty, but it works. I could paint it grey in future for a more factory appearance.

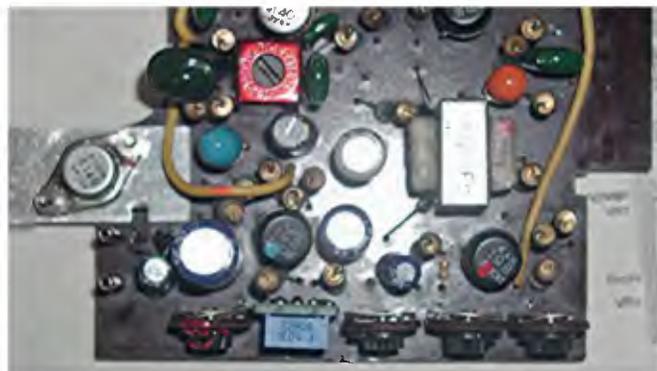
Firstly, on the simple side of things, the HOR. HOLD preset was defective and at a certain point of its rotation, the resistance value suddenly jumped (not corrected by cleaning). If it was set near that position, the resistance value was erratic. So I replaced it with a modern 10kΩ preset pot on a small piece of plated through-hole spot board, as shown in Fig.17.

Fig.17: one of the preset pots had gone bad, and since I couldn't easily source a replacement, I rigged up a modern trimpot of the same value to fit in the same location.

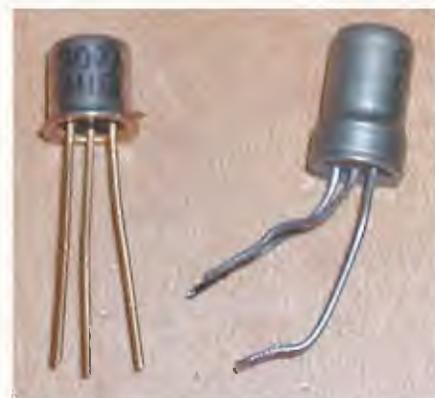
The cause of the sudden massive change in horizontal frequency was very interesting. NPN germanium buffer transistor X22, a 2SD65, was intermittent. It would suddenly lose its ability to buffer, and the sudden loading on the horizontal oscillator forced the scan frequency up very

I concluded that one of two things was happening to this transistor: either the collector connection inside the transistor was intermittently going open-circuit, or the base-to-emitter terminals inside the transistor were being intermittently shorted out by something like a tin whisker. Both mechanisms result in the same failure to buffer.

Of the two, I'm very suspicious that it is tin whisker disease, because I could not detect any voltage drop at all across the base-emitter junction at the time of the failure, and one would have expected about 300mV.

Fig.18: despite being a silicon transistor, the BC107A (left) was a perfectly fine replacement for the internally faulty germanium 2SD65 (right) in my set. That's only because of the way it was used in the circuit though; it isn't operated in a linear manner. If it were, a germanium replacement with similar properties would have been required.

and the transistors around it are silicon types, I simply replaced it with a high-quality gold-plated leg vintage BC107A (Fig.18).
