VINTAGE RADIO

Monopole D225 tombstone radio from 1934

By Assoc. Prof. Graham Parslow

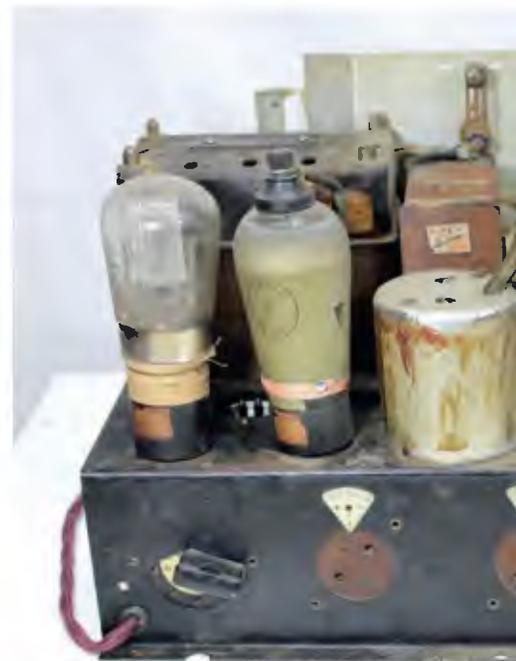
The photo of the top of the chassis shows four different valve bases of 4 to 8 pins. It also shows the mains transformer without the top cover and reveals the unusual pattern of winding and lamination.

The earlier chassis photo had the transformer cover removed so that its windings and laminations could be seen. This is what it looks like with the ventilated cover in place.

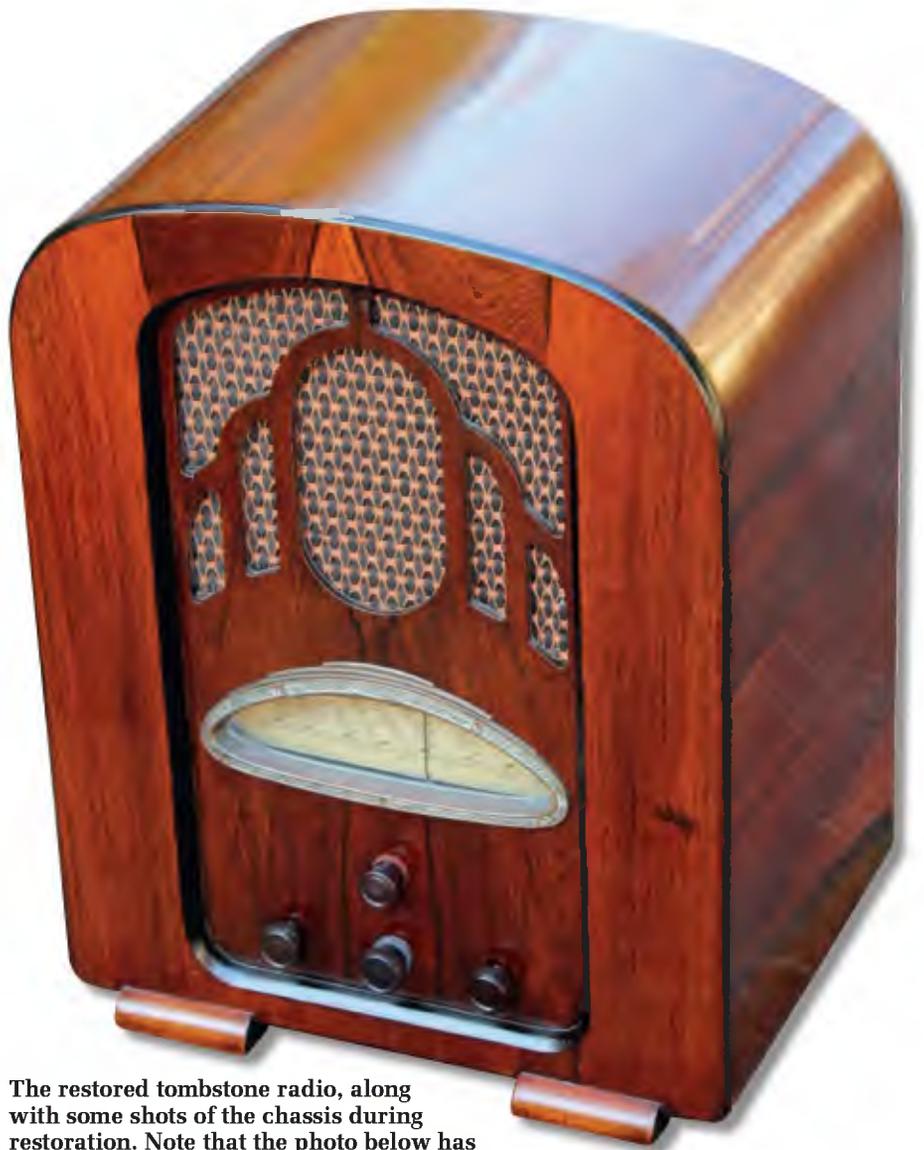
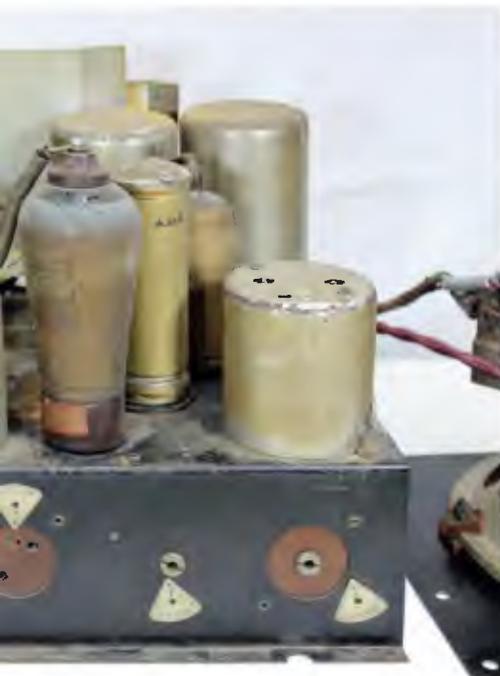
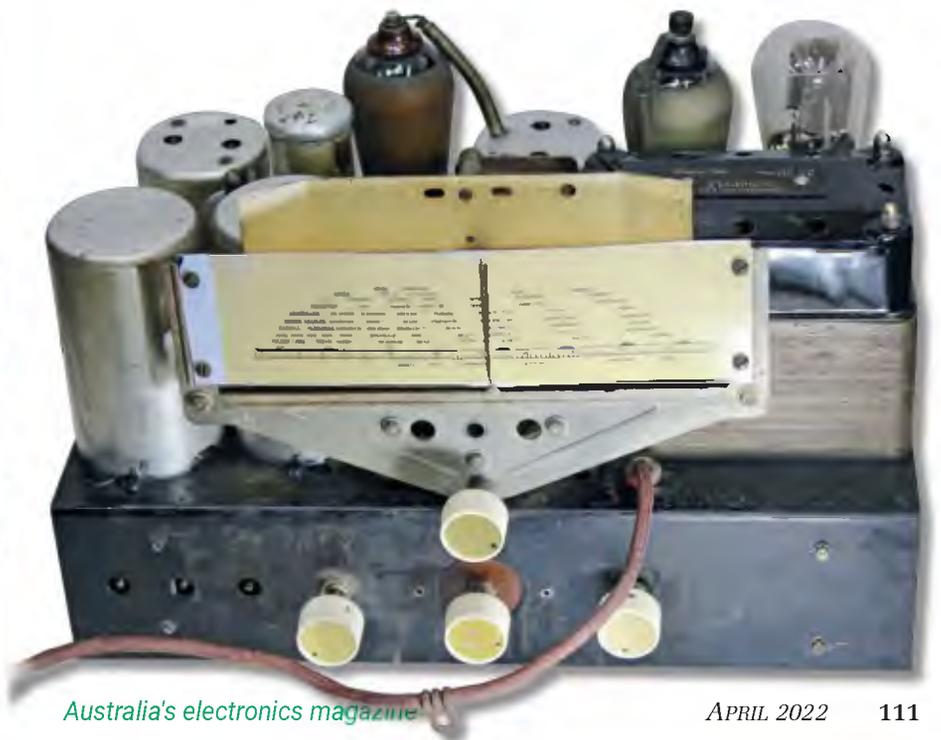
The restored tombstone radio, along with some shots of the chassis during restoration. Note that the photo below has the dial already repaired.

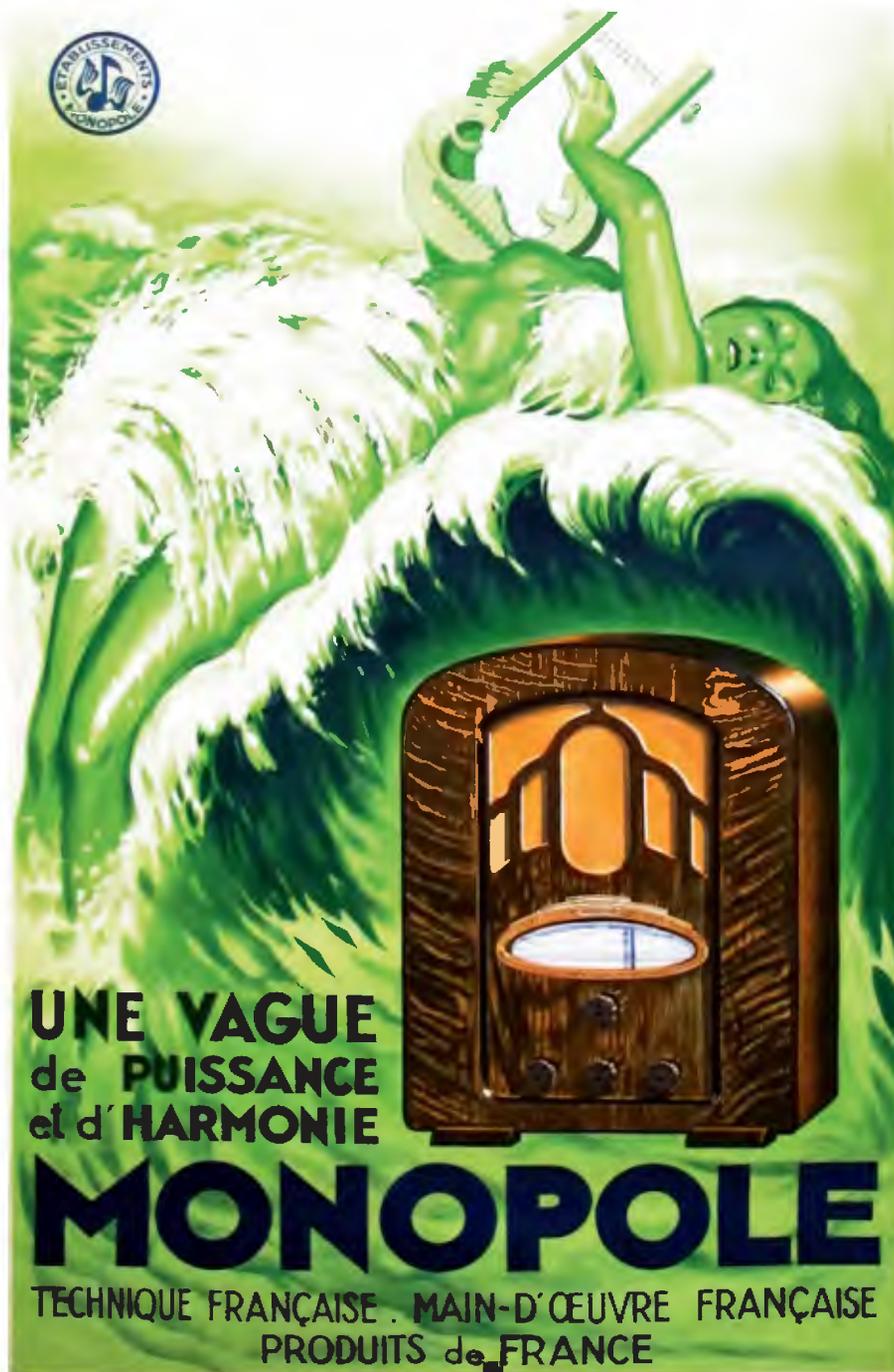
A French advertising poster showcasing the D225 radio. The advert is stated to be from “Damour-Editions”, and measures 120cm high and 80cm wide.

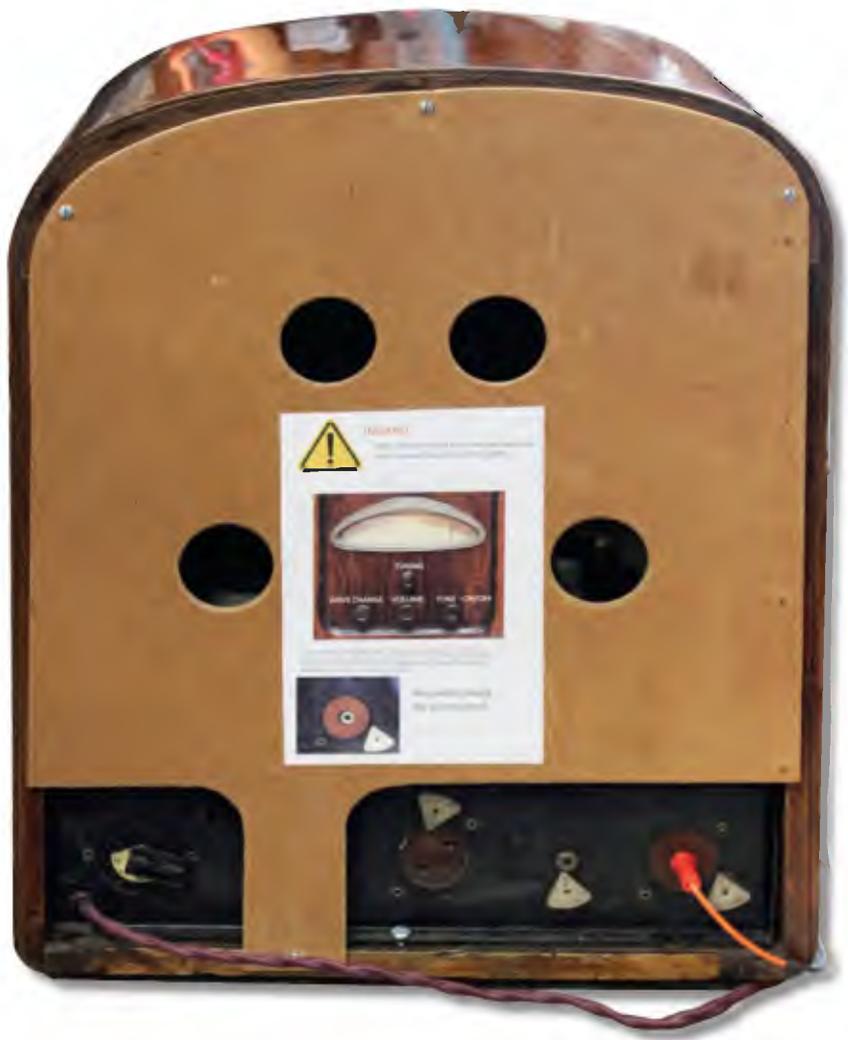
This shows the rear panel and label I fabricated. Also present are (from left-to-right) the power cord, mains voltage selection switch, speaker socket (hidden), a 'pickup' audio input socket, Earth connection and antenna connection.

I carefully installed the chassis into the cabinet to avoid damaging the French-polished finish. I then added a ventilated rear panel along with a warning of the high voltage hazard inside – the top caps on two of the valves are the anodes, not low-voltage control grids. I also included a note telling the user that an aerial must be installed (which you can see in the adjacent photo).

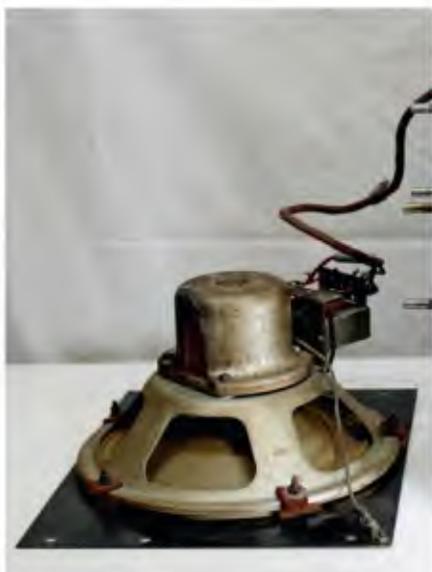
The electrodynamic speaker was a replacement Australian 8-inch (200mm) Rola of 1930s vintage, with the cone in perfect condition.

This speaker was not original, it was instead an Australian-made 8-inch Rola speaker of the same vintage.

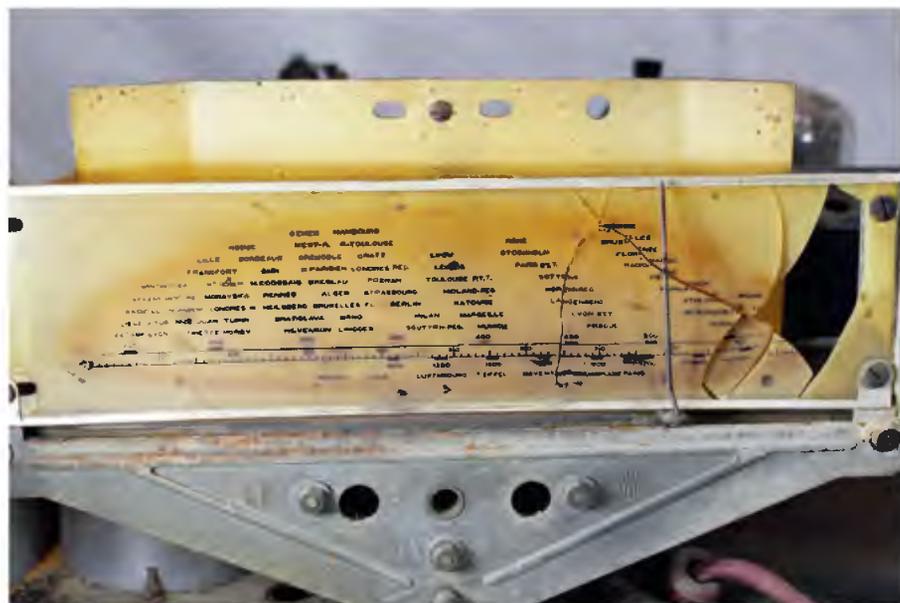
The celluloid dial was discoloured and cracked. It was so brittle that an attempt to glue the pieces together fragmented it even further.

The chemistry of this is interesting. Celluloid dials are fabricated from nitrocellulose with an added plasticiser like camphor that makes the product supple. With age, the camphor evaporates, leaving a brittle sheet. UV light also catalyses denitrication of the cellulose with the release of nitrogen oxides that give the celluloid a brown colour (note how the area exposed to light is darker).

The celluloid dial originally came cracked and yellowed, due to the way celluloid degrades as it ages. It was much easier to make a new dial than fix it.

The only solution was to completely redraw the dial at a larger scale and reduce it to size. I used PowerPoint to create the text and lines on a yellow

background, then printed it on 60gsm paper with adequate transparency to allow the dial light to shine through. I mated this to a rectangle of clear polycarbonate for support.

The original dial lamp was open-circuit, so I replaced it with a 3.5V torch globe.
