VINTAGE RADIO

Calstan Model 559M2 AM/SW superhetrodyne

By Fred Lever

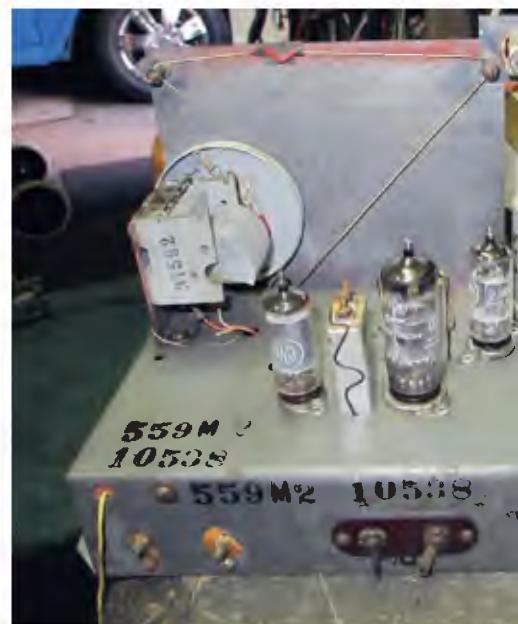
I purchased this radio (serial number 10538) from eBay in a non-working condition. From the photos in the eBay listing, I could see that some of the knobs and back-plate were missing and the dial was not in good condition. In summary, the radio was looking a bit sad (see Figs.1 & 2), so I decided to rescue it.

Figs.1 & 2: the Calstan (also known as Slade) 559M2 radio was initially provided in 'worn' state, with some knobs missing and the dial a bit scuffed.

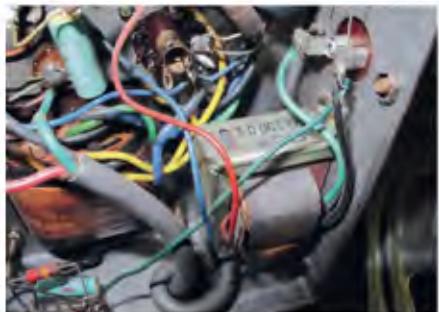
The type of components used suggests the set was made in the late 1960s or early 1970s. The Rola 7000/3-5 output transformer has a date stamp of 30 October 1968 (Fig.6), and there are

Fig.6: the output transformer had the date 30 October 1968 stamped on it.

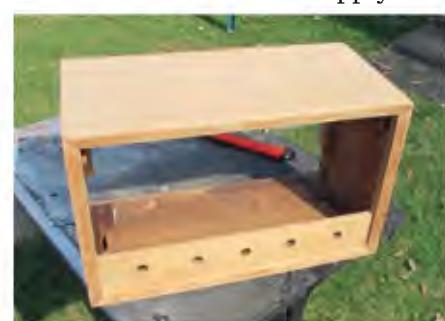
Fig.8: I cleaned and re-glued the cabinet as it was showing its age.

Some of the plies were separating from the base timber, so I added some strengthening bits, glued the lifting plies down, bogged it up and sanded the whole thing back – see Fig.8.

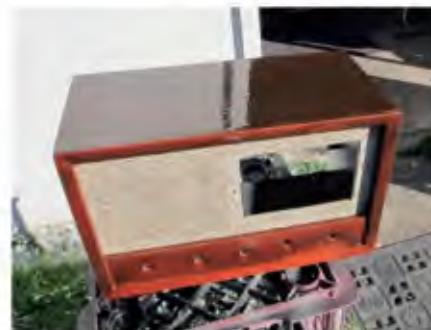
The front cloth cleaned up nicely with fabric cleaner, looking almost new. I applied a turps-based sealer and, once dry, a same-brand gloss coat to the timber. The wretched thing fish-eyed with something leaching through the sealer, disturbing the gloss coat badly (Fig.9). Talk about disasters in the paint shop!

Fig.9: a fabric cleaner was used on the front panel cloth, and a gloss coat to the timber cabinet.

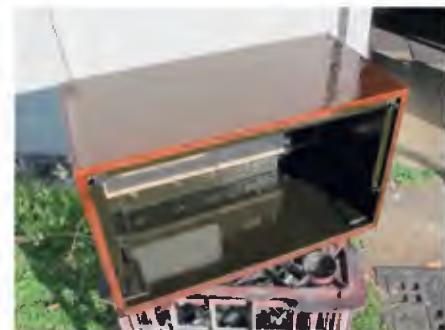
Fig.10: a black coat of paint was then applied to the inside, and the front knobs sprayed gold.

While that was drying, I brushed a turps-based black coat on the inside (Fig.10). I finished it off by spraying the knobs gold and cutting a piece of scrap Perspex for a back panel to prevent burnt fingers (shown below).

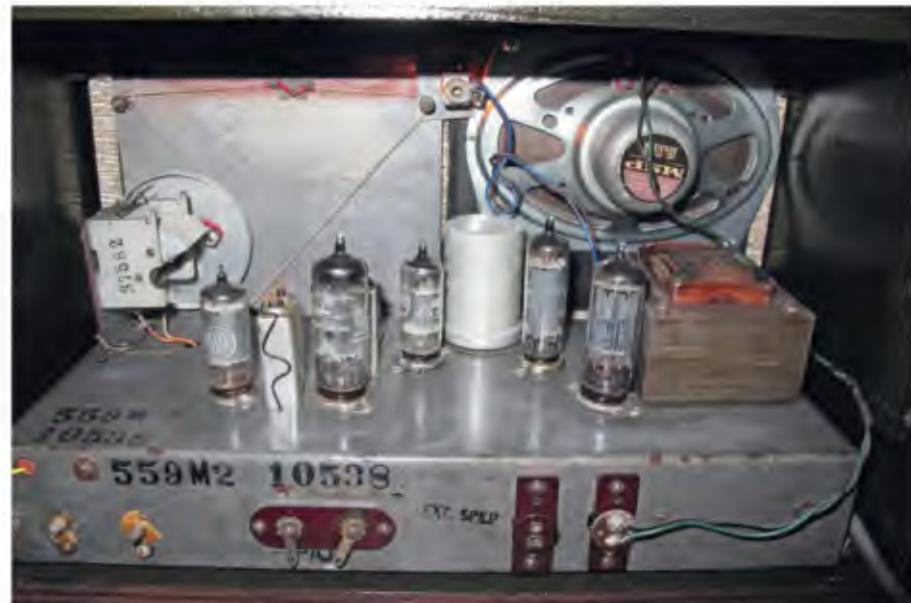
Fig.11: the chassis was then remounted inside the cabinet with the MSP speaker, measuring 9 x 6-inches and rated at 15Ω. After mounting the chassis, the rear of the cabinet was sealed with a piece of clear Perspex as a safety measure (see the photograph below).

I tarted the chassis and speaker up a bit by cleaning them and applying some gloss spray, then reassembled the set. The gloss coat took about a month to harden, so that was another painting disaster! I still need to add Letraset labels for the controls onto the front of the refinished cabinet. The knob functions from left-to-right are tone control, volume control, power switch, band switch and tuning.
