# VINTAGE EQUIPMENT

## AVO Valve Tester Restorations

By Ian Batty

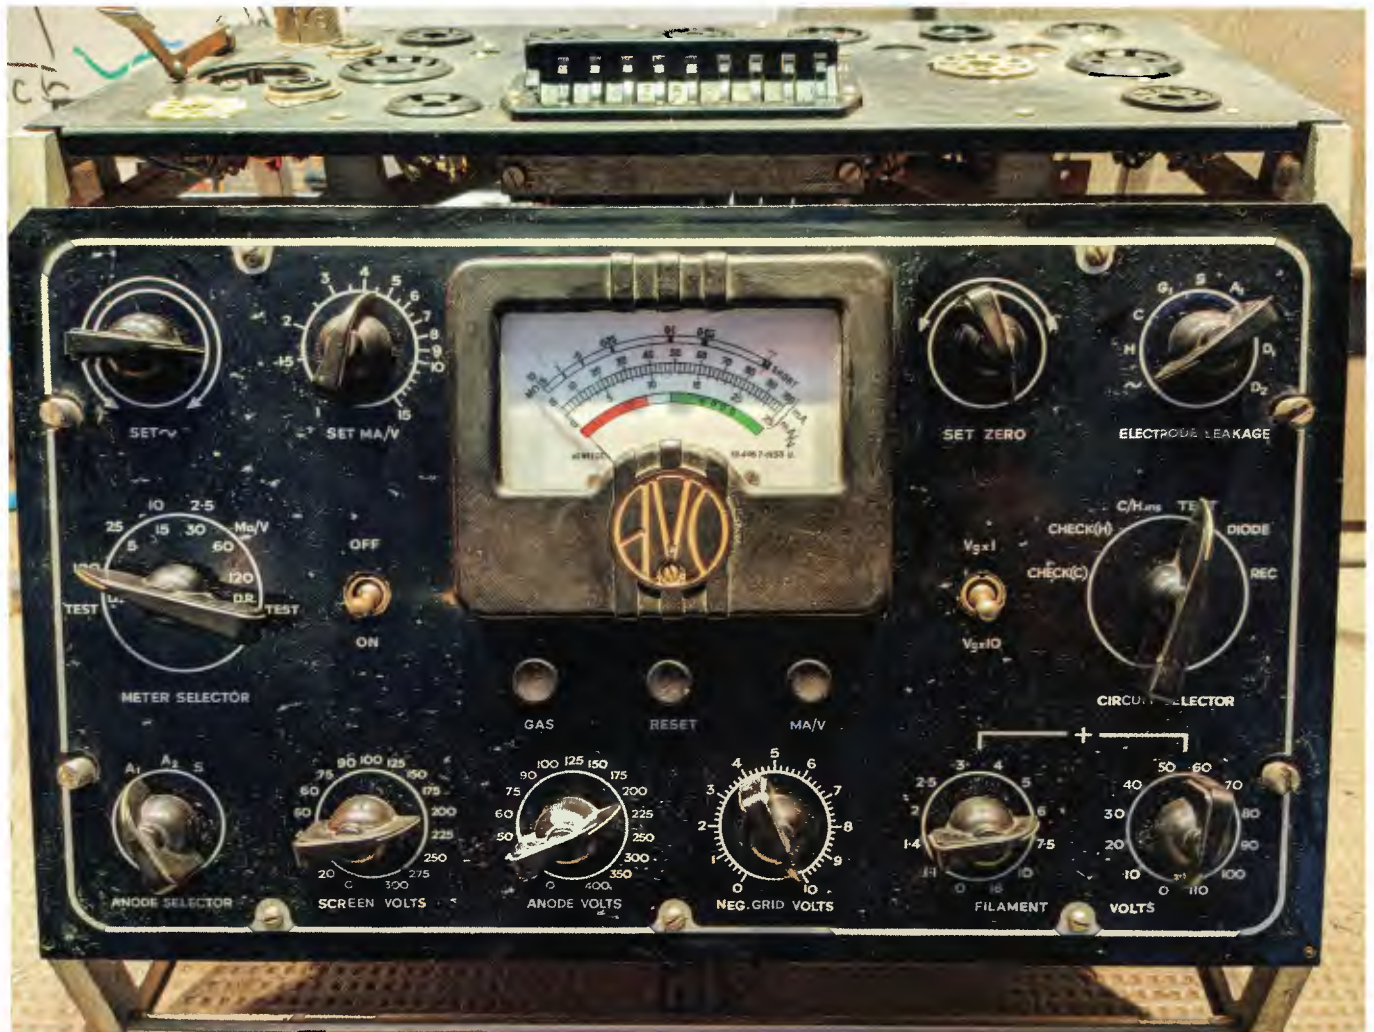
I was also asked to check a VCM MkII out by a fellow HRSA member (see lead photo and Photo 11).

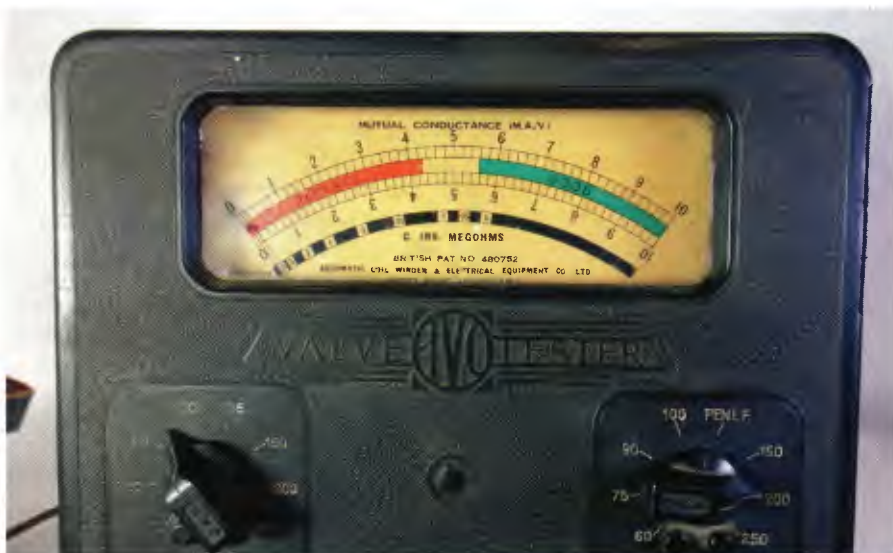
I tested several 6.3V valves: a 6J5 triode, a 6SH7 pentode and a 6V6 beam tetrode. As I was uncertain of its calibration, I set the mains tapping for 230V and adjusted my bench variac to give 6.3V on the heater of the valve under test. I got consistent readings, all low (Photo 8).

**Photo 8:** The meter scale on the original AVO Valve Tester. The 0-10 scale could read out either the  $g_m$  directly or a proportional value where 10 represented the expected  $g_m$ . Interestingly, valves with a gain as low as 56% of nominal were still considered 'good' – presumably due to the expense of replacing them.

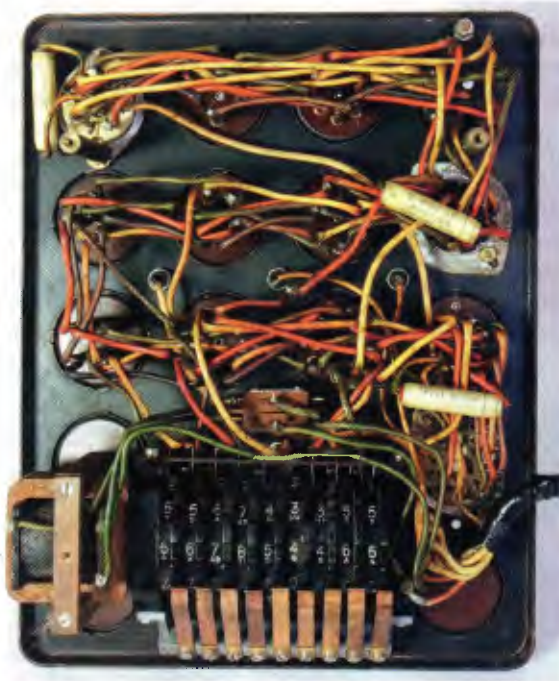
It would be odd to find one of the switches, plugs or sockets causing a low-sensitivity fault (Photo 9). They all tested OK.

**Photo 9:** The inside of the socket panel of the Valve Tester. The wiring is quite busy, but the good news is that it rarely goes wrong. Note the copper-plated springs used to create the detents on the thumbwheels.

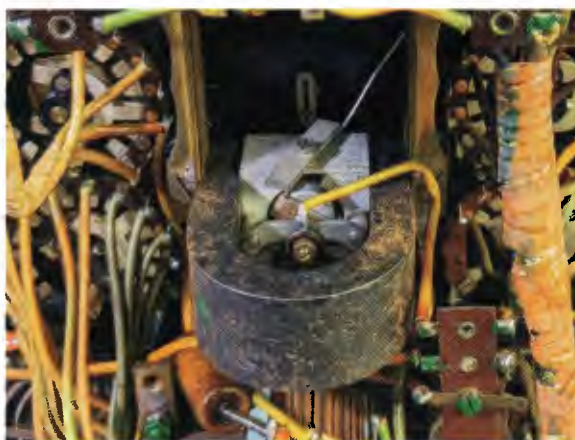
I was really hoping there was nothing wrong with the meter (Photo 10) as it would be a nightmare to fix, and finding a replacement would be almost impossible without buying a whole new instrument. It moved freely, without hesitation going to full scale or coming back to zero. And it settled to the zero mark without any tapping or jiggling. So it seemed to be mechanically OK, but what about electrically?

**Photo 10:** The meter movement is a high-precision instrument, but unfortunately, it's exposed to the inside of the case in the original Valve Tester. So you have to be careful not to contaminate or damage it if you open the unit up. Note the magnetic adjustment tab visible at the back; this gives a 5% or so FSD adjustment range.

full-scale deflection (FSD), it needed just on 1mA.

The movement is specified for a 700 $\mu$ A FSD, so it was giving only about 70% of its usual indication, explaining the under-reading of transconductance measurements. I chatted with some instrument tech mates, wondering whether the permanent magnet had weakened with age. They agreed that this was a possibility.

The meter is a very fine piece of precision engineering. The internal photo of the meter shows a small moveable tab above the polepiece area. It's a variable magnetic shunt that changes the movement's sensitivity by some 5%. Regrettably, the loss of sensitivity in this example was well outside the meter's adjustment range.

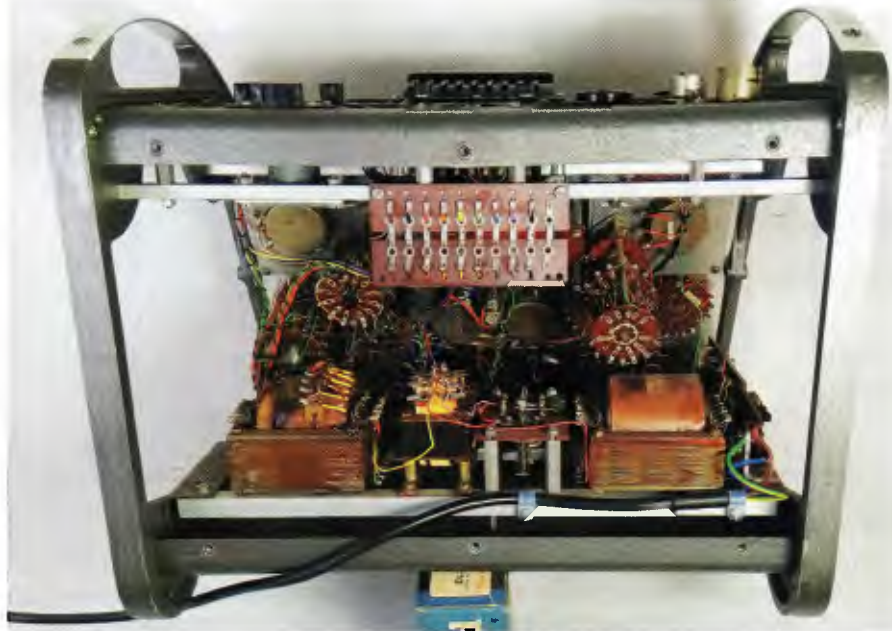
forwards from the main chassis. As the similar photo of the MkIV shows (Photo 12), the VCM's case is 'well-populated' with components. Repairs may demand extensive disassembly and desoldering.

The photo of the MkIV interior shows that it's built on a frame, with the bottom rails carrying the overload relay and three mains transformers. From left to right, these are the filament/heater transformer, grid supply transformer, overload relay and anode/screen transformer.

Photo 12: The VCM MkIV is a powerful instrument, but it's challenging to work on because many of the components are packed close together or inaccessible.

This gave an incorrect calibration indication, so I reasoned that the fault was in the calibration circuit. RV4 lacked sufficient range to correct the calibration indication, so I checked R19. Its value had gone high. Shunt resistors (to a final value of 23.9M $\Omega$ ) brought the combination down to its correct value and brought the calibration within the range of VR4.
