REPAIRING VALVES

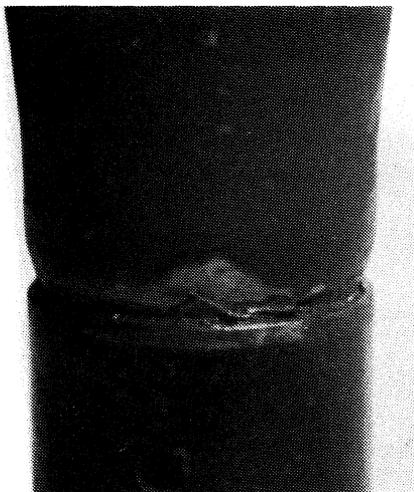
Fig.1A: A common problem with metallising. Not only has the base become loose, but the earthing wire has lost reliable contact with the shielding.

bility. A common method of earthing the shielding was by means of a fine wire embedded in the coating around the top of the base, and as can be seen in Fig.1A, any loosening of the base is likely to destroy the connection.

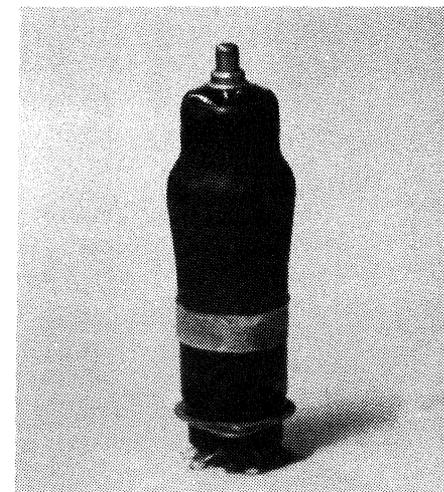
Fig.1C: After re-gluing the base and coating the wire with epoxy resin, cover the repair with a strip of tape or paper.

Figs.1B and 1C show one successful method of repair. Carefully lift out the earthing wire, scrape off the paint and then wind a layer of fuse wire on the metallising adjacent to the base, soldering the ends and the earthing wire together. Although these valves were often coated with lacquer over the metallising, contact to the fuse wire is normally adequate. If you have any doubts, first carefully clean the area to be covered with very fine sandpaper, being careful not to damage the coating further. After soldering, coat the wire and the base-envelope junction with epoxy resin.

The repair will not be very nice looking, but Philips in particular often stuck a narrow paper label around this area of their valves. A strip of tape or heavy paper to disguise the repair will not therefore look too much out of place.
