Vintage Radio

RCA's first TRF receiver

Renovating an RCA Model 20

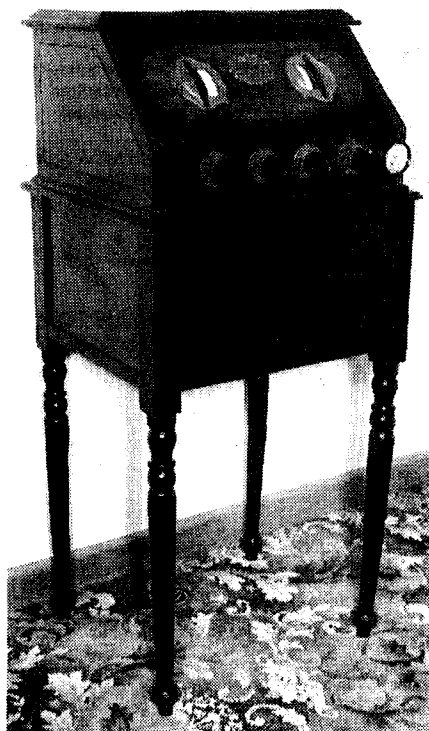
Fig.1 (above): This table model version of the RCA 20 has an overall black cabinet made by the Salt-Smith Trust of Salem, Indiana.

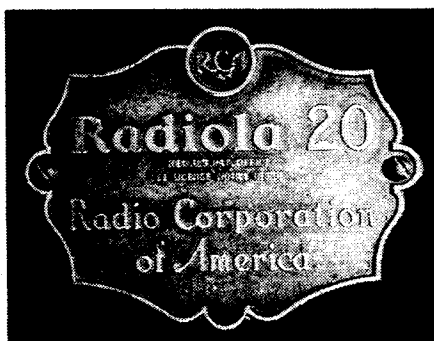
Fig.3: Only an ornate embossed brass badge was good enough for RCA. To avoid conflict with AWA's rights to the name 'Radiola', badges on sets intended for Australia had the name altered to Radio 20.
