Two postwar Kriesler mantel sets

A very popular radio with Australian households after the war was the Kriesler 'Beehive' model, first produced in 1946, which has become a collector's classic. The second set we discuss this month is the 11-29, a later model in the Kriesler mantel range which was also quite popular.

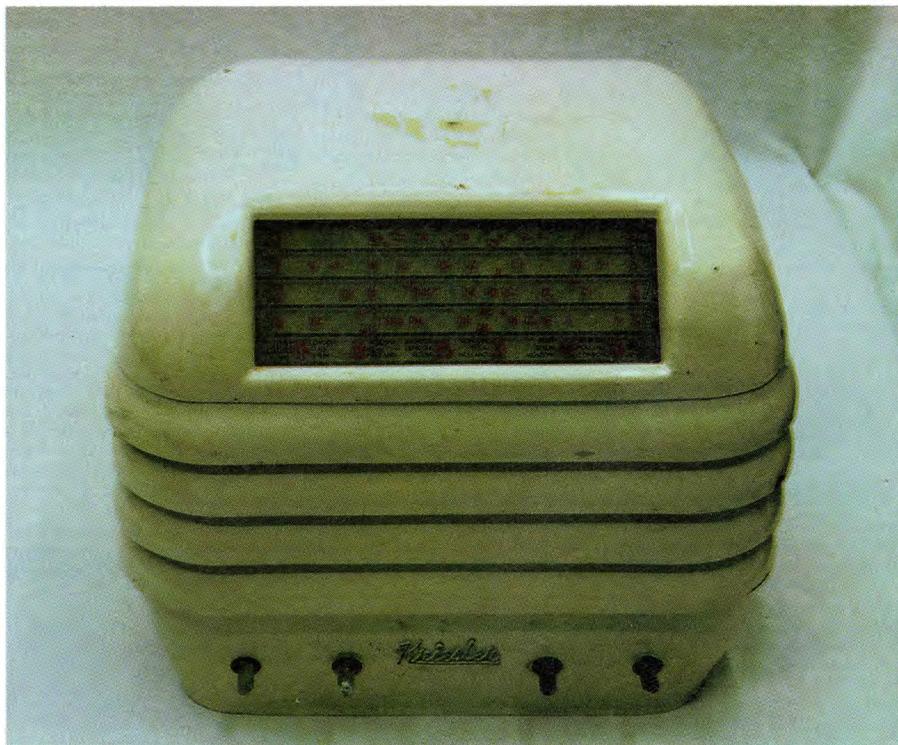
Fig.1: The Kriesler 'Beehive', in factory cream as repainted with household paint.

The photo in Fig.1 shows a factory painted cream, which has been subsequently been given the 'once-over' with the inevitable coat of Dulux Super Enamel — which in this instance looks as though it was applied with a clothes brush. The colour is, of course, the very fashionable 'off white'!

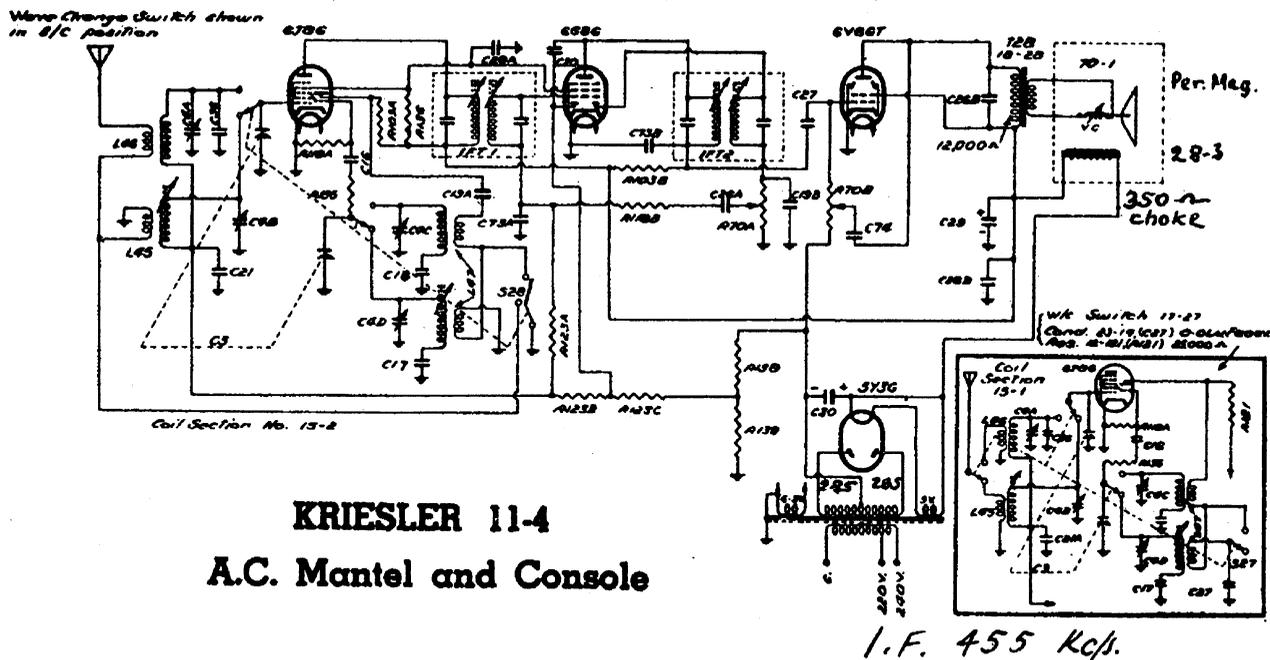
KRIESLER 11-4 A.C. Mantel and Console

Fig.2: The circuit of the 11-4, which dates from 1946.

The circuit (Fig.2) holds no great surprises. The shortwave aerial primary is in series with the broadcast primary, affording a cost saving — as too are the exciter sections, i.e., secondaries, of the oscillator coils. When switched to short waves, that portion of S28 is closed, resulting in an earthing

bar shorting out the broadcast oscillator tuning coil as well as the broadcast aerial coil primary.

The inset modification uses a four-position switch in which all coils are switched in the more conventional manner. Note also that in the modified front end, the oscillator anode isolating capacitor is in the earth end of the coil, and not the anode or 'hot' end.

Note that the reflexing is used around the 6G8-G IF amplifier stage, so that it also acts as the first audio amplifier. One of the valve's two diodes acts as the main detector, and the other as the AGC detector.

6G8-G are fed from a common resistor and bypassed via the same capacitor. Delayed AGC is applied to both the reflex stage and the mixer stage in what was slightly unusual practice. Back bias to all stages is obtained from the divider network R138 and R139, and the 6V6-GT is over biased to limit power output and total current consumption. There is no attempt at audio feedback (thank heavens).

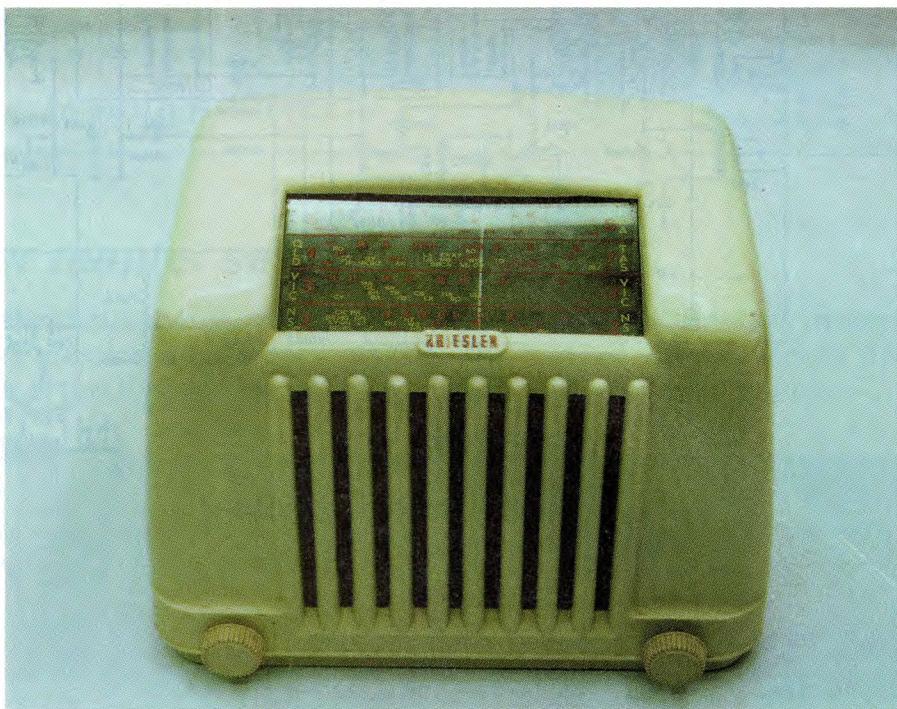
Fig.5: The later model 11-29, in factory cream bakelite.

This receiver was chosen for no other reason than it was featured on the dust cover of Ingliss' definitive history *This is the ABC* (K.S. Ingliss, Ingliss 1983). A sample is shown in Fig.5.

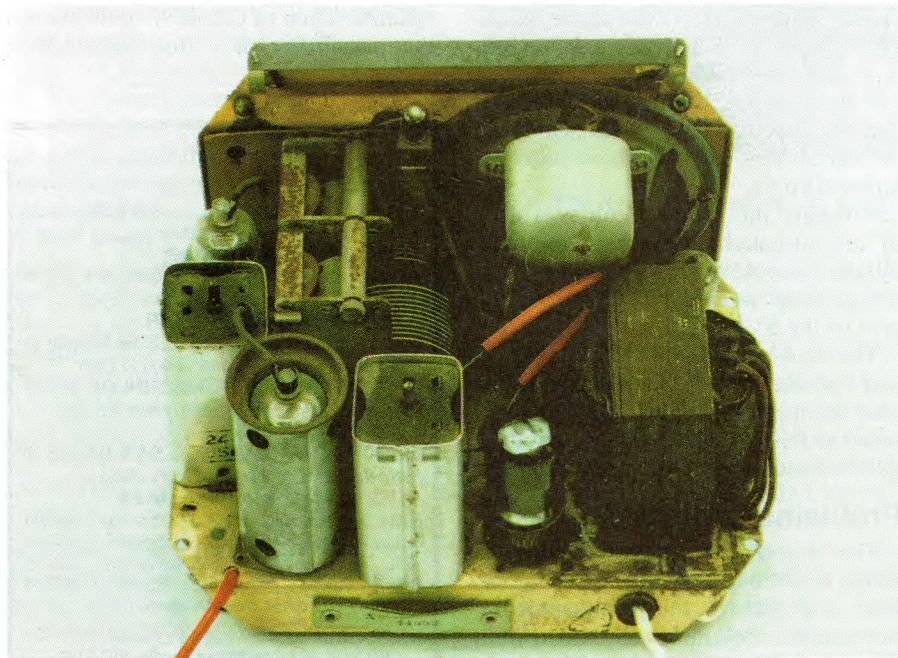
Fig.3: This particular chassis variant has an electromagnetic speaker and a replacement output transformer.

Basically, the major alterations consisted of a field coil electrodynamic speaker, a filter choke, a high wattage filter resistor used in conjunction with or instead of the filter choke, a 6X5-GT rectifier and an ECH 35 converter. A given variant could incorporate some or all or a combination of those alterations, as was seen by the above example. Above and below chassis photographs are shown in Figs.3 and 4.

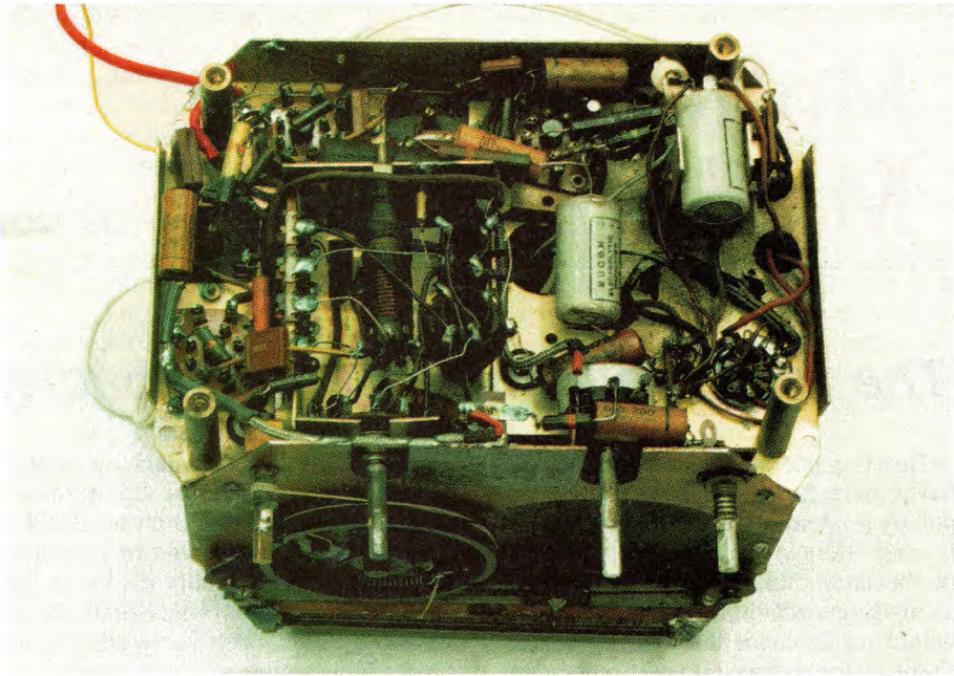
Fig.4: Under the 11-4 chassis. Apart from the replacement of electrolytics, this sample is very original.
