Vintage Radio

Vibrator Power Supplies - 3

Having looked at the theory of operation of the vibrator power supply, let's now turn our attention to bringing those old vibrator sets back to life and working as they were intended.

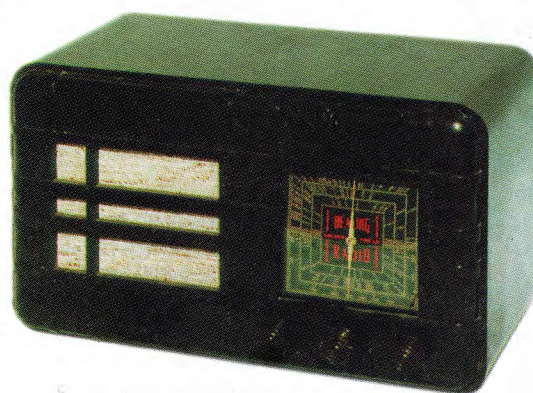
Fig.1: The Healing 408A four-valve mantel radio of 1938, which uses a vibrator power supply.

THERE WAS A huge range of sets made with vibrator power supplies, and Figs.1 and 2 show just about the ends of the spectrum. The small mantel set of Fig.1 is a Healing model 408A of 1938 vintage, using four 2.0 volt pre-octal valves, while the much larger console shown in Fig.2 is a substantial Healing dual wave model 668A, also of 1938.

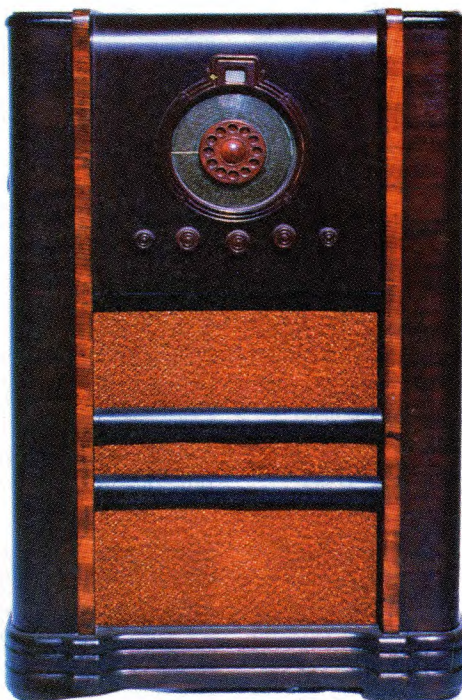
Fig.2: The Healing 668A dual wave six valve console set, also of 1938 and vibrator powered. It's a very good performer.
