Two magnificent consoles

While some radios are collected for their technical refinements, probably the majority are collected because of their visual appeal. The two console radios featured this month fit well and truly into this category.

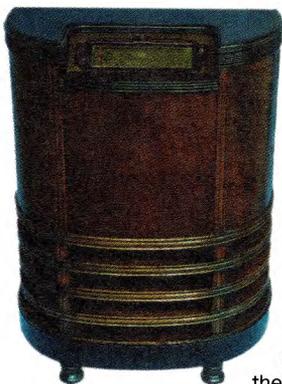
Fig.1: The eloquent Stromberg Carlson model 781, in its semi-elliptical console.

The completed and restored radio now looks every bit as enticing as the images described above. The solidly built cabinet is semi-elliptical in plan (i.e., looking from

above) and has a stratiform speaker grille, which is offset by the black plinth at the base of the cabinet and black trim on the top. The accommodating dial has a central magic eye tuning indicator, and the edge-operated controls are tuning on the right, and split volume and tone on the left.

Sitting below the dial are a series of 10 self-cancelling pushbuttons. Eight are pre-set station selectors, while the other two are for selecting short wave and manual tuning.

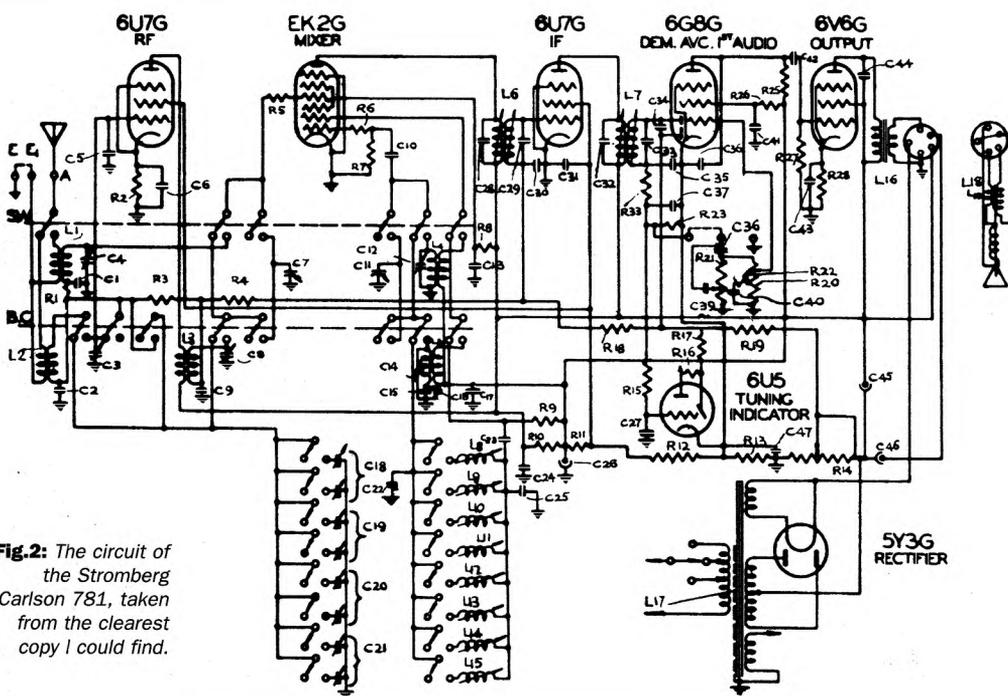
Fig.2: The circuit of the Stromberg Carlson 781, taken from the clearest copy I could find.

The rather cramped and blobby circuit (the best I could find) is shown in Fig.2, and suggests what's in the chassis. The basic pushbutton arrangement can be seen, but the actual wiring is a far cry from the simplified circuit. Each of the pushbuttons activates a spring loaded cancellation bar, which in turn operates a set of 10 axially arranged switch banks. The bare wiring from one to the other is extremely complex, and would be well-nigh impossible to trace and correct in the unfortunate event that it had been tampered with.

As you can see from Fig.2 this is quite interesting. A quick glance shows an RF amplifier, thereby giving the

expectation of good results. However when we trace the circuit through, we see that the RF amplifier is only switched in for the broadcast band manual tuning function.

The two switches with dashed lines to the right and designated 'SW' and 'BC' represent the pushbutton selectors for those two bands respectively, in which manual tuning is functional. In the circuit, the broadcast band is shown connected, but with the pushbuttons in circuit.

If you follow the first 'BC' contacts (i.e., the wipers and contacts as shown), you see the top of the tuning coil then connected to a series of pairs of trimmers (C18 to C21). These trimmers, which tune the aerial coil L2, then connect via the fourth 'BC' contacts and the second set of 'SW' contacts to the grid of the EK2-G mixer. The RF amplifier is not used. At the same time, though, the AGC is connected to the 6U7-G grid despite there being no signal input.

If the 'BC' manual option is selected by pressing the B/C pushbutton, the wipers of the 'BC' switch now swing over to the right hand contacts. This connects gang section C3 and trimmer C5 (at the 6U7 grid) in circuit, and the RF coil L3 is tuned by C8 and gang section C7 via the third and fourth con-

tacts of the 'BC' switch and the second set of contacts of the 'SW' bank.

If short waves are selected (from any given pushbutton option), all other pushbutton connections are cancelled, and the wipers of the 'SW' switch sections are moved over to the right-hand contacts. It becomes pretty clear that the shortwave coil goes direct to the EK2-G grid, being tuned by gang section C7 and trimmer C4. Again AGC is applied to the

6U7-G grid, despite it having no signal input.

As for the oscillator section, if the pushbutton tuning option is selected as shown, we see that coils L8 to L15 are slug tuned Colpitts oscillators. When manual tuning is selected, gang section C11 and trimmer C14 are switched in and tune L5. (The circuit is very difficult to follow because of its very poor quality draughting and printing.) The circuit has several mistakes in component parts corresponding to the parts list.

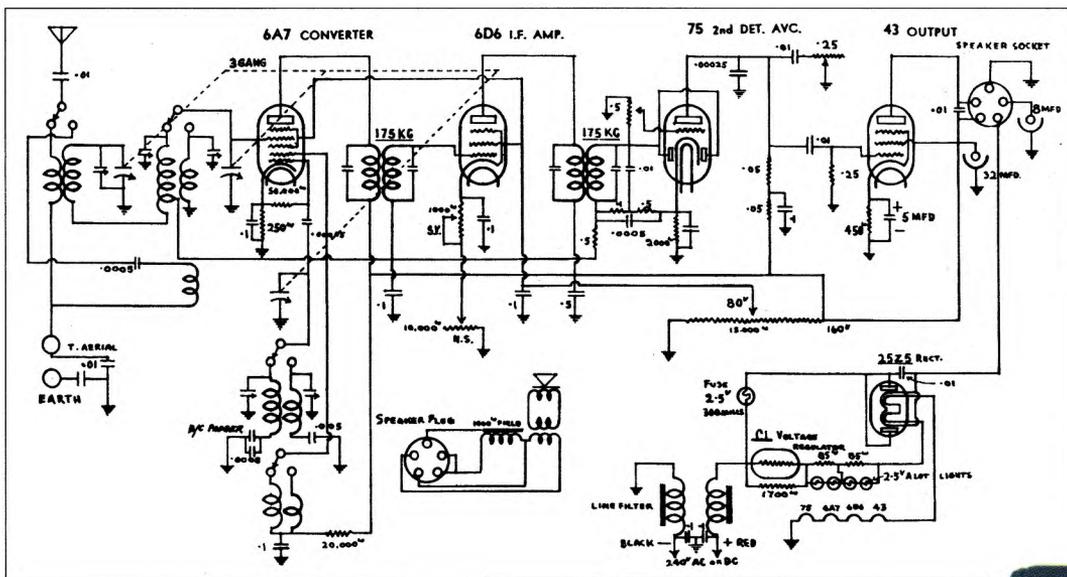
Fig.5: The circuit for Kriesler models 830-833, the closest I've been able to find to that actually used in the 710.

There is no known circuit for this radio, despite the numbers '710' being quite clearly stencilled on the chassis. The circuit is significantly different from that published for the 710A, and can only be guessed at. The front end very closely resembles the models 830-833 which were published in the Radio Trade Annuals and the *Australian Official Radio Service Manual* for 1938. The circuit shown in Fig.5 is for an AC/DC version, and there seems to be nothing in a normal 240V AC version that matches the front end.

Be that as it may, careful examination of the chassis showed that the coils and switching arrangements are as in Fig.5, apart from the DC isolation capacitors used in the AC/DC model.

What is unusual is that this circuit offers short wave reception with a 175kHz IF — and although there's a pre-selector coil for the broadcast band, there isn't for short waves.

The Kriesler chassis has four controls, the normal four plus a sensitivity control in the cathode of the 6D6 IF amp. The circuit actually shows two pots in series, as you can see: one marked 'NS' (presumably for 'noise suppressor') and the other 'SV' for sensitivity volume. Just why two controls are used in this position is a bit of a mystery. Was the second control a chassis control or a panel control? There is in fact only one on the 710.

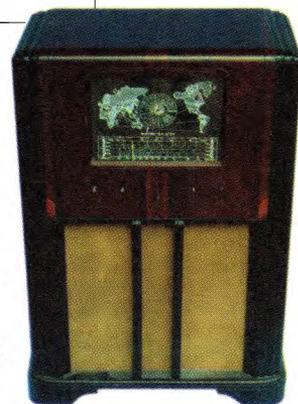
Fig.3: The cabinet of the Kriesler 710, a 1937 model famous for its elaborate dial.

There is no doubt that a radio with a broken or missing dial glass is significantly reduced in value, and there could be nothing more devastating than to have this happen with a Kriesler 710 'Map of the World' set (Fig.3), because here the dial glass is absolutely one of a kind and quite rare. In fact the dial glass almost IS the radio, as can be seen from the closeup in Fig.4. This is notwithstanding the handsome cabinet of pleasing proportions and veneers — and again, black striping and trim (and dust!).

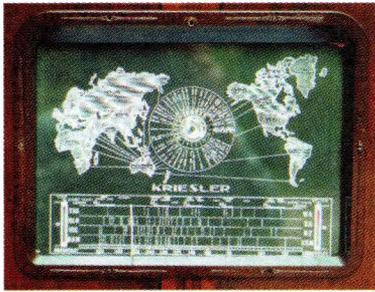
Fig.4: Here's a closeup of the 710's impressive 'Map of the World' dial glass, with its universal time indicator and tell-tales for volume and tone.

A novel feature is that the volume and tone controls are connected via cords and pulleys to little red tell-tales which travel vertically alongside the edges of the dial markings. The more red that shows, the more the controls are advanced...

However, without doubt the most stunning feature is the huge map of the world with its universal time indicator. If you look closely at Fig.4, you may see a prominent hole in the upper centre of the escutcheon. Undoubtedly a shaft and control knob should protrude through here, because directly behind the central disc are two pulleys. What you do is set the local time as per the inner disc, to the country marked radially on the rim. Then the time in any part of the world can be directly read off by referring the desired country to the time on the inner disc. However it takes no account of summer time!

It is going to require some fiddling around on a lathe to make up the required shaft and to then connect up the universal time indicator. Then the radio will be fully complete.
