# Vintage car radios

**J. LeJeune takes a look at car radio design in the post-war period, up to the time when transistors came into use, and in particular considers the power supply arrangements**

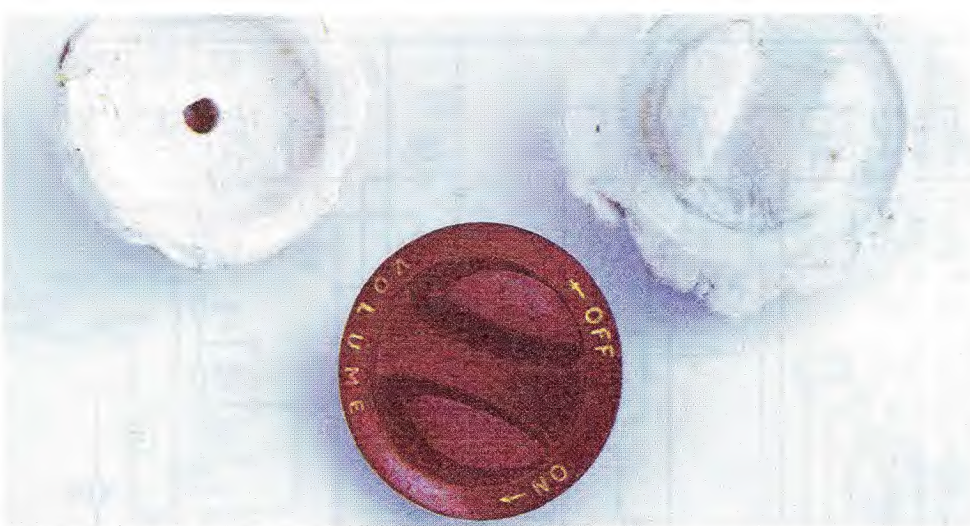
**Photo 2:** The original Ferguson 352U volume/on-off control knob and the moulds taken from it.

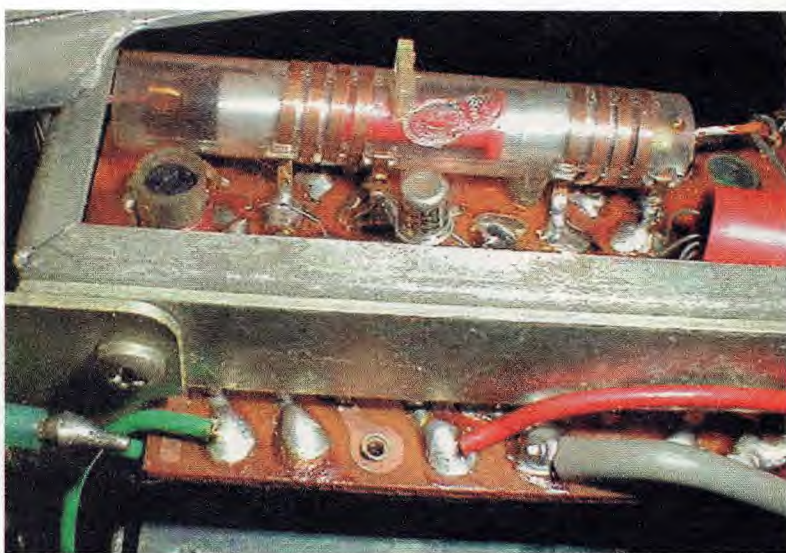
**Photo 3: The VHF tuner, after removal of its screening can.**
