# VINTAGE RADIO

## Making a few odd repairs

**It often only takes a few simple repairs to keep an old vintage radio in working order. It helps if the valves are in their correct sockets, though.**

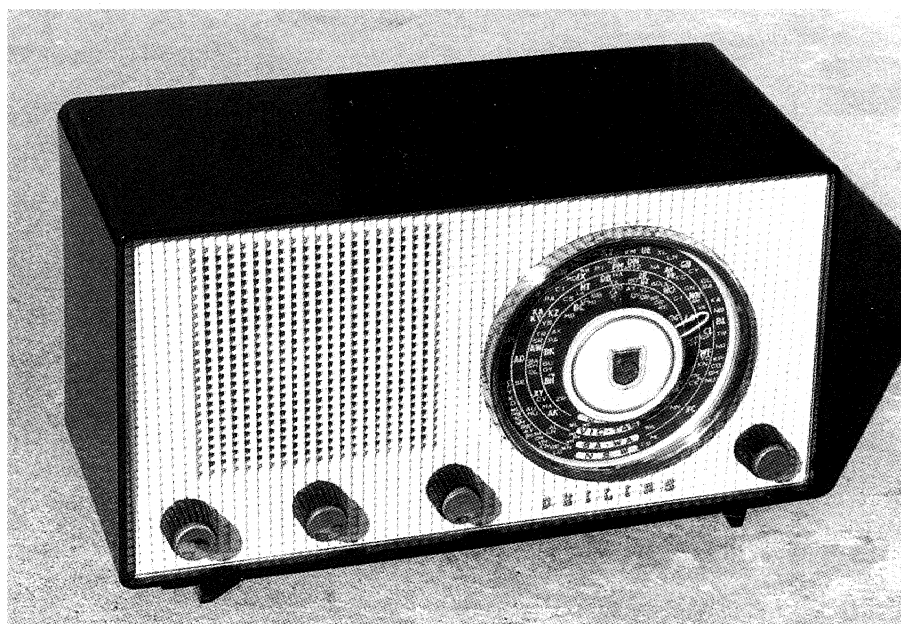
**This little 5-valve Philips receiver has been operating on a Silastic repaired speaker cone for the past seven years.**

The speaker in our kitchen radio (a late 1950s 5-valve Philips) was also "bogged up" with Silastic about seven years ago. Although this repair has not been checked since, the set is still working OK so it is, presumably, another successful speaker cone repair.

Once again, the little Philips receiver is on for at least four hours a day and gets constant use.

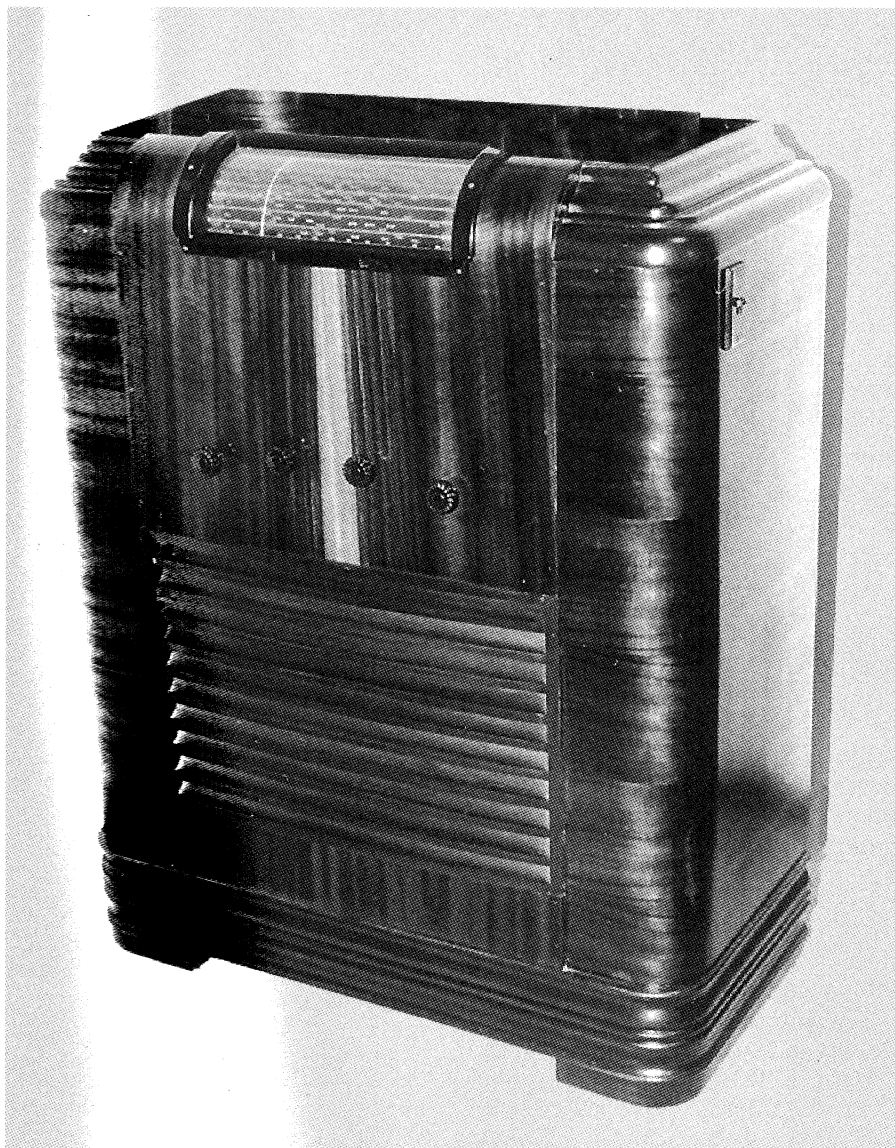
The console receiver that Doris "adopted" is a 1940, 5-valve, dual-wave unit with good performance. Shirl's cabinet restoration was a top job!

The main problem with the receiver was weak and distorted sound, which was quickly traced to an open screen resistor. Once the defective component was replaced the set fired up as it had always done and the ailment was completely cured.

The original restoration saw the replacement all the paper and electrolytic capacitors. The resistor values were all OK and, as a result, the set has been working as it was designed to work. It was only the failure of a screen resistor that brought this good run to a halt.

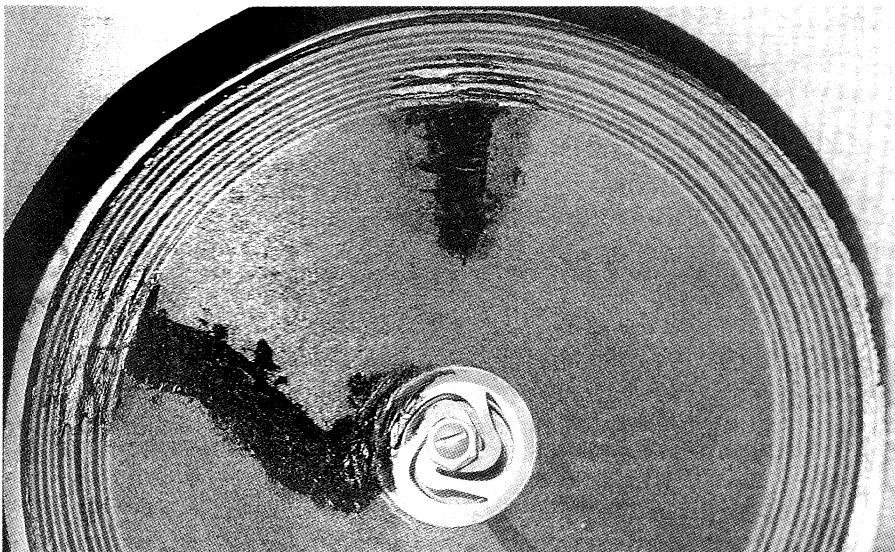
This particular speaker cone was split from rim to centre. The repair has not had any apparent adverse effect on its performance.

Another point of interest is the loudspeaker. Five years ago the speaker cone was starting to split at the outer edge and these splits were repaired using Dow Corning "Silastic". The type used was the automotive gasket formula – the one that smells like vinegar.

In this instance, the repair was still intact and looked as though it would remain that way for quite some time to come.

When applying Silastic to a speaker cone, it needs to be rubbed well into the paper for good adhesion and used as thinly as possible. Whilst this repair method has been mentioned before in this column, it was comforting to see a repair which has been in service for many years and showing no signs of lifting or cracking.

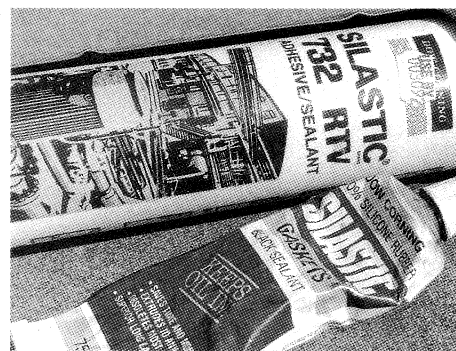
**Dow Corning's Silastic is ideal for speaker cone repairs. It is tough, flexible and adheres to the paper cone very well.**

Incidentally, a wet finger will smooth out the Silastic and help to finish off the job more neatly.

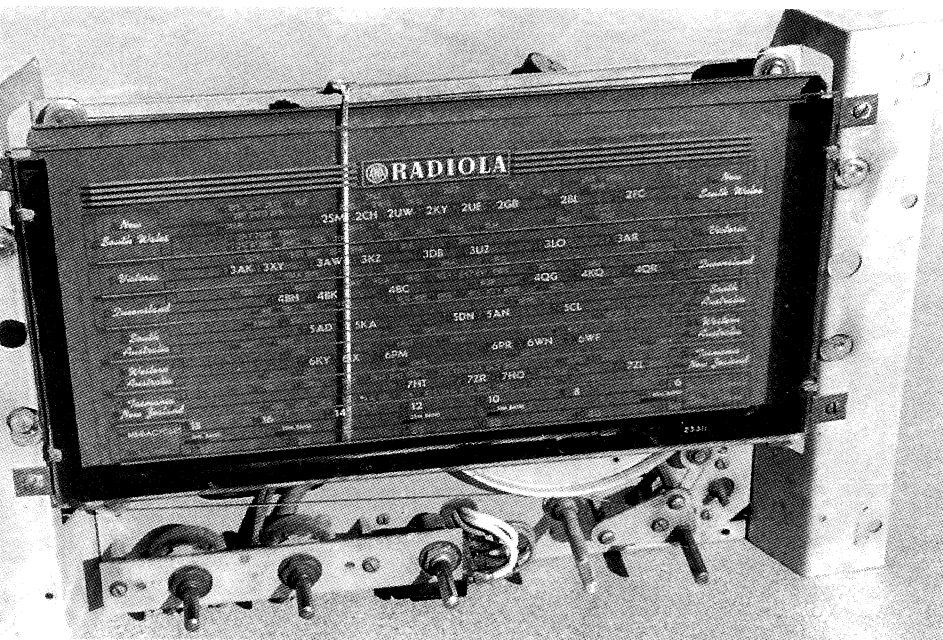
**This Radiola console chassis was sent to me for repair by someone in Queensland. Unfortunately, it was sent in without its loudspeaker and output transformer, which complicated the troubleshooting procedure.**

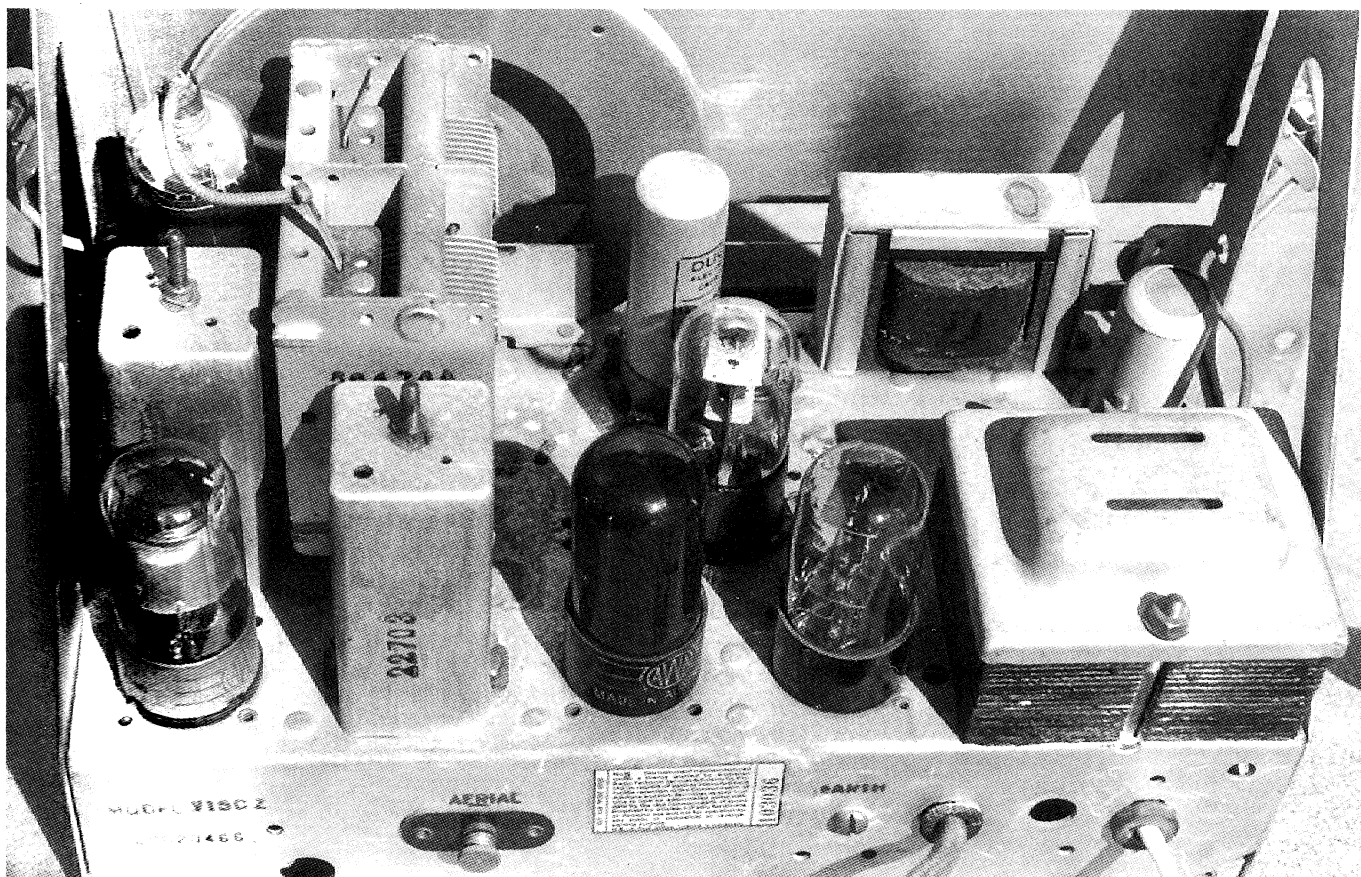
The main problem was solved when it was discovered that the 6SQ7 and the 6V6 valves failed to light up because some "expert" along the way had put them into the wrong sockets.

**A rear view of the Radiola chassis. The old receiver wasn't working because two of its valves (the 6V6 and 6SQ7) had been transposed in their sockets. Once the valve problems were sorted out, it worked quite well, even with its original paper capacitors.**

And yes, you guessed correctly! When the valves were changed over and a speaker and output transformer substituted, the set burst into life without replacing a single component. So, once again, that left the output transformer as the number one suspect.

After eliminating a number of other possibilities, the fault turned out to be in the filter choke itself. While the

winding was still intact, it was shorting to the core laminations which was most undesirable to say the least. A replacement choke solved the problem and the Radiola chassis was on its way to Queensland that afternoon.
