VINTAGE RADIO

The Diason P.P. 32/6 DC receiver

Designed for rural communities, the Diason P.P.32/6 employed six valves and ran off 32V DC. It was a good performer with some interesting design features.

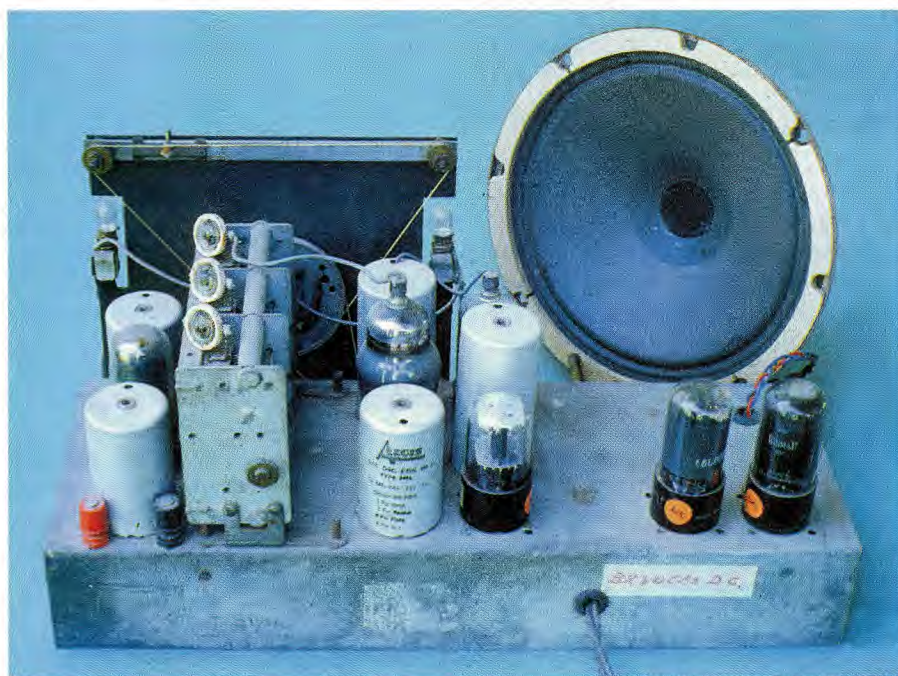
The chassis is easily removed from the cabinet for service, although the loudspeaker also has to be removed since its leads are too short.

The loudspeaker is attached to the cabinet and its leads are too short to allow the chassis to be withdrawn easily. Additionally, it is not practical to work on the set with the speaker in the cabinet. The leads can be extended or the speaker removed from the set to allow service as shown in the accompanying photograph (extending the leads is my preference).

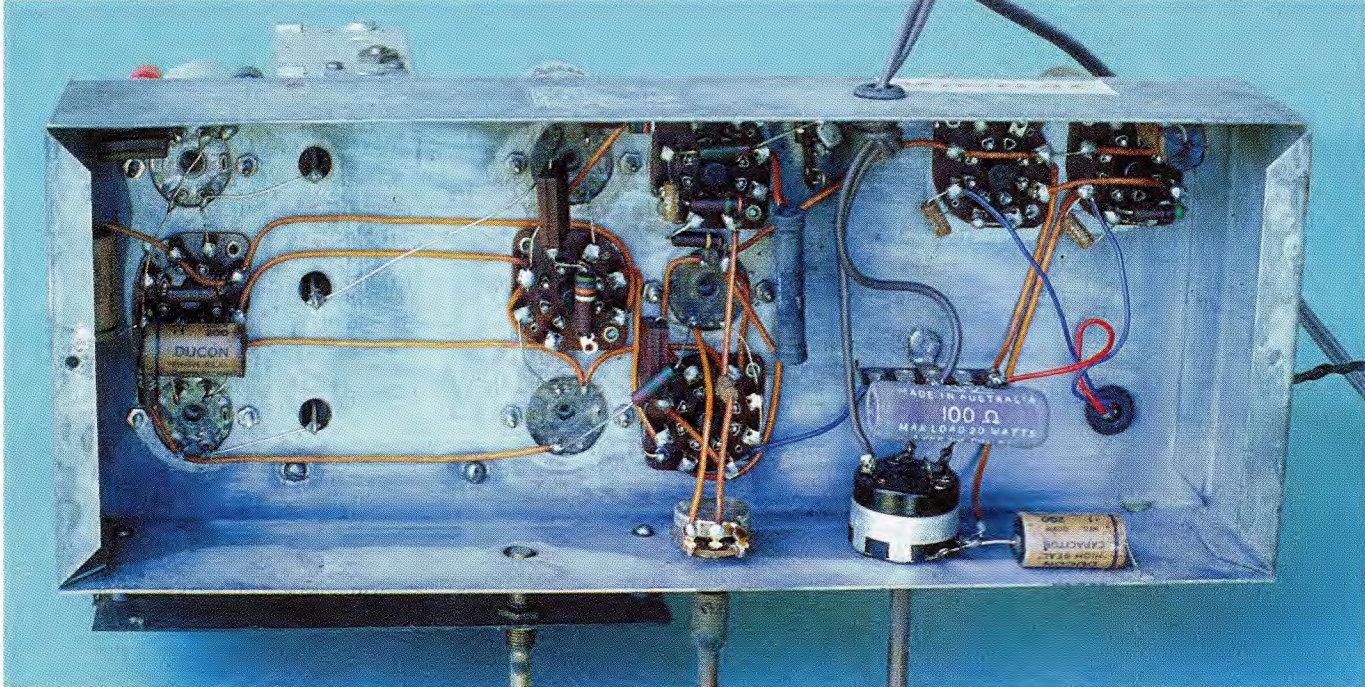
This under-chassis view shows just how few components there are. This made for a reliable set that's very easy to work on.

Inspection of the underside of the chassis didn't reveal any paper capacitors sufficiently leaky to warrant replacement. They must have been a good batch – either that or the low HT doesn't stress the capacitors as much as in a set with higher HT voltages.

Even so, I would still replace the most critical capacitors, these being C9 and C13 in this set.

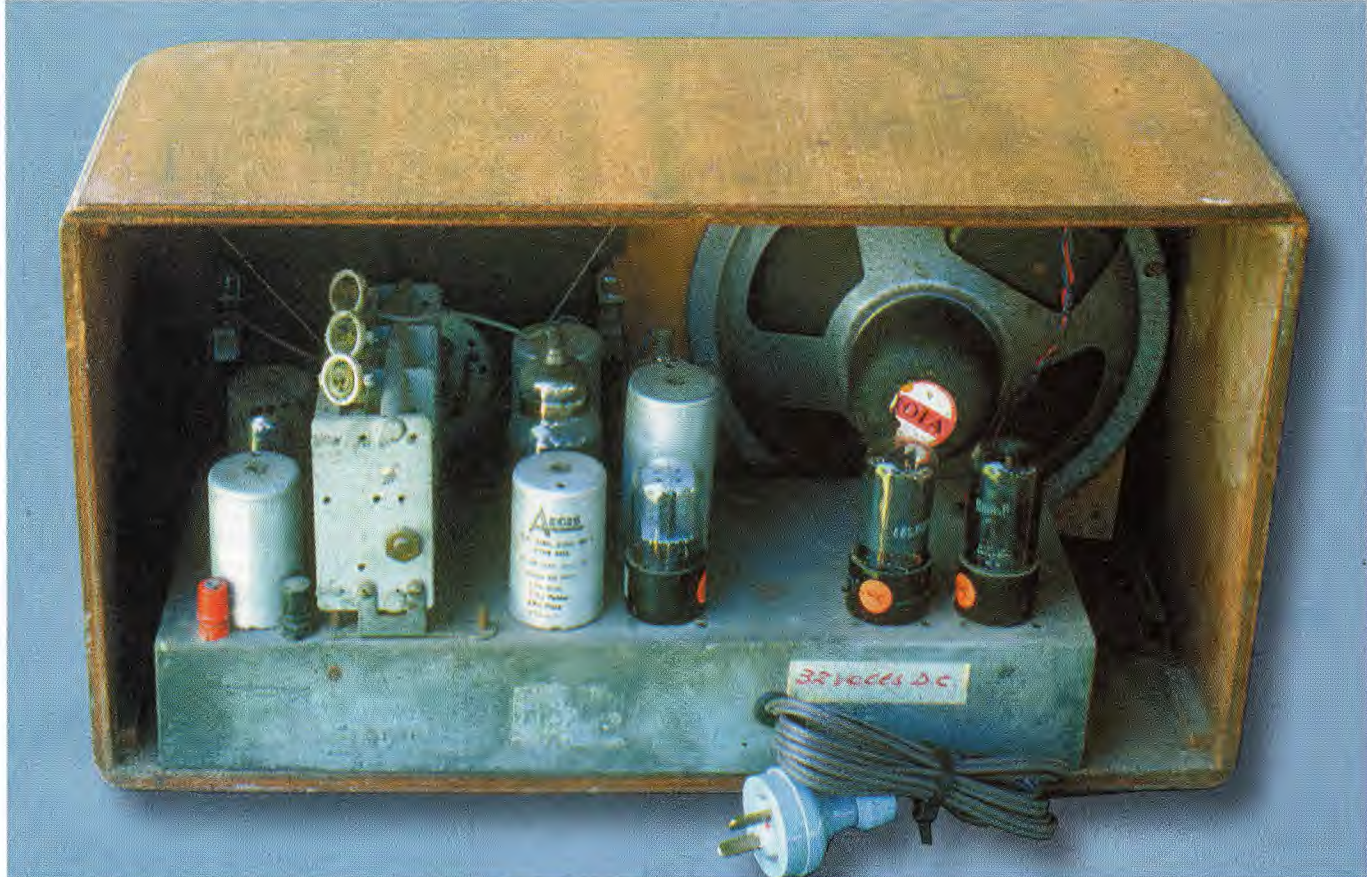
There's plenty of room for the chassis inside the cabinet. In this case, the twin power lead was fitted with a 2-pin polarised plug but many early DC sets were initially fitted with a 3-pin mains plug. As a result, many 32V sets have been plugged into the 240V AC mains with disastrous results.

The twin power lead was fitted with a 2-pin polarised plug. It's interesting to note that many DC sets were fitted initially with the normal 3-pin mains plug and, as a result, many 32V sets have been plugged into the 240V AC mains with disastrous results. People forget that voltages other than 240V AC were often used in earlier times.

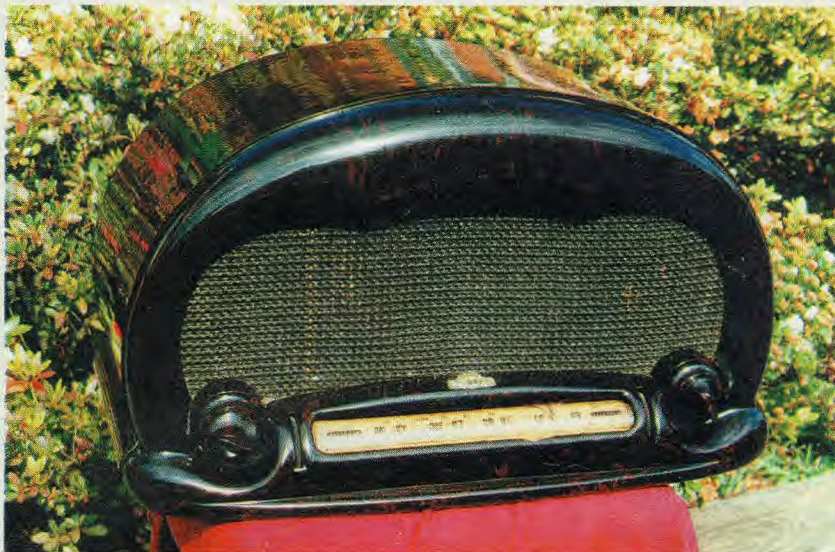
Photo Gallery: Astor Model JN

Manufactured by Radio Corporation (Melbourne) in 1948, the Astor Model JN is a 6-valve dual-wave superhet housed in a substantial Bakelite cabinet and fitted with an 8-inch (200mm) loudspeaker. The combination of the large loudspeaker and an effective loudness compensation circuit around the volume control resulted in good audio performance, for which Astor sets were renowned. The set was fitted with the following valves: 6U7-G RF amplifier; 6J8-G frequency changer; 6U7-G IF amplifier; 6B6-G first audio/detector/AVC rectifier; 6V6-G output; and 5Y3-F rectifier. (Photo and information courtesy of Historical Radio Society of Australia).

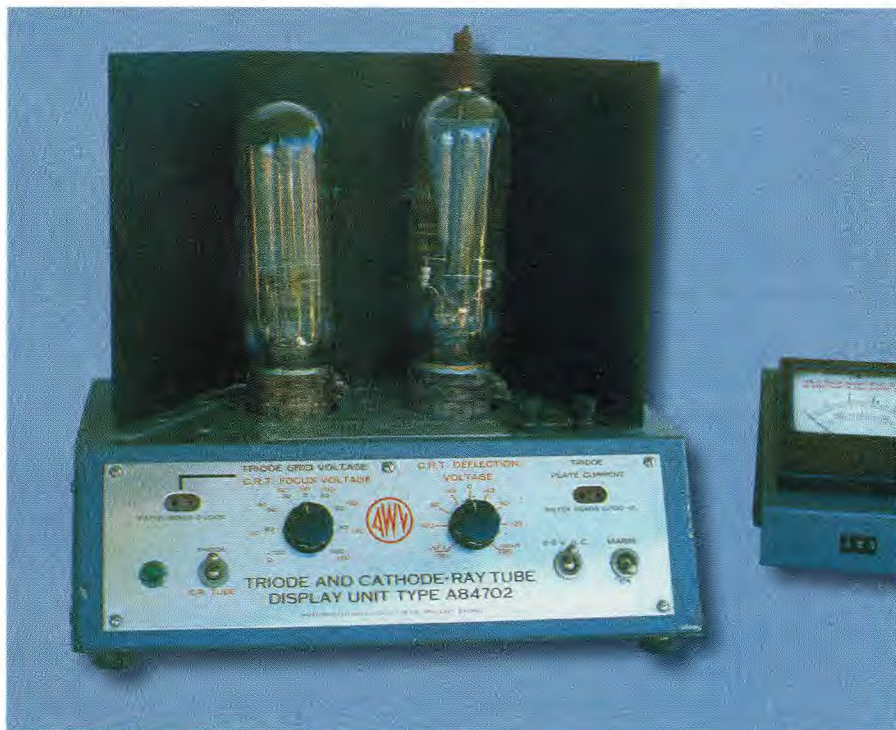
AWA TEACHING AID

Made by AWA during the 1960s, this device was designed to teach radio technology students how valves worked. The valve envelopes were large so that students could easily see the various parts that made up the two valves (one a triode, the other a CRT) on top of the chassis.
